# **RECAPP Facility Evaluation Report**

**Grande Prairie S Dist #2357**

**Alexander Forbes School**

B3492A

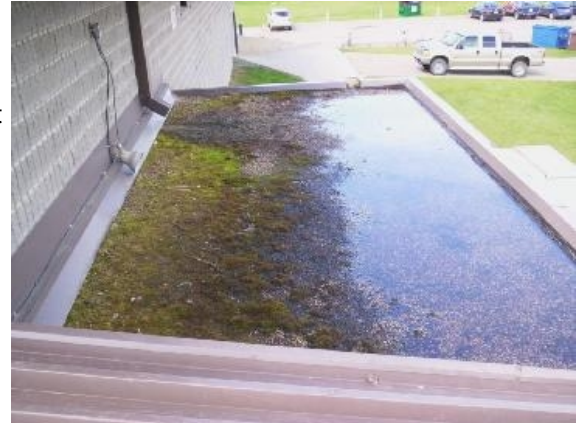
**Event: Repair built-up-roof.**

**Recommendation:**

Repair built-up-roof. (approx. 1000 square metres)

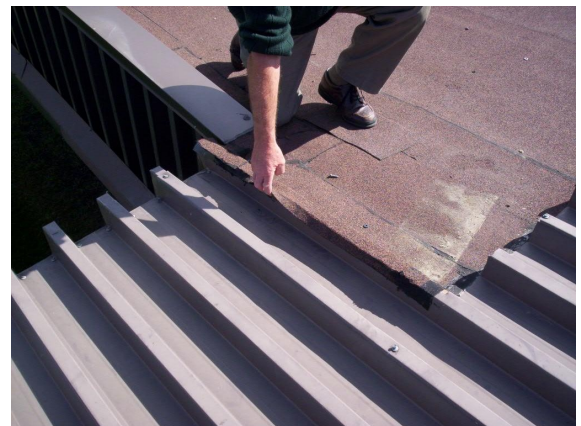
Roof leaks, ponding, rough base sheet. Connection between metal roofing and SBS loose. (SBS under warranty)

Repair SBS roofing.

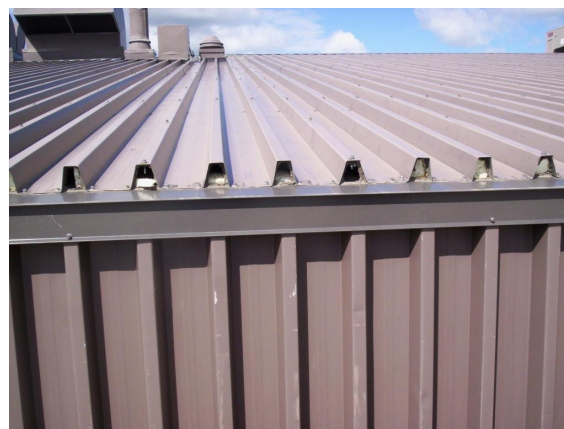
Metal roof screws had been removed or missing. Metal roof edges require insulation or metal closures. Snow falls off the metal roof during winter.

Repair metal roof and snow deflectors.

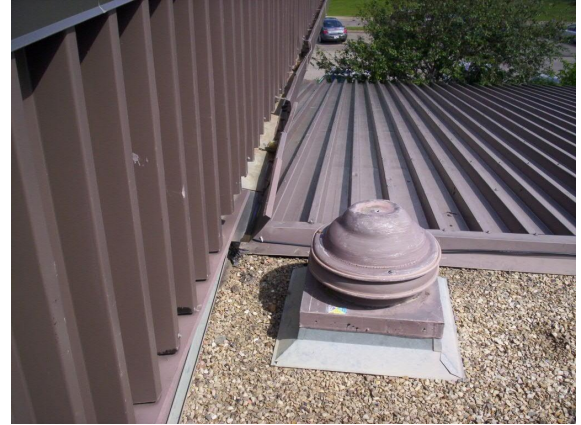
Roof drains on built-up roof have gravels inside causing ponding; need strainers protection.  
 Roof water gutters and drains between metal roofs have broken apart and are filled with debris.  
 Roof scuppers (Main Entrance Roof) plugged with debris causing ponding.  
 Metal eavestroughs are damaged.  
 Roof drains entered the buildings and connected to downspout which were installed too high above the concrete splashpads.

Repair and clean up roof drains, downspouts, scuppers and gutters.

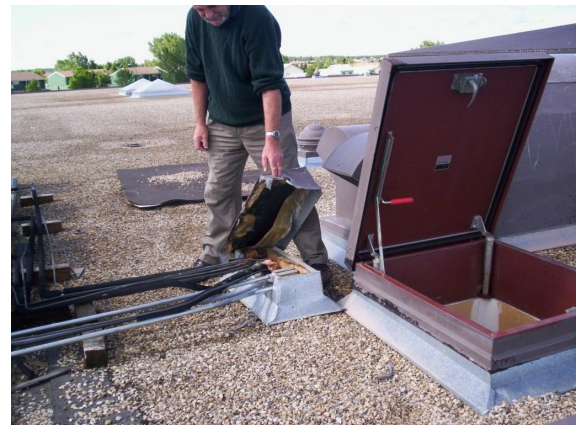
Metal roof covers for mechanical accessories are in bad condition.

Replace metal roof covers.

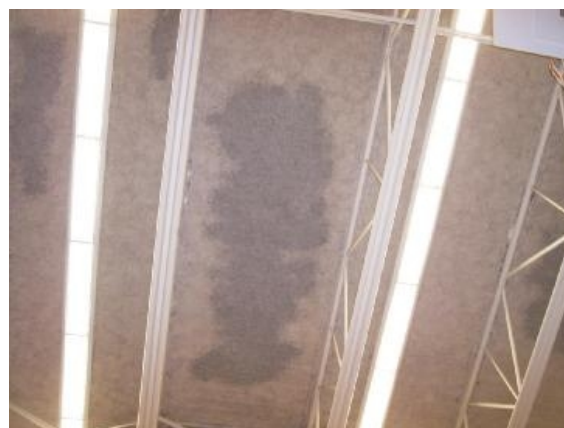
Spray on soundproofing material loose and damaged by impact. (approx. 601 square metres in Gymnasium and 105 square metres in Stage) Material may not achieve the expected fire rating and acoustical effect.

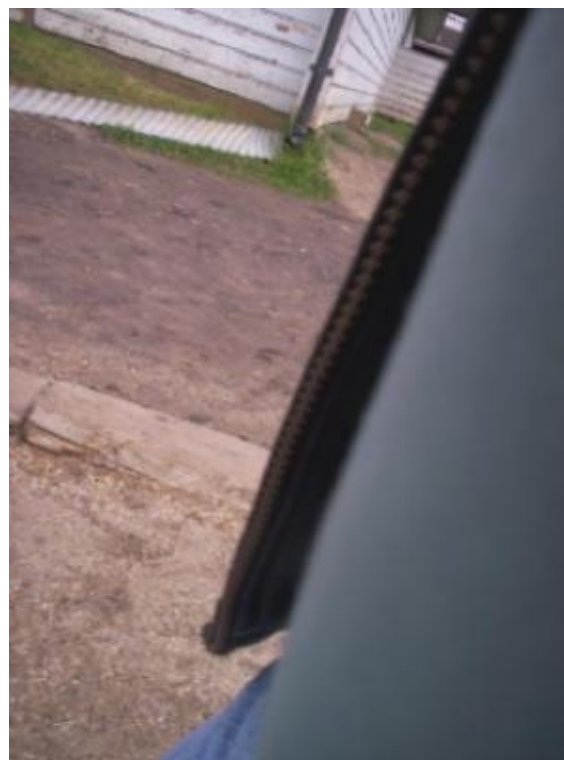
- Bad odor from floor in Classroom 150.
- Rotten and wet wood foundation and exterior wall.
- Rotten floor assembly.
- Ripple, soiled and stained carpet in Classrooms.
- Cupboards and countertops and doors with damaged plastic laminate finish.
- Moisture and wet in crawl space.
- Grading leveled with cedar siding.
- Cedar siding worn out and peeled off.
- Stained acoustic ceiling tiles.
- Condensation around aluminum windows.
- Unleveled floor in Corridor.
- Moisture and wet in crawl space.

- Regrade soil around building. \$1,500
- Replace concrete grade beam and raised foundation walls. \$80,000
- Replace new floor assembly. \$80,000
- Replace cedar siding. (approx. 97 metres x 3 metres) \$14,550
- Replace acoustic ceiling tiles. (approx. 700 square metres)

\$14,000  
 Provide sump pit and pump in crawl space. (1 unit) \$1,000  
 Replace carpet flooring in Classrooms. (approx 800 square metres) \$ 40,000  
 Replace cupboards and countertops with plastic laminate finish countertops and birch doors. (approx 60 metres) \$30,000  
 Replace aluminum windows. (16 windows) \$16,000  
 Repair floor construction. (approx. 70 square metres) \$14,000  
 Remove mould in accordance with the recommendations provided by consultant (See F2020.04 Mould) \$5,000

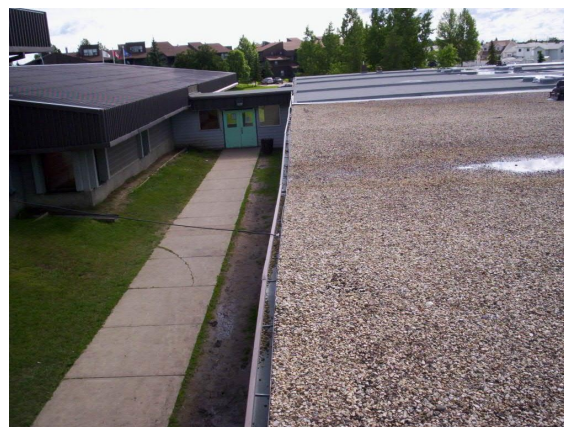
- Grading levelled with cedar siding.
- Rotten wood foundation.
- Rotten floor assembly. Holes in Boys' Washroom and Storage.
- Cedar siding worn out and peeled off.
- Built-up roof with blister, ponding, exposed base.
- Stained acoustic ceiling tiles.
- Moisture and wet in crawl space.
- Floor finish damaged in Classroom 160 and Storage 155.
- Ripple, soiled and stained carpet in Classrooms.
- Cupboards and countertops and doors with damaged plastic laminate finish.
- Condensation around aluminum windows.
- Mould in crawl space.

- Regrade soil around building. \$1,000
- Replace concrete grade beam and raised foundation walls. \$50,000
- Replace new floor assembly. \$50,000
- Replace cedar siding. (approx. 61 metres x3 metres) \$9,150
- Replace built-up roof. (approx. 470 square metres) \$35,250

Replace acoustic ceiling tiles. ( approx. 400 square metres)  
 \$8,000  
 Provide sump pit and pump in crawl space. (1 unit) \$1,000  
 Replace carpet flooring in Classrooms. (approx. 400 square metres) \$20,000  
 Replace sheet vinyl in Corridor. (approx. 70 square metres)  
 \$3,500  
 Replace cupboards and countertops with plastic laminate finish  
 countertops and birch doors. (approx. 30 metres) \$15,000  
 Replace aluminum windows. (8 windows) \$8,000  
 Repair floor construction. (approx. 70 square metres) \$14,000  
 Remove mould in accordance with the recommendations  
 provided by consultant (See F2020.04 Mould) \$5,000
