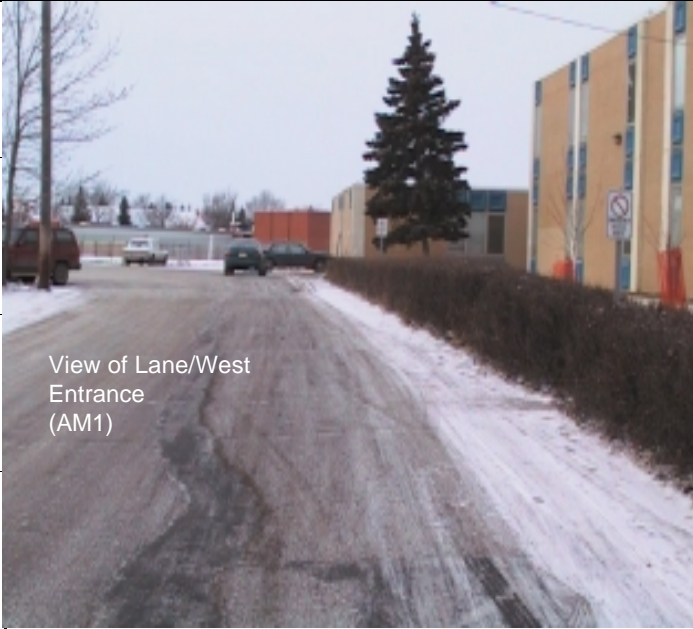
<p>View of Lane/West Entrance (AM1)</p>

Section 1	Site Conditions	Rating	Comments/Concerns	Estim. Cost
1.2	Access/Drop-Off Areas/Roadways/Bus Lanes			\$20,000
1.2.1	Vehicular and pedestrian access points (i.e., size, number, visibility, safety).	3	Functional main pedestrian access (south) empties on to congested lane/parking area. East entrances are off very busy street with little set back. Further investigation is required to identify potential solutions and associated costs. Adequate pedestrian access in terms of number/size. Complete detailed study.	\$10,000

<p>Slab Settlement East Entrance (AM2)</p>
(AM1)	South Entrance of school empties on to a congested area which is a public laneway and parking area. Creates congestion at start and end of school day.	
(AM2)	At both Entrances on the East side of the school settlement has occurred. The North East has been mud-jacked but the South East may require the same.

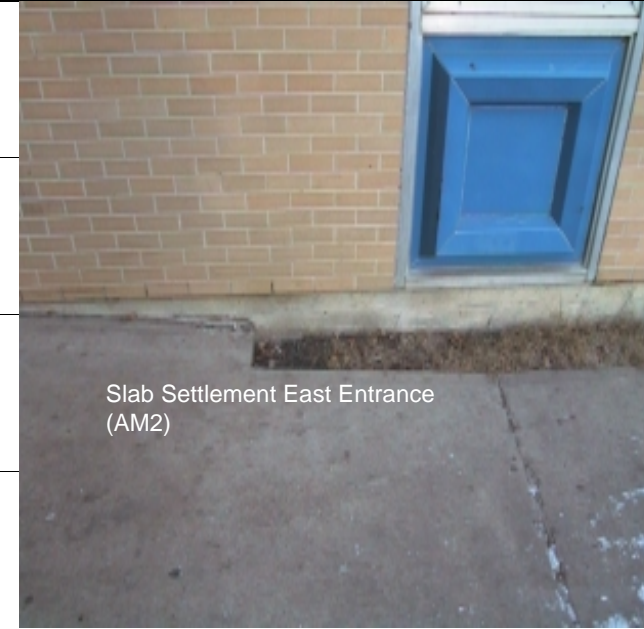
1.1.6	Surface drainage conditions (i.e., drains away from building, signs of ponding).	4	No apparent signs of drainage problems.	
1.1.7	Evidence of sub-soil problems.	3	Sidewalk/entry slabs east entrances have settled. North has been mudjacked, south requires same.	Costs have been identified in 1.3.5.

1.3.4	Layout and safety of sidewalks.	4		
1.3.5	Surfacing and drainage of sidewalks (note type of material).	3	Settlement in slab by Southeast entrance. Poor concrete finish slab outside north entrance.	\$10,000

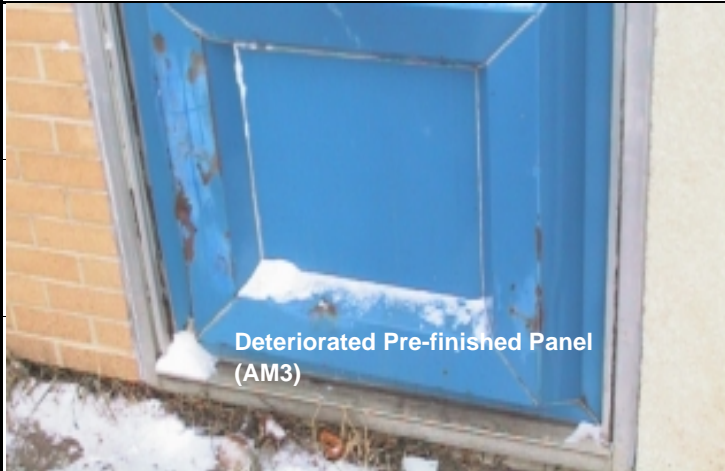
2.3.1	Exterior wall finishes (i.e., signs of deterioration, cracks, brick spalling, effluorescence, water stains).	3		Typical prefinished metal panel (blue) leaks in heavy rain conditions otherwise exterior finishes good.	\$15,000

Deteriorated Pre-finished Panel (AM3)	Deteriorated Window/Pref. Metal Panel (AM4)
(AM3)	Pre-finished metal panels are potential source of moisture infiltration. Some replacement has occurred but the remaining should be replaced within 5 years.	
(AM4)	Pre-finished metal panels and window assembly are a source of moisture infiltration. Some replacement has occurred but the remaining should be replaced within 5 years.

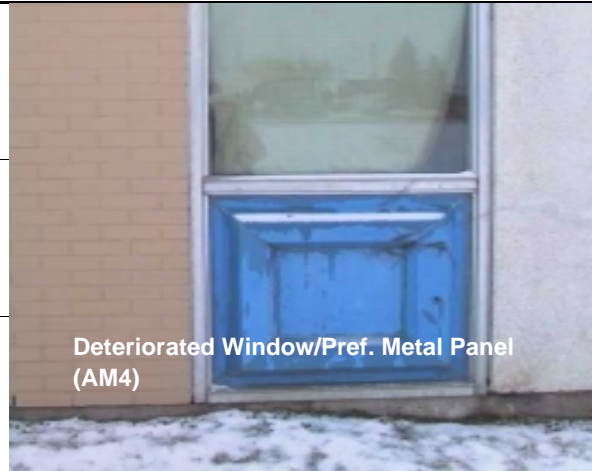
2.4.3	Exit door hardware (i.e., safety and/or code concerns).	3	Heavy traffic areas showing signs of age.	\$5,000
2.4.4	Windows (i.e., signs of deterioration, rusting metal, glass cracks, peeling paint, damaged seals, sealed unit failure).	3	Original windows showing signs of age. Leaks reported east/west sides of building.	\$50,000

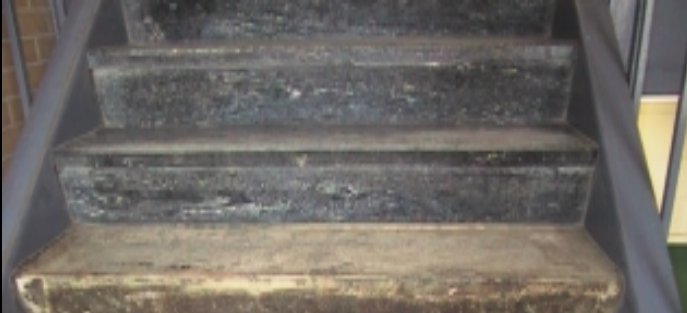
Poor Condition Stair Treads (AM5)	Poor Condition VCT (AM6)
(AM5)	Flooring materials throughout school in high traffic areas require replacement.	
(AM6)	Flooring materials throughout school in high traffic areas require replacement.

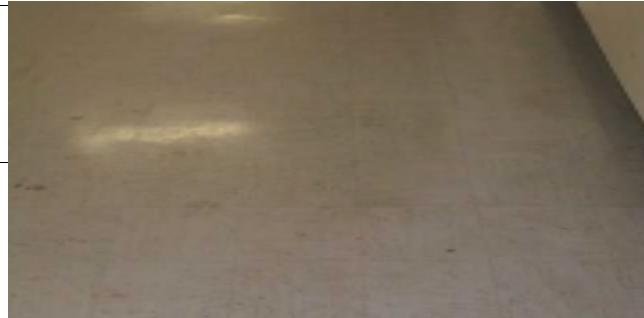
3.2.1	Floor materials and finishes.	3		Generally vct in classrooms generally good condition. Corridors patching loose tiles evident. Corridors identified for replacement. Music room, office area & resource center carpeting good condition. The floor in boy's lockers, grout appears soiled/blotch tile.	\$65,000

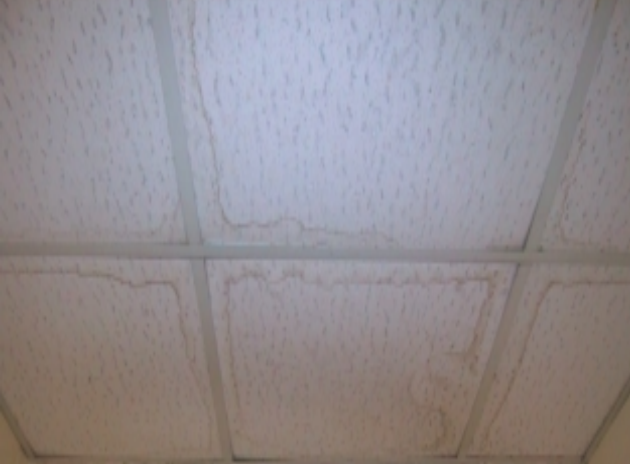
<p>Poor Condition Ceiling Tile (AM7)</p>

3.2.2	Wall materials and finishes.	4		Generally painted block on plasterboard & in good condition.	
3.2.3	Ceiling materials and finishes.	3		Ceiling tile age particularly evident in corridor areas where chipped & soiled. Different tiles present (replacements) Classrooms areas also show age. With installation of ventilation system ceilings should be replaced.	\$150,000

<p>Poor Condition West Entrance Doors (AM8)</p>
(AM7)	Original ceiling tile throughout school shows signs of damage, water stains, soiling and is in need of replacement.	
(AM8)	Main Entrance Doors are in poor condition.

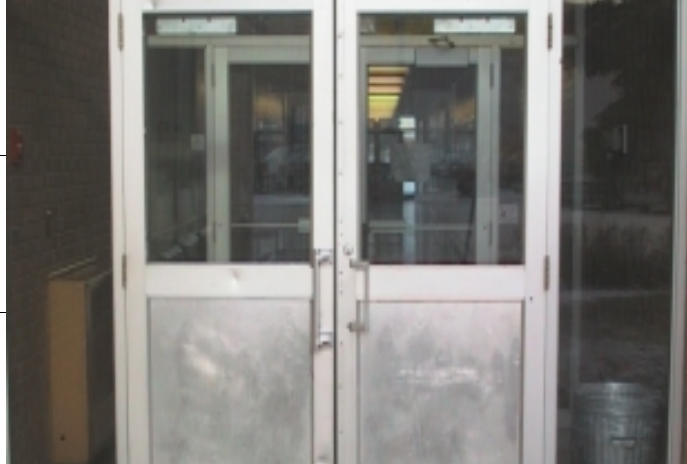
2.4	Exterior Doors and Windows		<b>Bldg. Section</b>	<b>Description/Condition</b>	\$312,500
2.4.1	Doors (i.e., signs of deterioration, rusting metal, glass cracks, peeling paint, damaged seals, sealed unit failure).	3		Heavy traffic areas showing signs of age.	\$5,000
