School Facility Evaluation Project
Part IV - Additional Notes and Comments

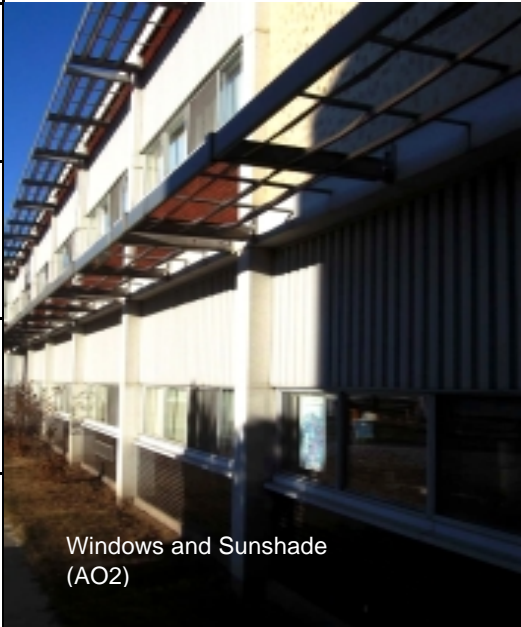
<p>Windows and Sunshade (AO2)</p>

2.3.2	Fascias, soffits, parapets (i.e., signs of looseness, stains, rust, peeling paint).	3	59	Sunshades at front of school are badly dented and aged. Complete replacement or total removal recommended.	\$30,000

2.4.3	Exit door hardware (i.e., safety and/or code concerns).	4	All	No problems noted.	
2.4.4	Windows (i.e., signs of deterioration, rusting metal, glass cracks, peeling paint, damaged seals, sealed unit failure).	3	All	Most windows are original and are nearing the end of their life expectancy. The majority of them are aluminum sliders which perform poorly from a thermal point of view and also present security problems. Although none have actually failed, a program of gradual replacement with energy efficient windows should be implemented to lower maintenance and operational costs.	\$500,000

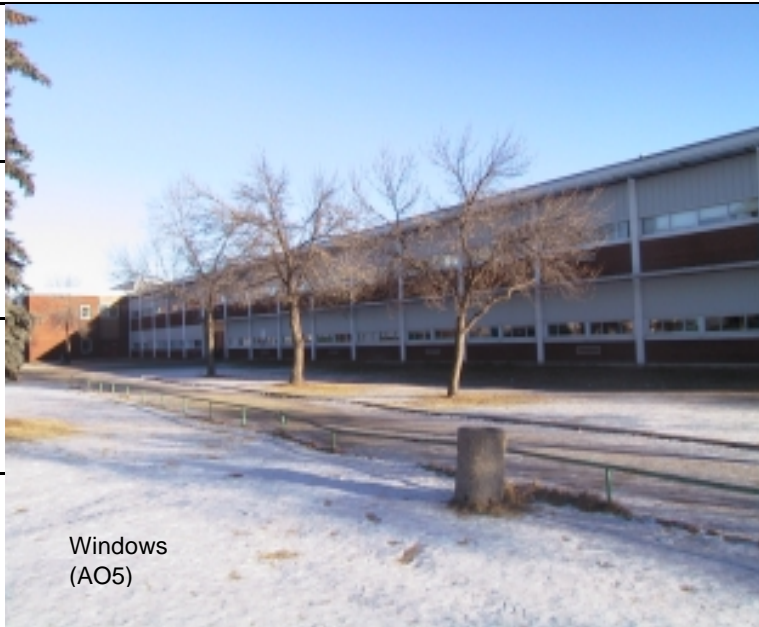
<p>Windows (AO5)</p>

2.4.5	Window accessories (i.e., latches, hardware, screens, locks, alarms, holders, closers, security devices).	3	All	Windows throughout have hardware which is either broken or not operating smoothly. There are also screen missing from many windows.	Incl. in 2.4.4 cost

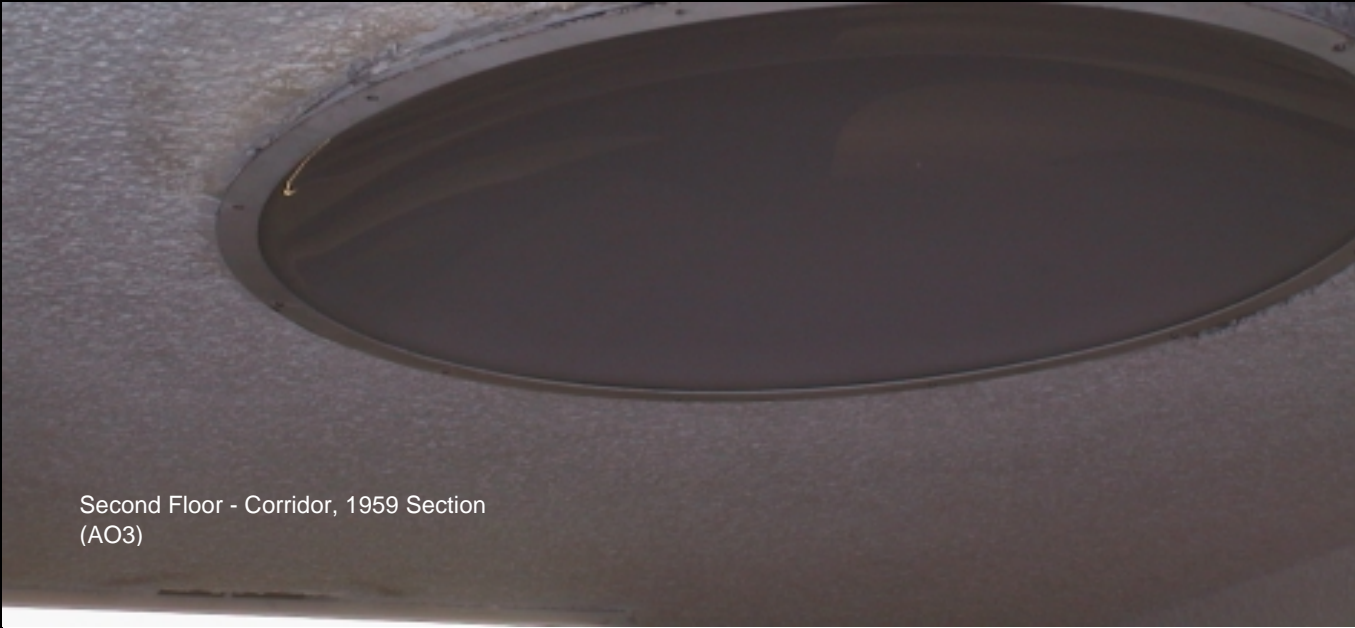
<p>Second Floor - Corridor, 1959 Section (AO3)</p>	
Skylights	Round plastic dome skylights appear to be leaking at various locations. A closer investigation is required to determine extent of failure and if units require replacement or refitting. The above photo shows that the skylight is no longer beeing used, and that the leakage caused damage to adjacent ceiling finishes.
