RECAPP Facility Evaluation Report

Champion School

B2934A
Champion

Evaluation Company: Stantec Consulting Ltd.
Evaluation Date: October 27 2010
Evaluator Name: Michael Connolly

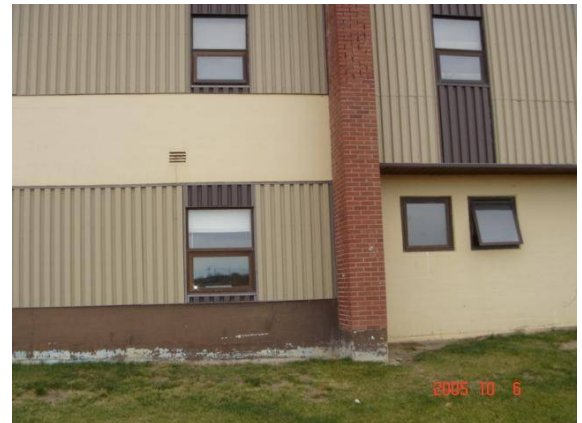
Metal gutter and downspout assemblies are provided at the east elevation, and along the west elevation at the southern classroom portion of the school. A portion of the downspouts include leaders which convey the water below grade away from the foundation. The majority of downspouts discharge to areas of landscaping around the building.

Damaged building finish due to lack of drainage

Provide extensions/leaders and/or splash blocks at downspout discharge locations to convey storm water away from the foundations.
