RECAPP Facility Evaluation Report

Edmonton School District No. 7

Centennial School

B3073A
Edmonton

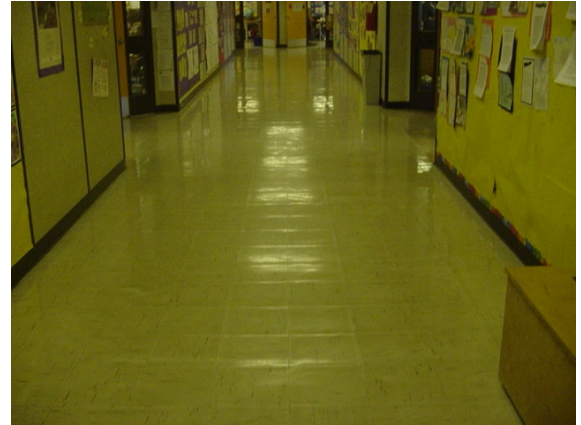
Event: Replace Resilient FlooringVCT - 1983 Addition****Concern:**

The VCT flooring in the 1983 Addition is deteriorated with several warping in the floor.

Replace all VCT in the 1983 addition.

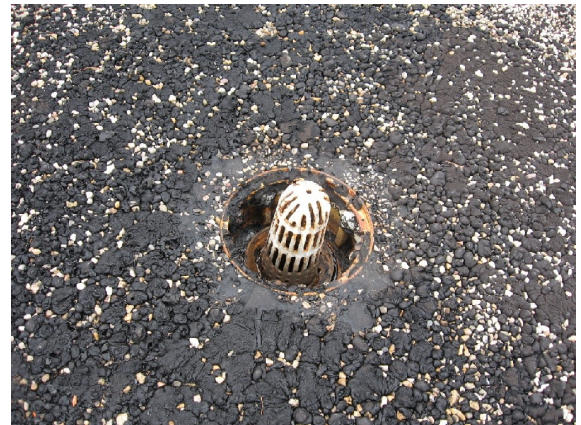
Event: **Replace missing roof drain covers.**

Some roof drain covers are missing.

Install missing roof drain covers.

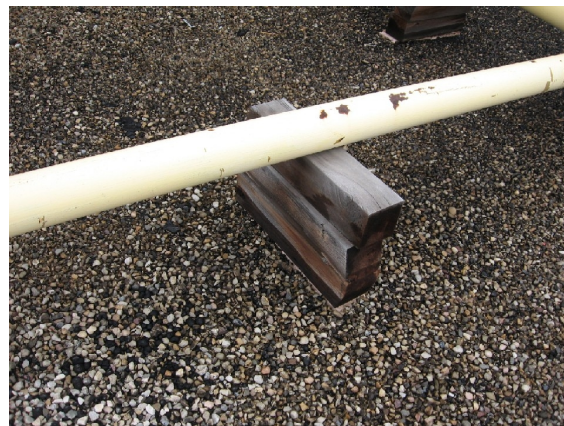
Event: Replace gas pipe support on roof**Concern:**

All gas pipe supports on roof are deteriorating. The wood blocks supporting the gas pipe are sitting directly on the roof without any foam board. It may damage the roof membrane and cause roof leaks.

Insecure gas pipe support and possible roof leaks.

Replace all gas pipe supports with new.

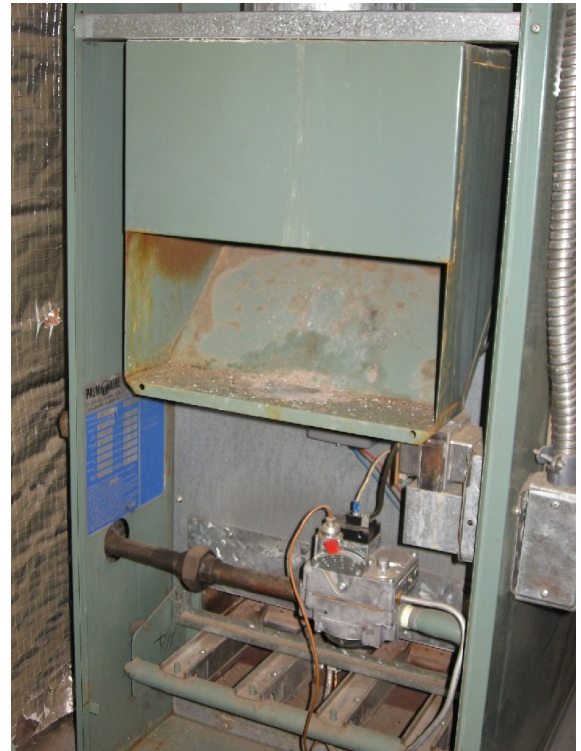
Event: Replace original furnaces in Pods

The original furnaces have exceeded their life expectancy. Sign of rusting has shown on the unit housing.

Replace original mid-efficiency furnaces with new of the same capacity.

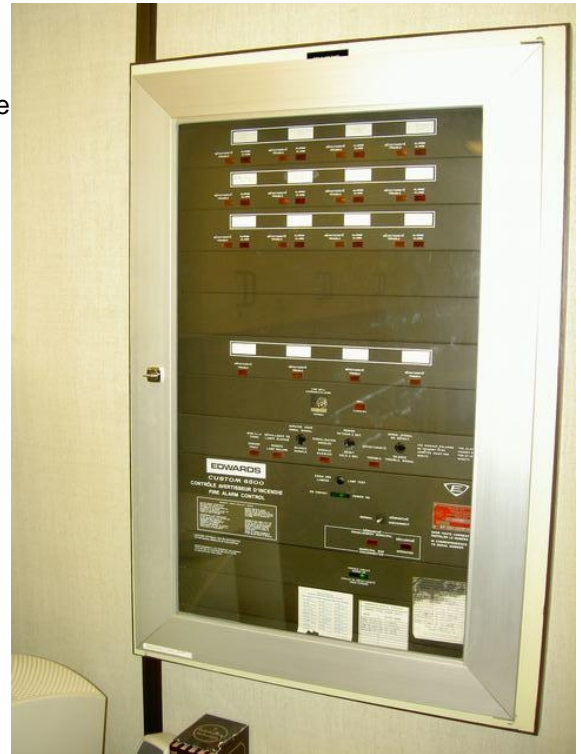
Event: Replace fire alarm system

Replace existing fire alarm system with a new addressable system.

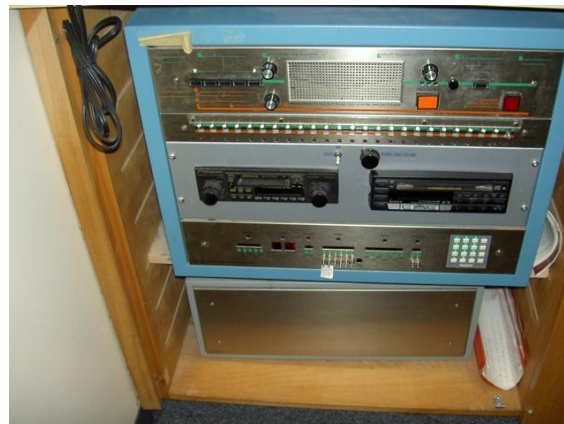
Event: Replace Rauland P.A. system

Existing Rauland P.A. System is obsolete. Replacement parts are no longer available. Standard system for schools is a microprocessor based system.

Inoperable P.A. system.

Replace existing P.A. System with new microprocessor based system (Bogen Multicom 2000).

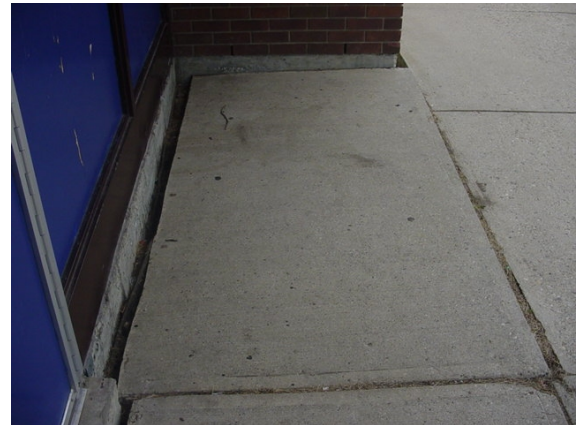
Event: Replace concrete walkways.**Concern:**

Remove concrete walkways and provided an adequate substructure for the surface material. Filling in the gaps does not solve the on-going shifting of the walkway, however a more economical solution.
