RECAPP Facility Evaluation Report

Clara Tyner Elementary School

B3075A
Edmonton

Evaluation Company: Asset Evolution Incorporated (AEI)
Evaluation Date: May 8 2006
Evaluator Name: Mario Plastina

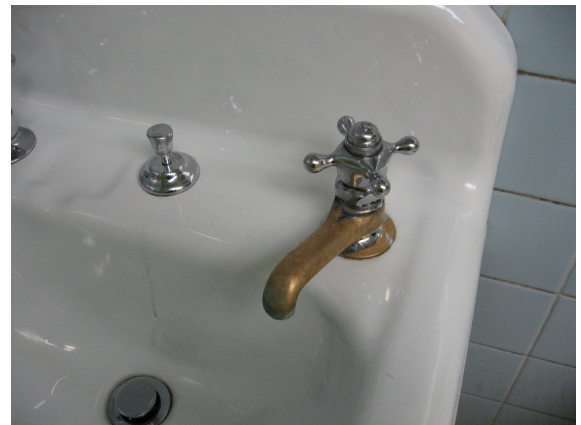
Event: Replace original lavatories with new**Concern:**

Original lavatories have exceeded their life expectancy. Some of the lavatories have show sign of rust.

Rusting parts may impose health issue to the users.

Recommendation:

Replace all lavatories with new stainless type lavatories.

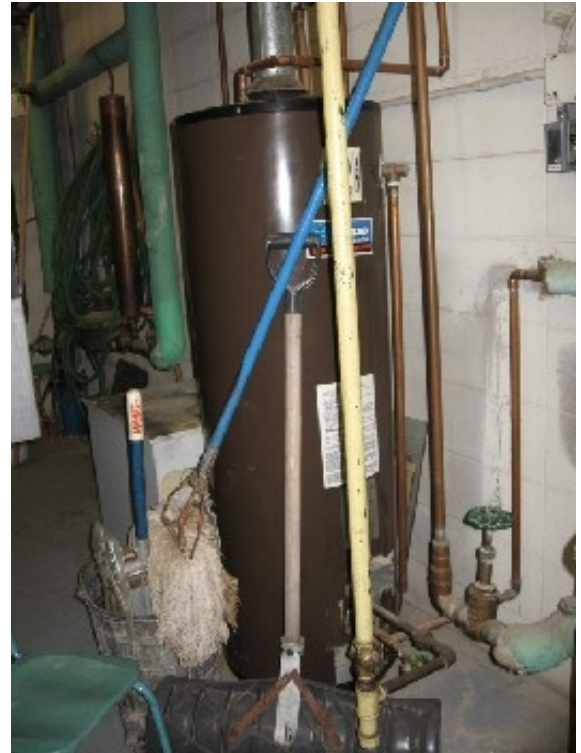
Event: Install missing pipe insulation**Concern:**

Recommendation:

Install missing pipe insulation.
