RECAPP Facility Evaluation Report

Crawford Plains School

B3082A
Edmonton

Evaluation Company: Asset Evolution Incorporated (AEI)
Evaluation Date: May 10 2006
Evaluator Name: Mario Plastina

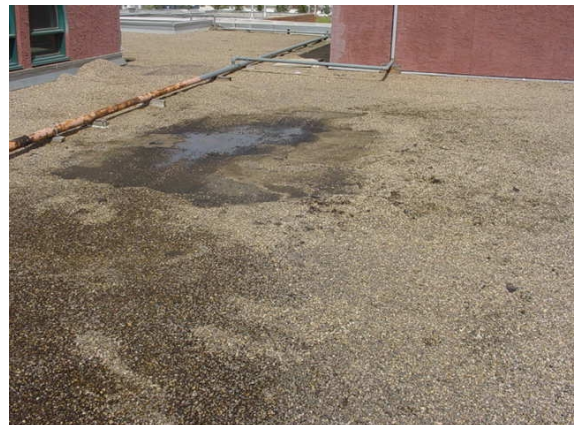
Event: Replace original built-up roof assembly.**Concern:**

Several leaks were evident from the number of stains observed on the interior ceiling tiles. Over the years, numerous repairs have been conducted on the built-up roof

Replace complete built-up roof assembly on the 1983 original building.

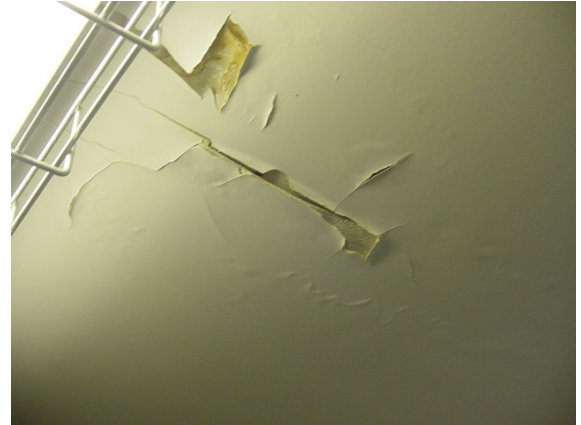
Event: Repair & repaint ceiling

Water damaged to the ceiling was observed in the boy's change.

Repair and repaint ceiling.

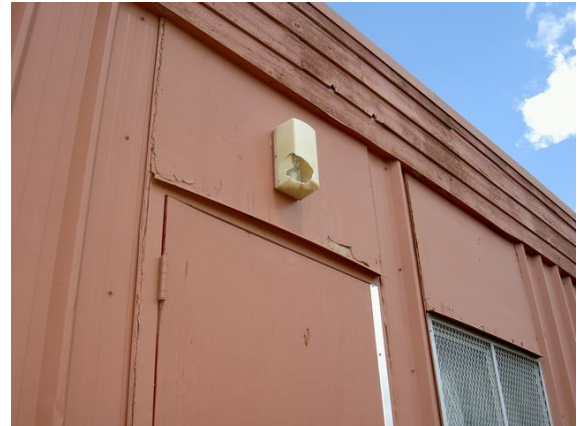
The exterior incandescent lighting fixtures for the pod are in poor condition. Several of the fixtures have damaged or yellowed lenses.

Replace exterior incandescent fixtures for the pod.
