RECAPP Facility Evaluation Report

Edmonton School District No. 7

Dunluce Elementary School

B3094A
Edmonton

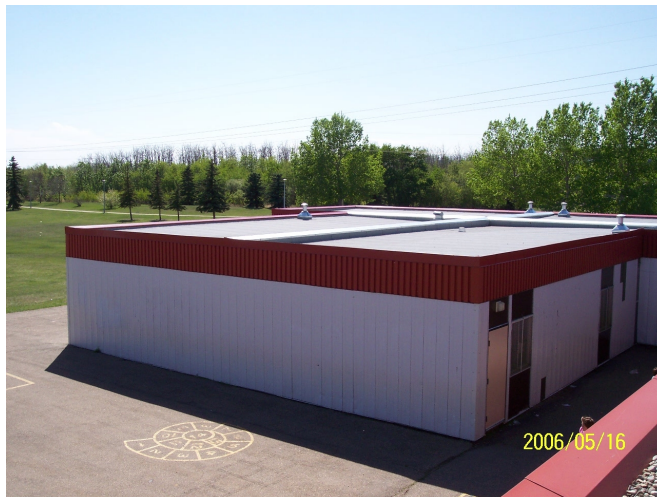
- Heating & ventilation provided by Palm Air Furnace connected to supply diffusers at window sill. Condition: 4 (acceptable)
- Linear supply diffusers at window sills. Condition: 4 (acceptable)
- Ductwork - supply, return. Condition: 4 (acceptable).
- Gas lines to furnace. Condition: 4 (acceptable).
- Chimneys - metal, up to weather cap on roof. Condition: 4 (acceptable).
- Controls - low voltage to wall mounted thermostat. Condition: 4 (acceptable).

<u>Rating</u>	<u>Installed</u>	<u>Design Life</u>	<u>Updated</u>
3 - Marginal	1984	0	NOV-06

Exterior metal siding and fascia requires replacement

Replace 150m2 of exterior metal siding and fascia.

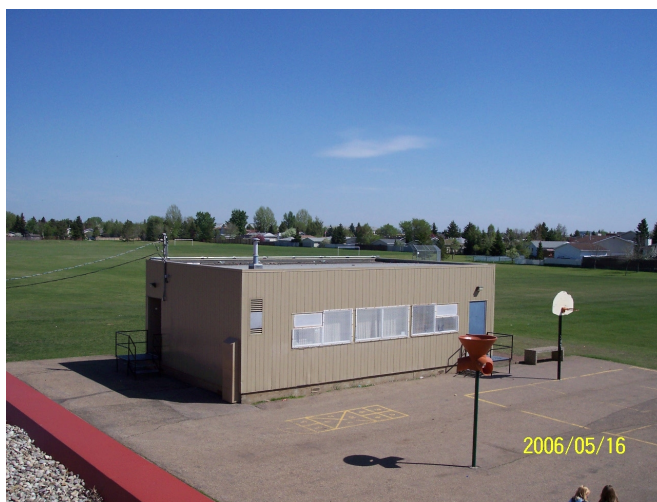
- Built-up roofing
- metal siding
- Metal fascia
- prefinished metal capping
- roof drains connecting to interior downspouts
- PVC windows c/w top hung unit and wired mesh on outside
- wood floor assembly
- vertical blind
- acoustic ceiling ties and panels
- exterior wood door and metal frame
- interior prefinished wall panels
- Classroom has both carpet and vinyl tile finishes.
- tackboards and projection screen
- chalkboards and whiteboards
- millwork
- Corridor has vinyl tile finishes.
- Corridor has acoustic ceiling panels c/w T-bar system

<u>Rating</u>	<u>Installed</u>	<u>Design Life</u>	<u>Updated</u>
3 - Marginal	1978	0	NOV-06

Replace metal siding and fascia (50 metres long)

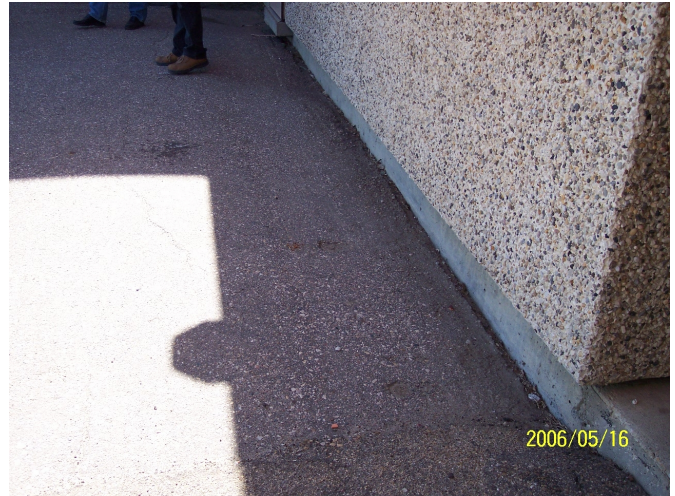
Negative grading around the perimeter of building.

<u>Rating</u>	<u>Installed</u>	<u>Design Life</u>	<u>Updated</u>
3 - Marginal	1978	0	NOV-06
