RECAPP Facility Evaluation Report

Edmonton School District No. 7

Greenfield School

B3138A
Edmonton

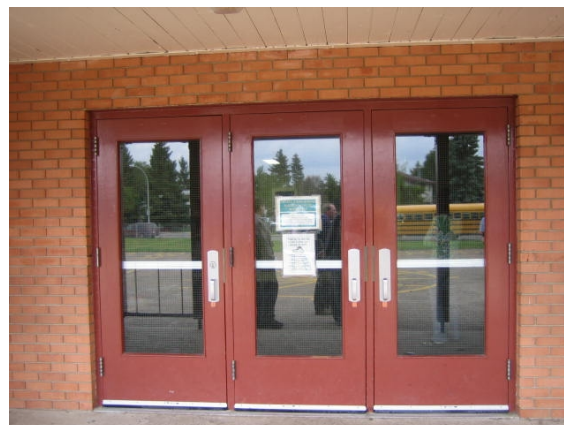
Event: Replace Exterior Doors (Four Doors)

Concern:

The exterior doors from classrooms 12, 13, 35 and 36 are aged and worn and have operational problems especially during colder months when the doors stick.

Recommendation:

Given the age of the doors and the continued maintenance required, replacement is recommended.

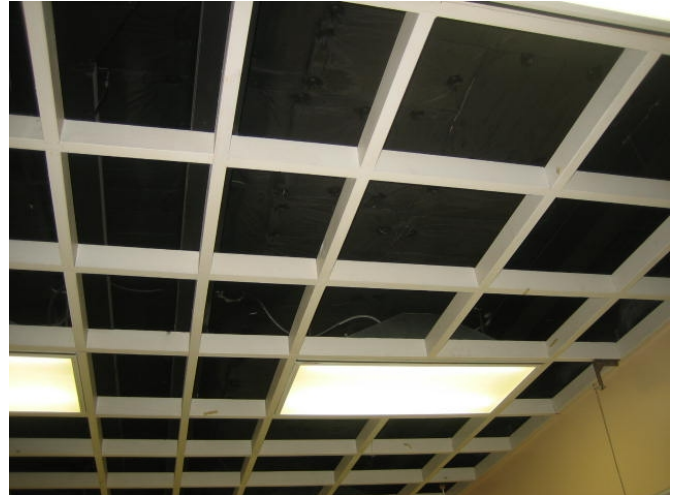
**Event: Install New ACT Ceiling****Concern:**

Staff report continuing issue of dust falling on building occupants due to the suspended, but open, 2x4 wood grid ceiling. Maintenance reports that it is an ongoing cleaning task to keep the grid dust free. The installation of a new suspended acoustical tile ceiling system is recommended. Work with mechanical trades to ensure sufficient air movement/occupant comfort with new, enclosed ceiling.

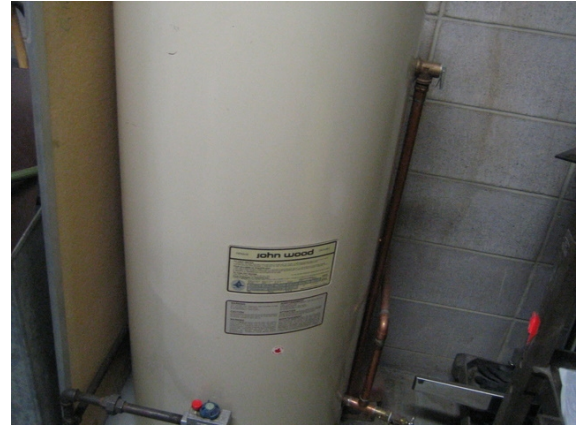
Event: Replace DHW Heater

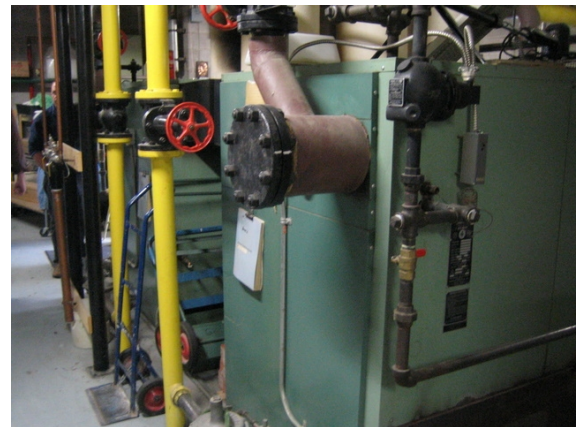
Event: Replace 2 Heating HW Boilers

Aged as well as the boilers. Cost for replacing the chimneys is included in the cost estimate for replacing the boilers.

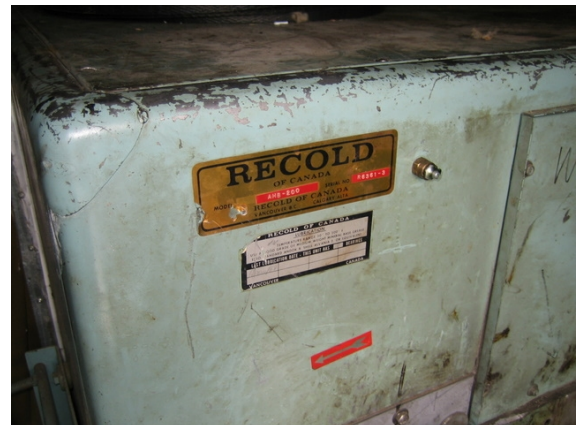
Event: Replace Air Handlers**Concern:**

Failure of the air handler would mean no air flow or heating. In addition, the ongoing maintenance costs to keep the existing unit running will likely increase, and finding replacement parts will become more difficult.

Recommendation:

Replace air handlers based on recommendation from an engineering study.

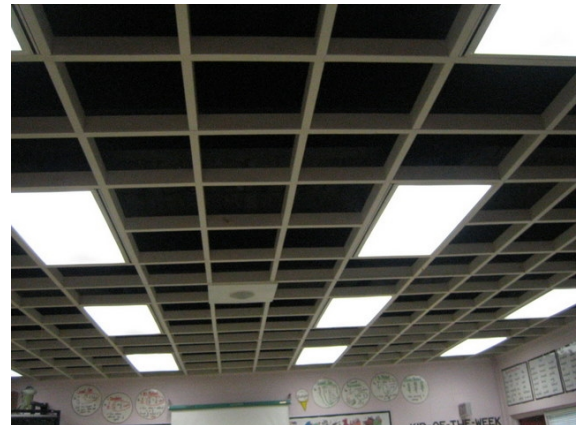
The open ceiling plan appears to be short circuiting air flow in some portions of the building such as the library. In addition to the replacement of a the air handler, the return air system needs to be corrected. Either a suspended ceiling with strategically placed return air grills should be used, or if the open ceiling system is continued, then ducted returns should be installed to ensure that return air is taken from various parts of the room.

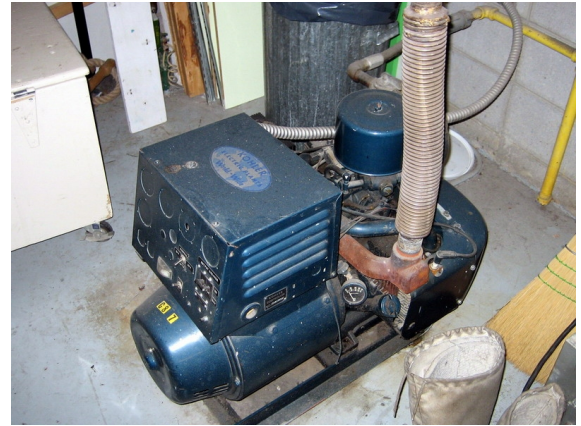
Event: Replace Generator

Recommendation:

Replace with larger 35KW natural gas Emergency Generator unit. Includes: Emergency Generator, ATS, battery charger, muffler, feeder, wiring and panel. Connect to additional lighting to provide better coverage.

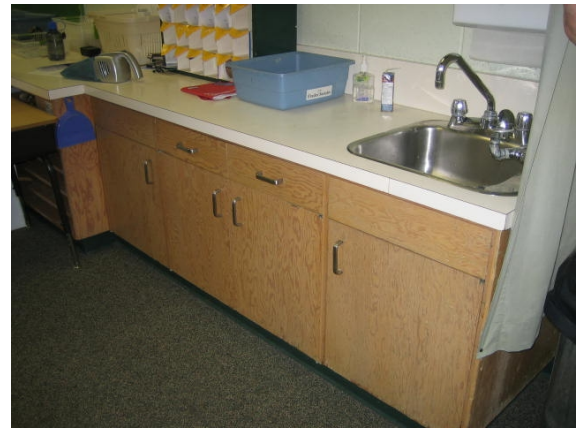
Event: Replace Casework**Concern:**

The casework in the classrooms is worn and shows signs of deterioration. High maintenance required. The casework in the custodian office is worn.

Consequences of Deferral:

The deterioration of the visual integrity of the facility and continued maintenance are consequences of deferral.

Recommendation:

Remove and replace the casework in the classrooms. Typical casework is 3m of lower cabinetry with counter top and one sink. Replace in classrooms 11, 12, 13, 14, 22, 23, 65, 66, 60, 61, 62, 70, 34, 35, 36, 37, 55, 56, 57, and 58 (twenty classrooms in total). \$106,356.00

Remove and replace approximately 3m upper and lower casework cabinetry including one counter top and one sink. Location is custodian office. \$7,659.00
