RECAPP Facility Evaluation Report

Greenview Elementary School

B3139A
Edmonton

Evaluation Company: VFA Canada Corporation
Evaluation Date: September 13 2006
Evaluator Name: David S. Greeley, P.Eng.

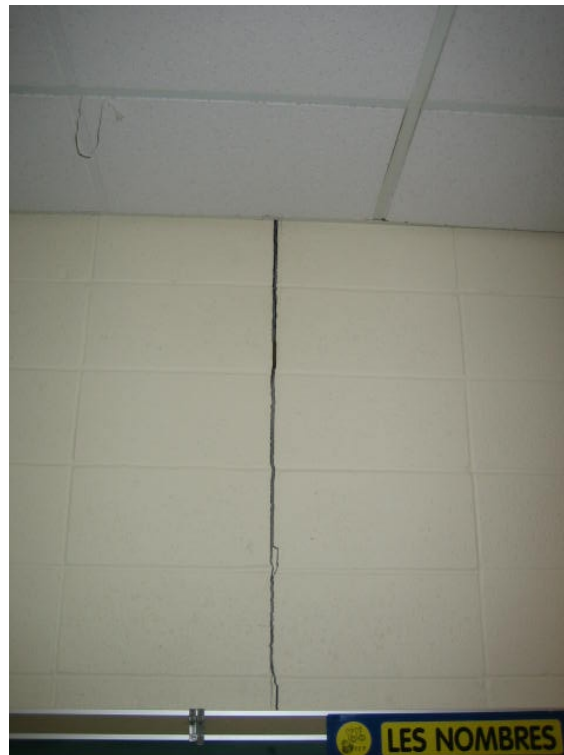
There is longitudinal cracking in the interior CMU fixed partition between rooms 11 (staff) and 12 (ECS). Crack has a gap width of 3 to 6mm.

Continuing deterioration of the structural capacity of the facility at this location is a consequence of deferral.

Retain a consulting engineering specialist to examine the cracking and report on causes with recommended repair methods.

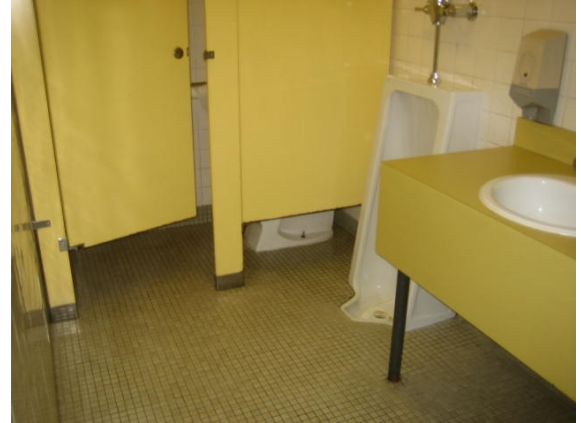
The toilet and urinal partitions in the boys and girls washrooms are worn, some with operational issues.

Continued operational concerns with partitons is a consequence of deferral.

Replace partitions in boys and girls washrooms in the facility. Assume 12 toilet partitions and 4 urinal partitons.

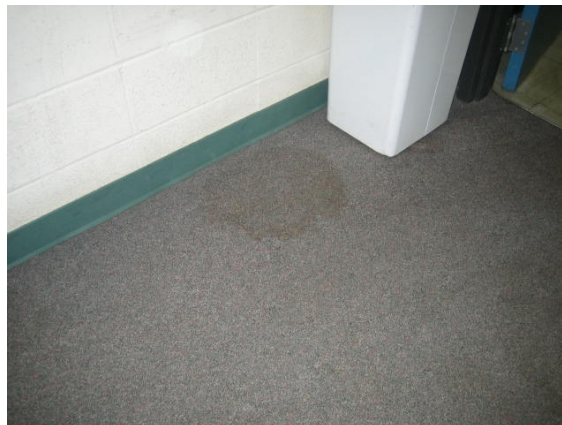
The carpet in offices and classrooms showing signs of wear.

Remove and replace the carpet in offices 1 through 10. Area is 128.8m2. \$9,000.00.

Remove and replace the carpet in classrooms 11, 43, 44, 54, and 58. Area is 529.8m2. \$29,800.00.

Remove and replace the carpet in classrooms 19, 20, and 21. Area is 223.8m2. \$13,700.00.

Remove and replace the carpet in classrooms 22, 23, and 24. Area is 222.3m2. \$13,600.00.

Replace the carpeting in the corridors of Greenview Elementary School. Corridors include C8, C7, and C4. Area estimate is 228.4 square meters. \$14,700.

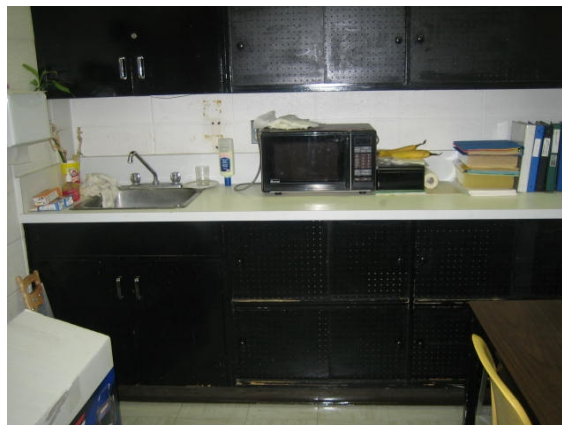
The fixed casework in the following rooms: 11 (Staff), 49 (Classroom) and 58 (lunch) is at the end of its useful life. Replacement should be planned.

Increasing maintenance and loss of visual integrity of the facility are consequences of deferral.

Remove and replace the casework in the identified rooms. Assume 6.7 lineal meters of upper, 37.1 lineal meters of lower and counter top, and 2 sinks.

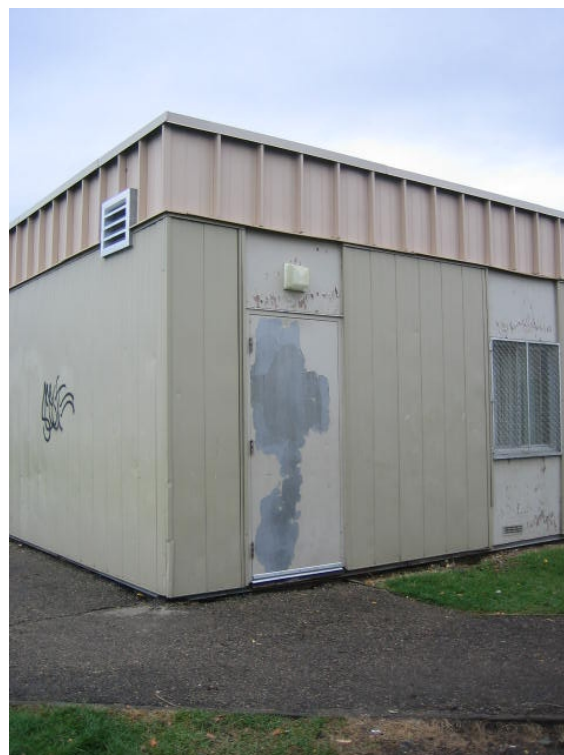
The paint finish on the exterior doors at both Pods has failed, with the paint peeling and flaking.

Possible deterioration of the doors and loss of visual integrity of the facility are consequences of deferral.

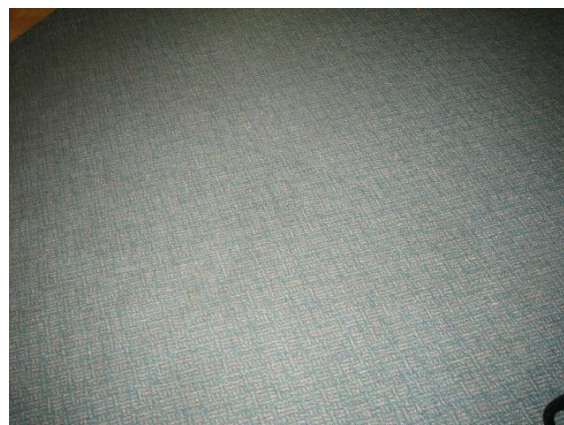
The carpet in the 1980 Pod classrooms is aged and worn.

The carpet in the 1982 Pod classrooms is aged and worn.

Remove and replace the carpet in the classrooms in the 1980 Pod. Classrooms 25, 26, 28 and 29. Area assumed 75% (303.2) = 227.4m².

Remove and replace the carpet in the classrooms in the 1982 Pod. Classrooms 15, 16, 17 and 18. Area assumed 75% (311.2) = 233.4m².

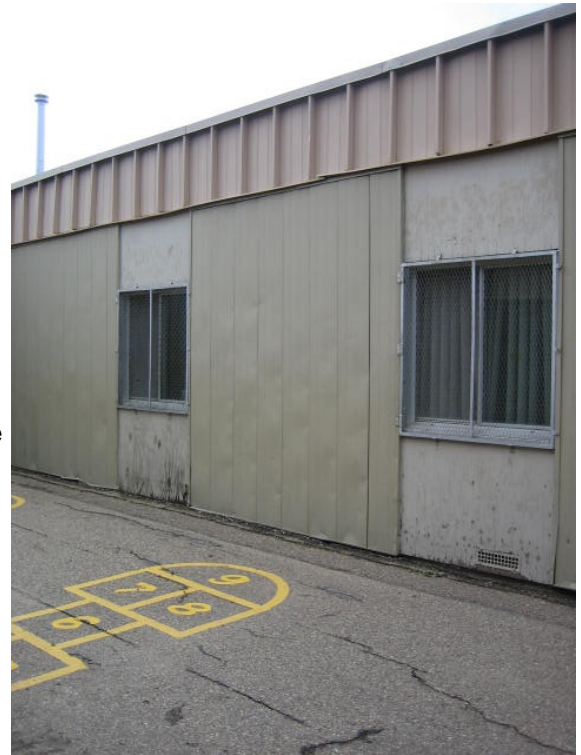
The exterior painted wood wall panels beneath each window on both Pods have finishes which are peeling, cracking and splitting. In some instances, the wood is deteriorating. Immediate replacement warranted. The Pods include classrooms 14, 15, 17, 18, 25, 26, 28, and 29.

Immediate replacement is warranted to prevent envelope failure and the potential for water entry.

Remove and replace the deteriorated wood wall panels. Assume 65 square meters of replacement and refinished panel.

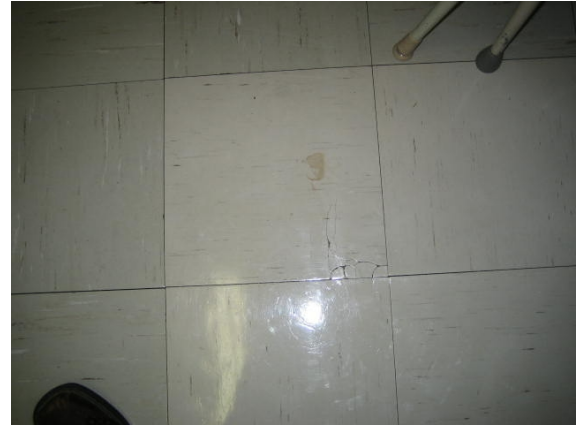
The vinyl composite tile (VCT) in the four classrooms in the 1980 Pod is aged and worn.

The vinyl composite tile (VCT) in the four classrooms in the 1982 Pod is aged and worn.

Replace the VCT/VAT flooring in the 1980 Pod classrooms

#25, 26, 28, and 29. Total area is assumed as 25%(303.2 m2) = 75.8 m2. A hazardous materials report for Greenview indicates ACM's may include the floor tile in the 80 Pod. An allowance for abatement has been included in the estimate (floor replacement estimate: \$4,331; abatement allowance estimate: \$18,935). Estimate does not include allowance for the down time for this occupied floor space.

Replace the VCT/VAT flooring in the 1982 Pod classrooms #14, 15, 17 and 18. Total area is assumed as 25%(311.2 m2) = 77.8 m2. A hazardous materials report for Greenview indicates asbestos containing materials may include the floor tile in the 82 Pod. An allowance for abatement has been included in the estimate (floor replacement estimate: \$4,759; abatement allowance estimate: \$20,319). Estimate does not include allowance for the down time for this occupied floor space.
