# **RECAPP Facility Evaluation Report**

**Julia Kiniski School**

B3174A  
Edmonton

**Evaluation Company:** Koliger Schmidt architect engineer  
**Evaluation Date:** June 15 2007  
**Evaluator Name:** Mario Macchione

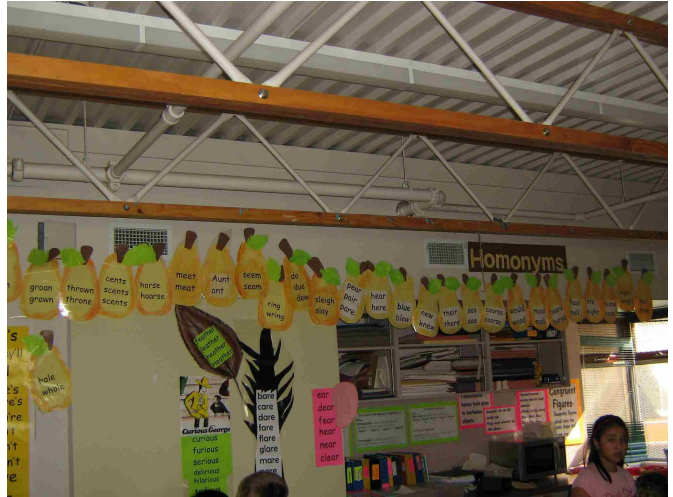
1992 section - roof structure

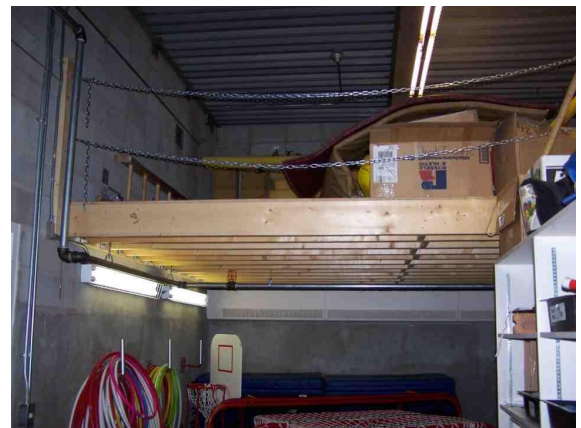
Wood framed mezzanine - recent construction.

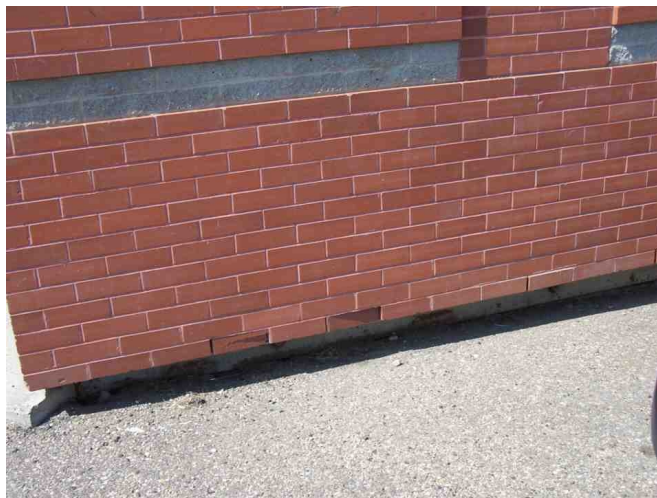
Exterior facade- minor damage noted at sill at one location.

Abnormal amount of moisture is migrating to the brick face.

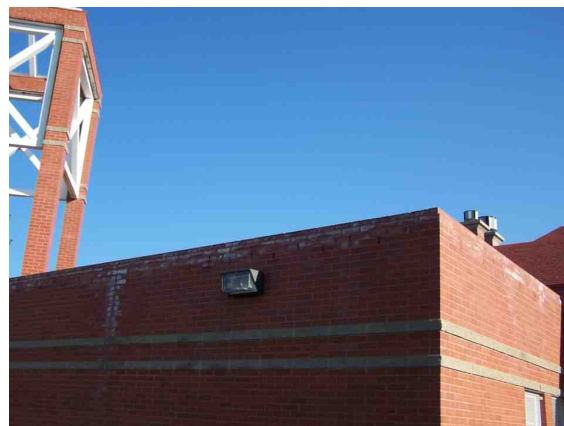
Excessive efflorescence

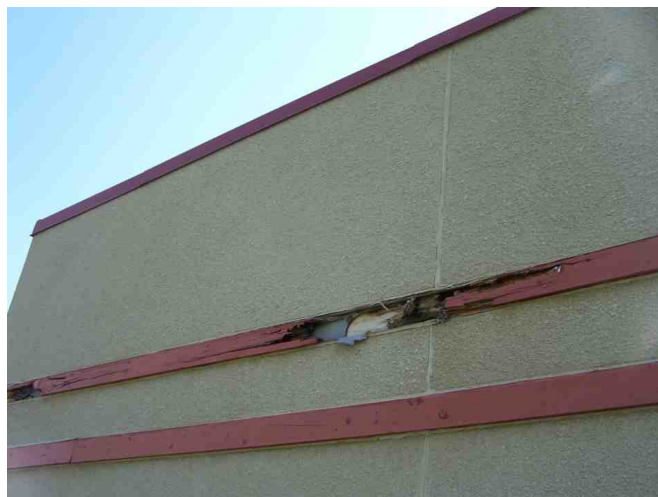
Stucco finish appears to be in good condition, but excessive wood rot is present at window sill and wood trims around the entire 1992 building.

Water is now permitted to enter behind the stucco finish which will in time contribute to premature stucco cracking/failure.

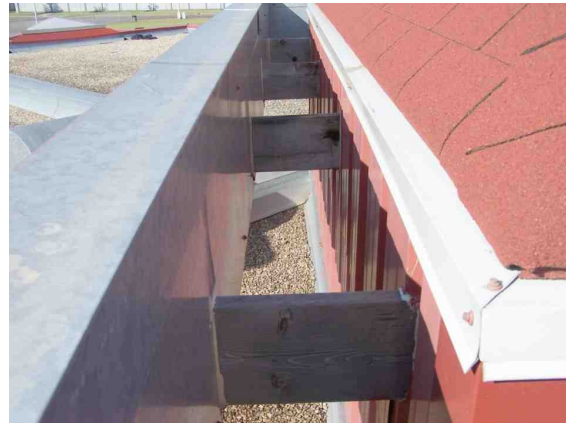
Exposed wood left to weather; left unprotected future repairs costs will be greater.

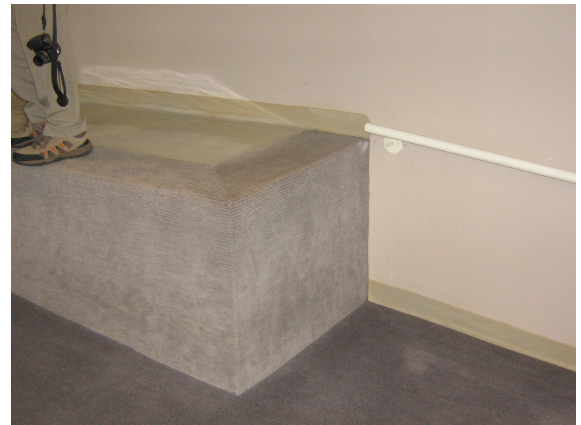
Platform rise is too high.

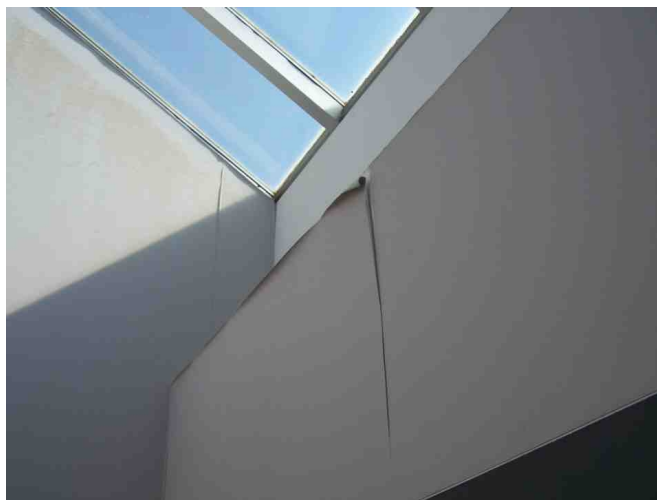
Wall coverings are de-laminating, damaged and stained.

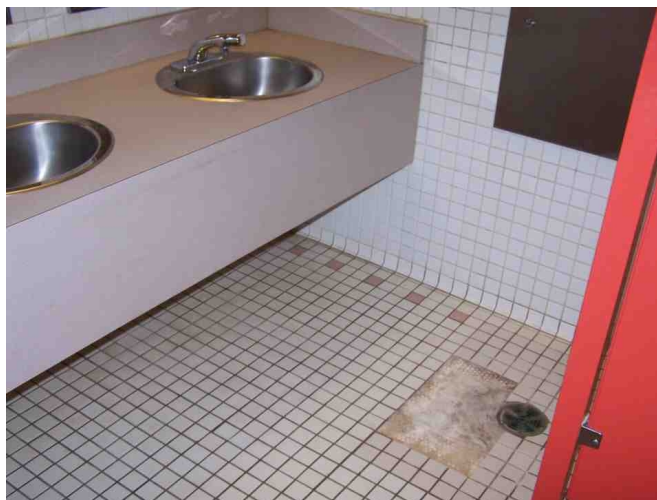
Damaged flooring.

Flooring tiles are damaged in a couple of rooms

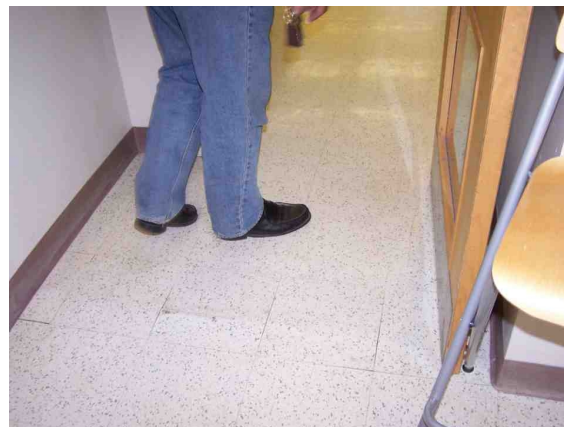
Lifting and damaged flooring.

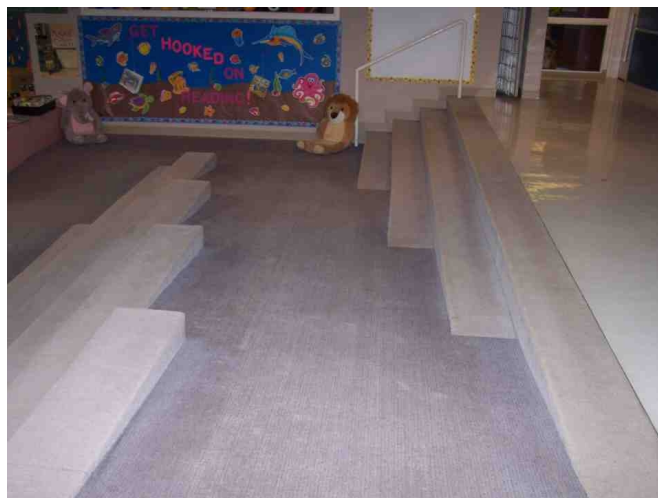
Stamps accesses the library

Carpet is worn in the library areas and the office areas.

Replace carpet at library, stamps and offices (350m<sup>2</sup>).

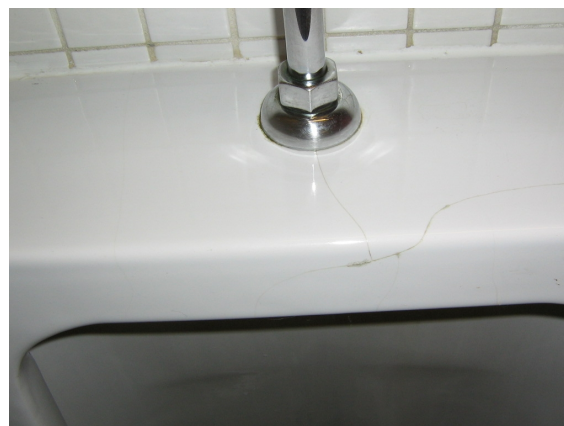
Most of the urinals are cracked. The cracks provide a place for bacteria to grow.

Crack at top of urinal.

Replace all 5 urinals.

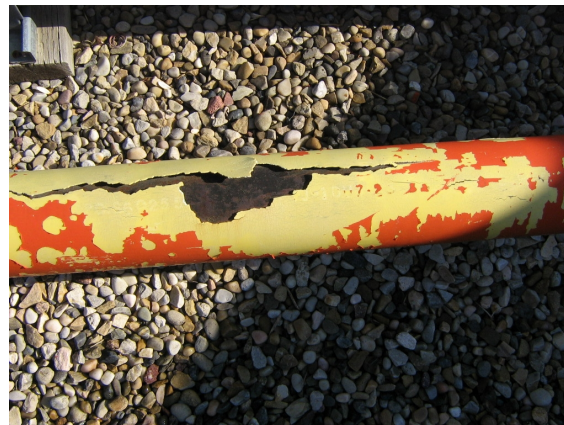
The jacketing on the natural gas piping is cracked. It should be replaced to prevent corrosion of the piping. The yellow jacket piping installed on the roof of the school is intended for below the ground installation. Exposure to the sun's UV rays has broken down the coating on the pipe.

Typical natural gas pipe on the roof.

Replace all the natural gas piping on the roof with piping suited for above ground useage.

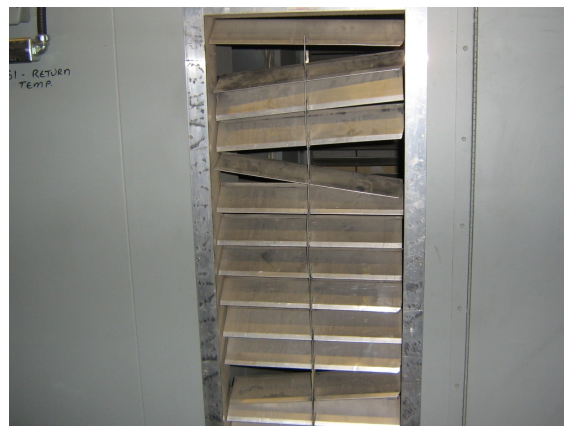
The damper on the side of AS-1 is damaged.

Damaged damper.

Repair the damper.

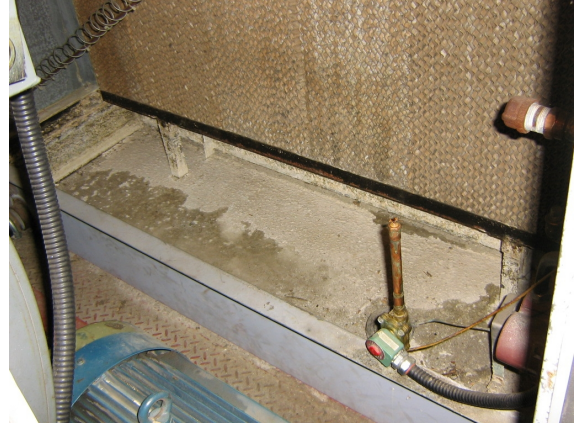
The humidifiers are not being used. The section of humidification media in the air handling units collects impurities and increases the static pressure of the system.

Abandoned humidification media in AS-2.

Remove the humidification media in the air handling unit.

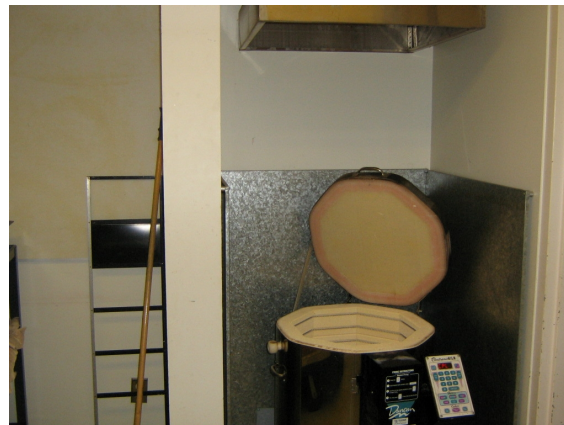
Kiln has an existing exhaust hood but inadequate exhaust.

Provide the kiln with its own roof mounted exhaust fan with a manual on/off switch.

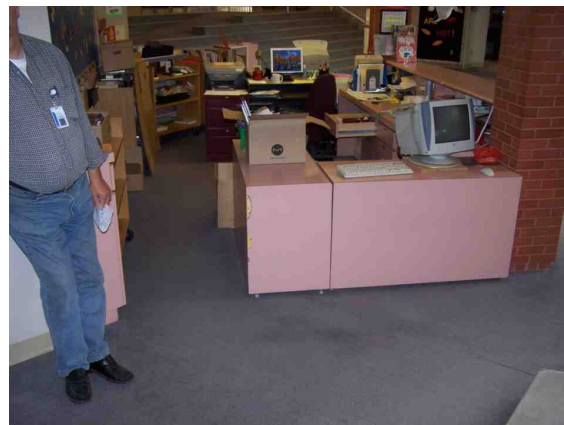
Damaged millwork

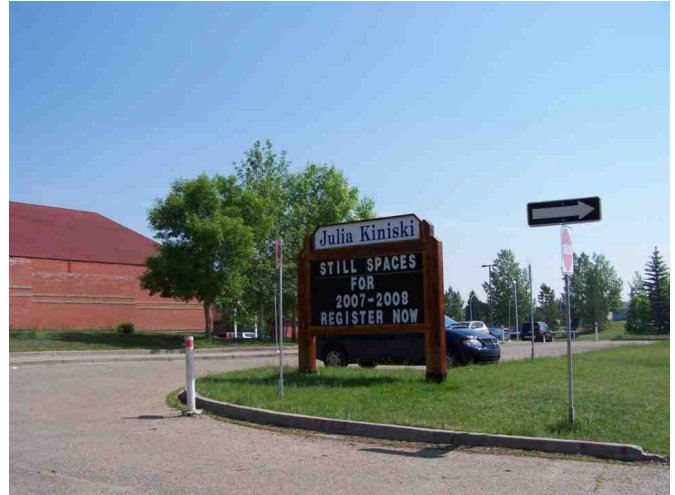
A number of sections of concrete curbs are damaged and/or have been removed because of damage.

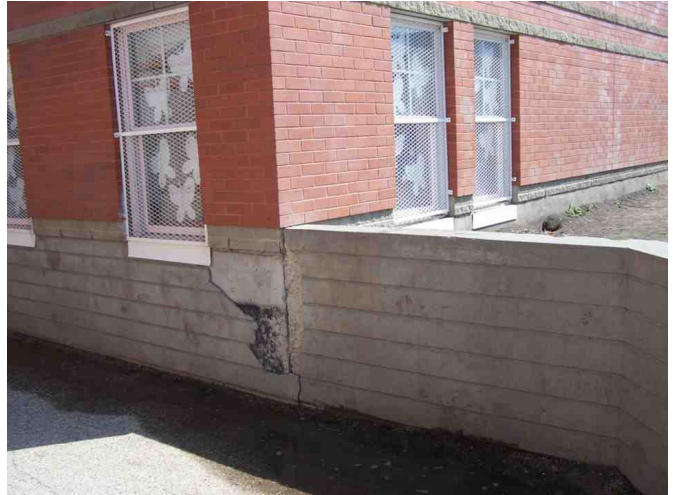
Damaged parging; further deterioration will occur due to moisture infiltration and the freeze thaw cycles.
