RECAPP Facility Evaluation Report

Kameyosek Community School

B3175A
Edmonton

Evaluation Company: Koliger Schmidt architect engineer
Evaluation Date: June 8 2007
Evaluator Name: Mario Macchione

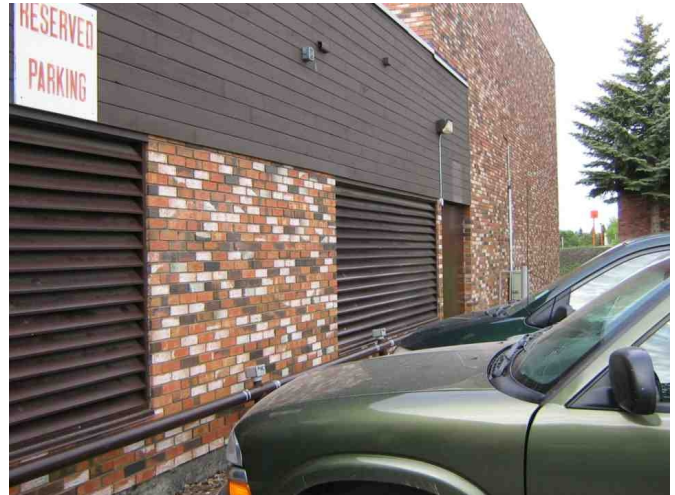
Pre-finished metal louvers

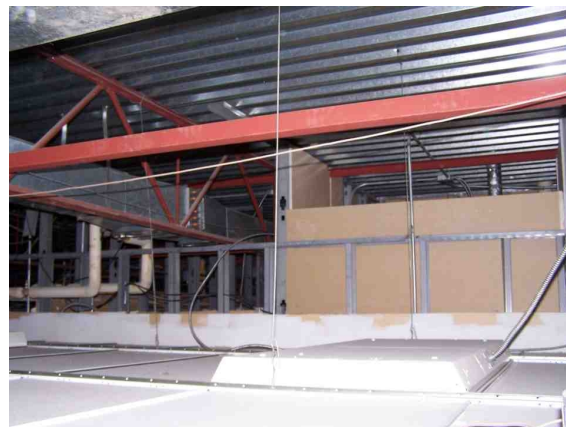
Fire separations do not appear to be constructed; walls separating exit corridors from the room terminate just above the suspended ceilings.
Generally the interior elements are in acceptable condition.

Fire separations are incomplete.

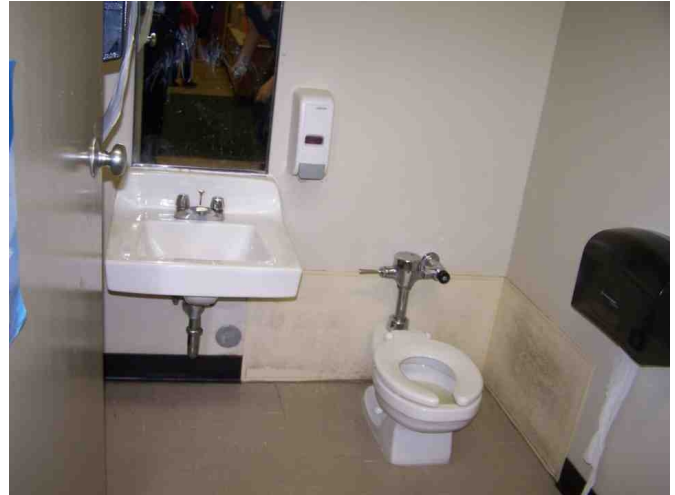
Damaged walls.

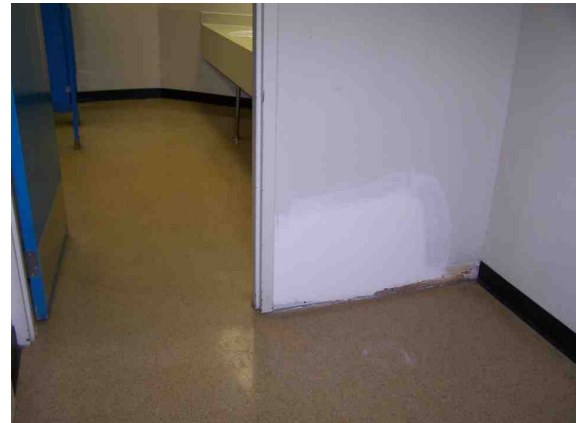
Damaged drywall surfaces including washrooms walls.

Damaged wall surfaces.

Repair damaged drywall surfaces including washrooms walls and paint (160m²).

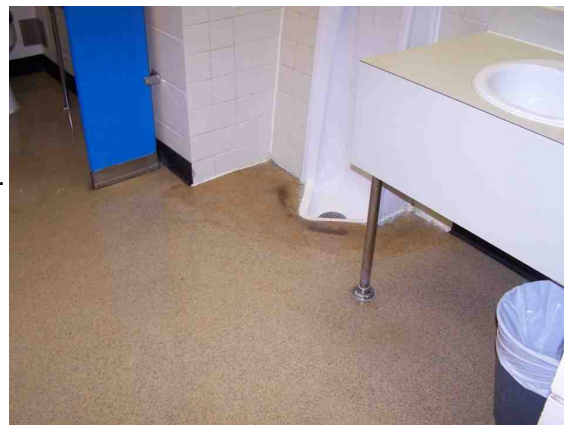
Flooring has cracks and is stained at a number of locations.

Flooring is stained

Remove and replace sections of damaged flooring (180m²).
Incorporate control joints as required.

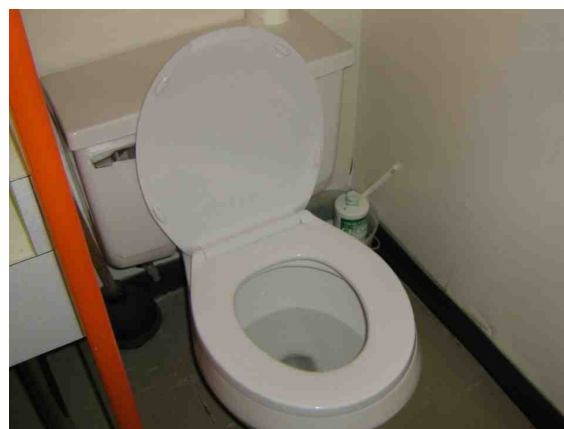
Typical water closet with closed front seat.

Replace the closed front seats with the open type.

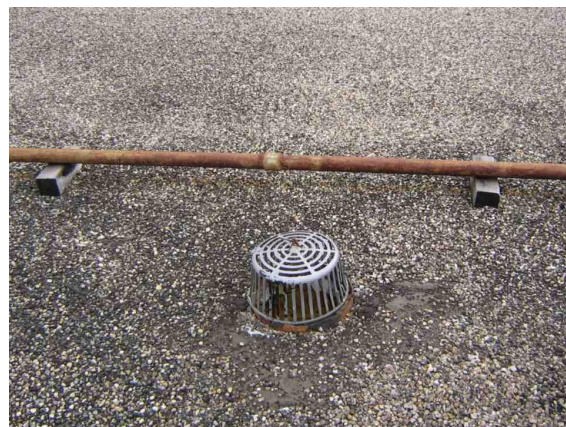
The natural gas line is run across the roof and is rusted.

Gas line on roof is rusted.

Replace the gas line.

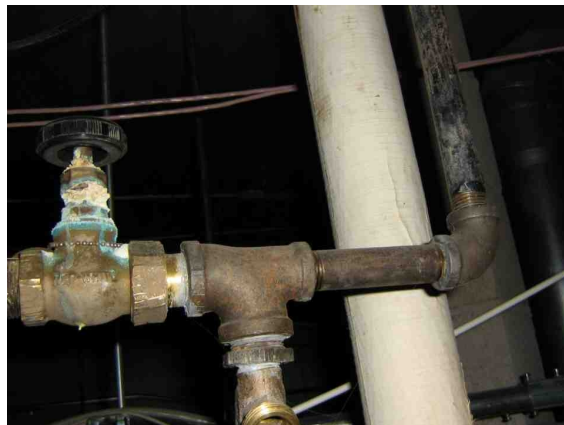
There is evidence of the valves leaking i.e. stained ceiling tiles.

Valve at the coil evidence of leaks.

Replace all the components of the hot water heating distribution system.

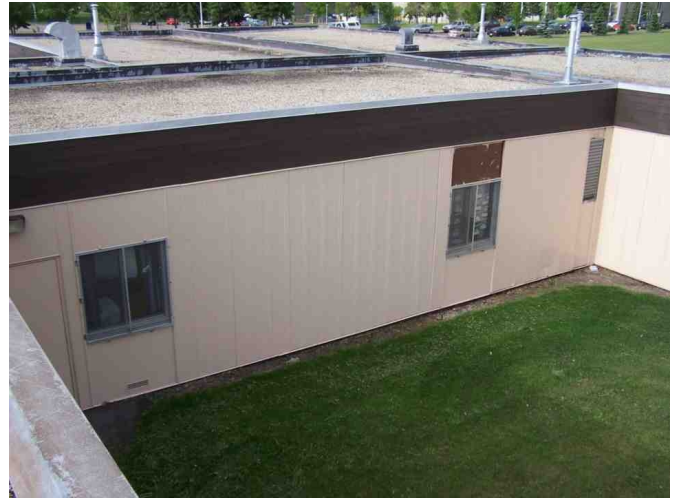
Typical 1980's Portables

Exterior facade is in poor condition
