RECAPP Facility Evaluation Report

Edmonton School District No. 7

Kate Chegwin Junior High School

B3176A
Edmonton

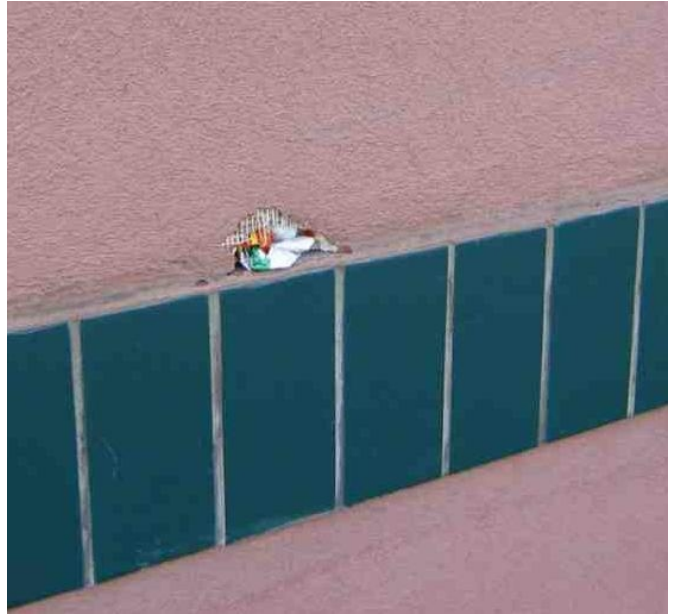
Exterior stucco facade.

<u>Rating</u>	<u>Installed</u>	<u>Design Life</u>	<u>Updated</u>
3 - Marginal	1	75	MAR-08

Damaged Stucco

Exterior stucco facade is damaged and discoloured.

Recommendation:Repair damaged stucco and apply top coat to entire facade (600m²).

<u>Type</u>	<u>Year</u>	<u>Cost</u>	<u>Priority</u>
Repair	2008	\$57,200	Medium

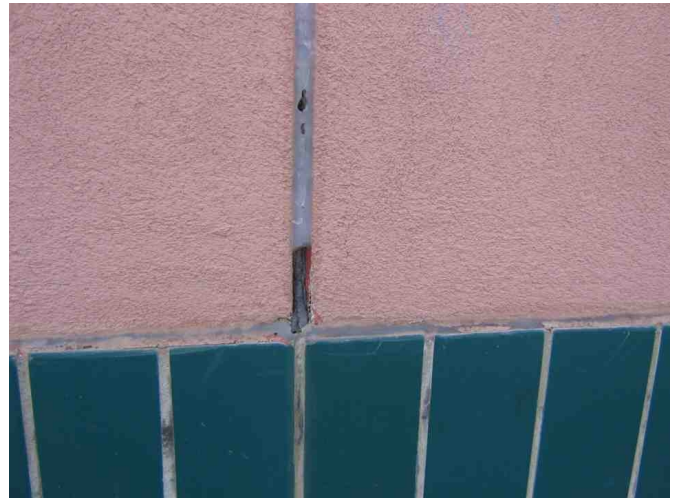
<u>Rating</u>	<u>Installed</u>	<u>Design Life</u>	<u>Updated</u>
2 - Poor	1992	20	MAR-08

Sealant failure/separated.

Damaged and or failed sealant.

Rake back (100 linear meters) and apply sealant to all joints.
(co-ordinate with proposed stucco repairs).

<u>Type</u>	<u>Year</u>	<u>Cost</u>	<u>Priority</u>
Failure Replacement	2008	\$9,152	High

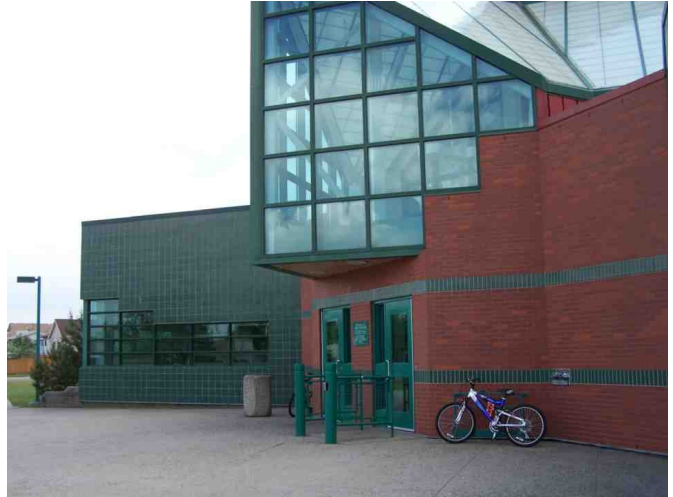
Water stained soffits

Water damaged soffits

Investigate whether the damage is caused by wind driven rain or other. Sand and refinish soffits (5 soffits - approximately 60m² in total).

<u>Type</u>	<u>Year</u>	<u>Cost</u>	<u>Priority</u>
Repair	2008	\$5,720	Medium

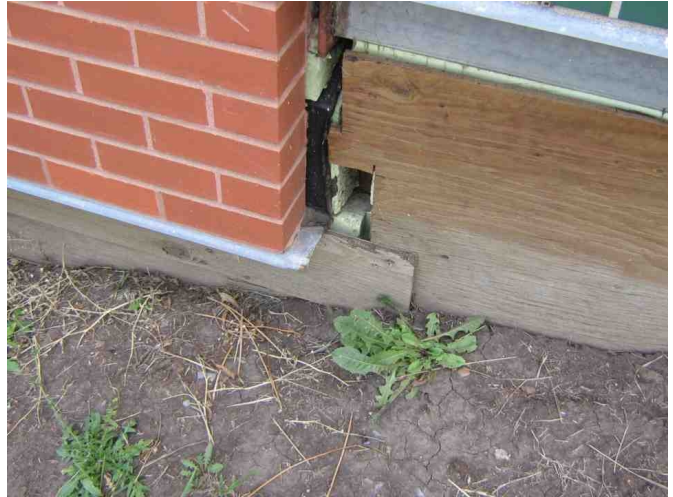
<u>Rating</u>	<u>Installed</u>	<u>Design Life</u>	<u>Updated</u>
2 - Poor	1991	0	MAR-08

Unfinished wall/ insulation protection.

Event: Repair and install new perimeter foundation applique.

Repair damaged area and install (350 linear Meters)

<u>Type</u>	<u>Year</u>	<u>Cost</u>	<u>Priority</u>
Repair	2008	\$22,880	High

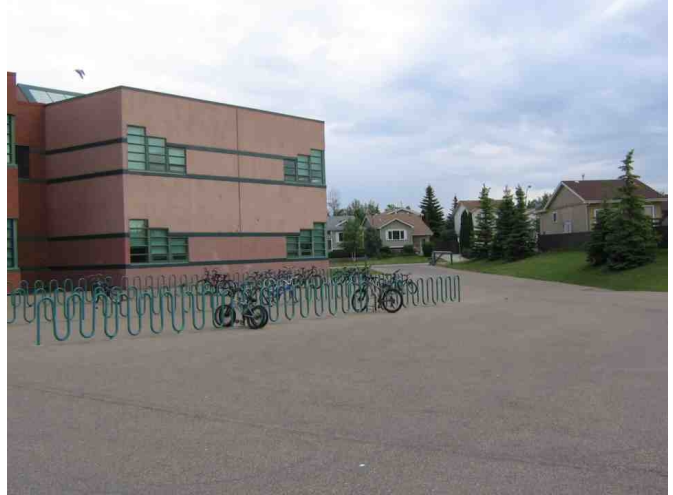
Discoloured window frames- northeast facing windows.

Event: Repair 10 Exterior Standard Windows -1992 Section

<u>Type</u>	<u>Year</u>	<u>Cost</u>	<u>Priority</u>
Repair	2008	\$11,440	Medium

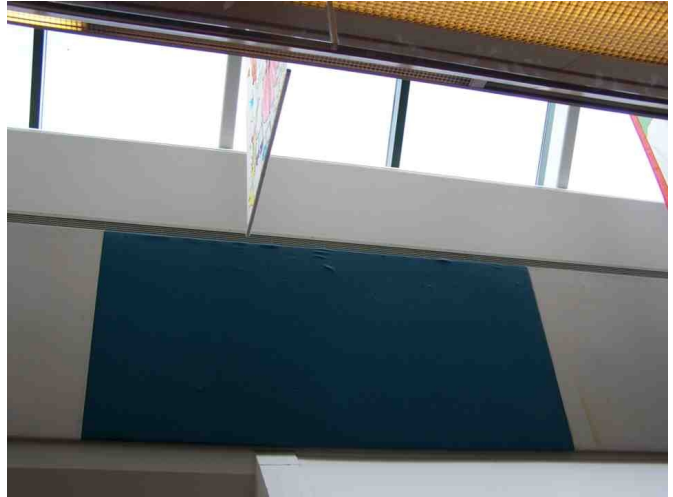
Water stained acoustic panels.

A large number of panel have water stains due to leaking skylights.

Event: Repair 120 units Acoustic Wall Panels**Concern:**

<u>Type</u>	<u>Year</u>	<u>Cost</u>	<u>Priority</u>
Repair	2008	\$34,320	Low

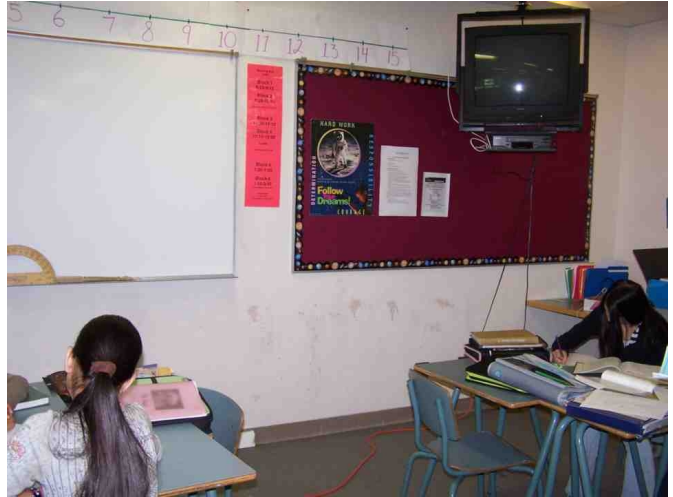
<u>Rating</u>	<u>Installed</u>	<u>Design Life</u>	<u>Updated</u>
2 - Poor	1991	10	MAR-08

Walls have allot of surface damage and markings in classrooms.

Excessive surface wall damage throughout the school's teaching rooms.

Repair walls and Paint.

<u>Type</u>	<u>Year</u>	<u>Cost</u>	<u>Priority</u>
Repair	2008	\$228,800	High

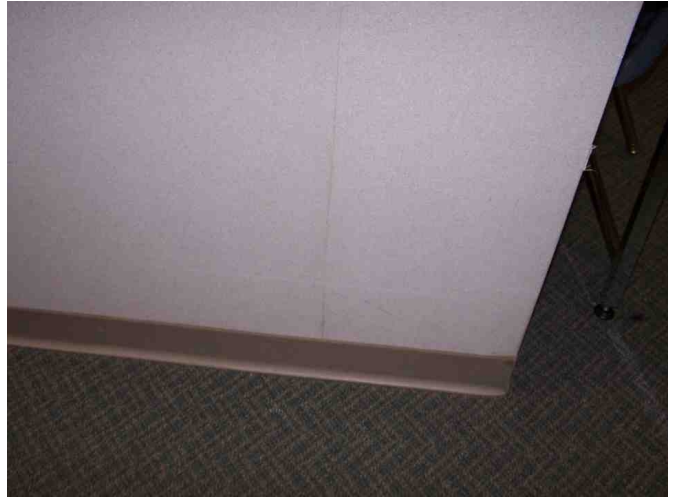
Dis-coloured wall panels

Damaged/stained wall surfaces

Replace damaged wall panels (40 wall panels). For stained panels; clean with appropriate cleaner

<u>Type</u>	<u>Year</u>	<u>Cost</u>	<u>Priority</u>
Repair	2008	\$13,728	Medium

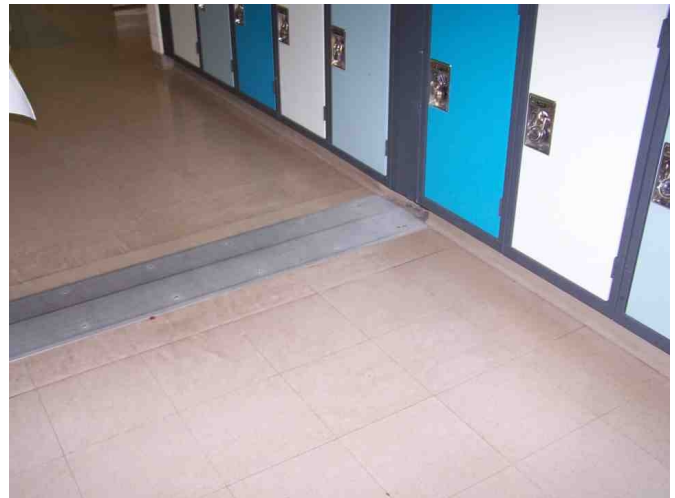
<u>Rating</u>	<u>Installed</u>	<u>Design Life</u>	<u>Updated</u>
2 - Poor	1991	20	MAR-08

VCT flooring is worn. Expansion joint cover is a maintenance concern.

The surface appears to be worn off; discoloured tiles, flooring adhesive swirl lines are visible through the VCT material.

Event: Replace Resilient Flooring**Concern:**

<u>Type</u>	<u>Year</u>	<u>Cost</u>	<u>Priority</u>
Failure Replacement	2008	\$263,120	Medium

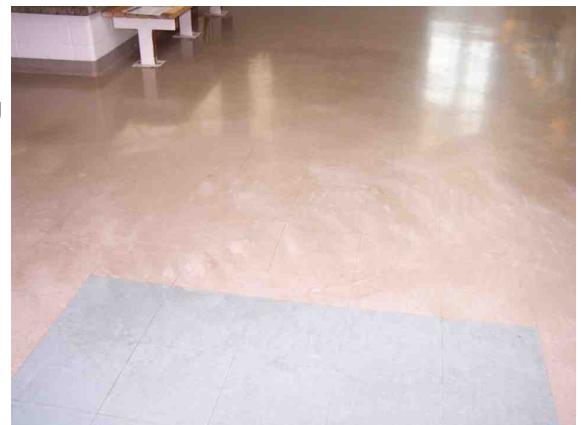
Flooring wear surface is worn off.

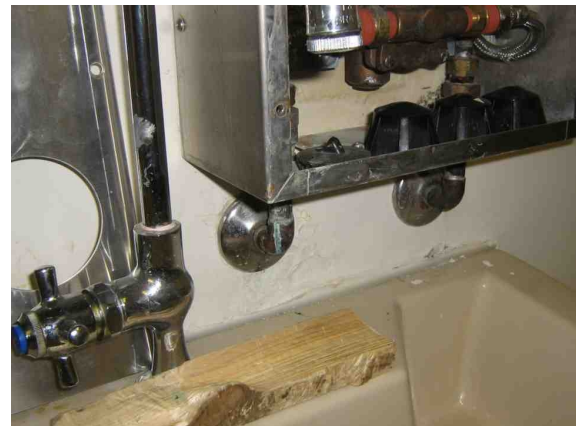
Mixing valve in the science room is leaking.

Mixing valve leaking.

Replace the mixing valve.

<u>Type</u>	<u>Year</u>	<u>Cost</u>	<u>Priority</u>
Failure Replacement	2008	\$6,864	Unassigned

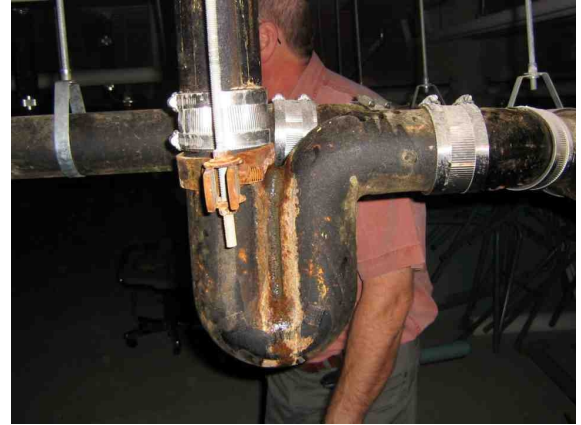
Two of the traps in the crawl space are leaking.

Trap leaking in crawl space.

Repair the two leaking traps and check all the plumbing drains in the crawl space for leaks.

<u>Type</u>	<u>Year</u>	<u>Cost</u>	<u>Priority</u>
Repair	2008	\$1,144	Medium

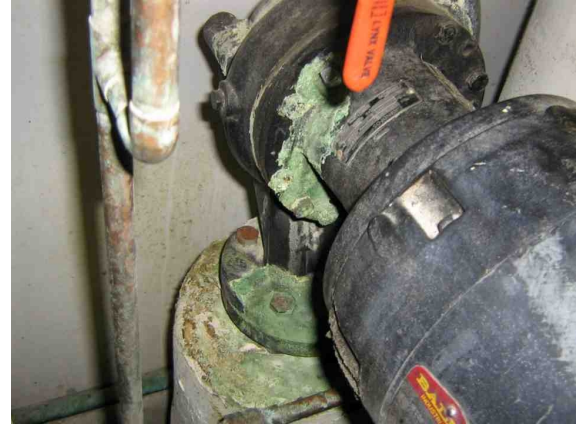
Pumps are leaking.

Evidence of pump leaking.

Replace four pumps.

<u>Type</u>	<u>Year</u>	<u>Cost</u>	<u>Priority</u>
Failure Replacement	2008	\$30,888	Medium

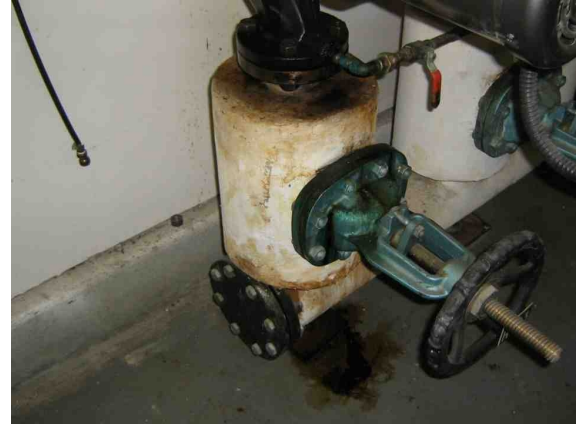
The hot water heating piping in the mechanical room has numerous leaks at the flanges and valves.

The piping in the mechanical room is leaking at the flanges and valves.

Leaking valve has damaged the insulation around it.

Repair the leaks in the mechanical room.

<u>Type</u>	<u>Year</u>	<u>Cost</u>	<u>Priority</u>
Repair	2008	\$6,864	Medium

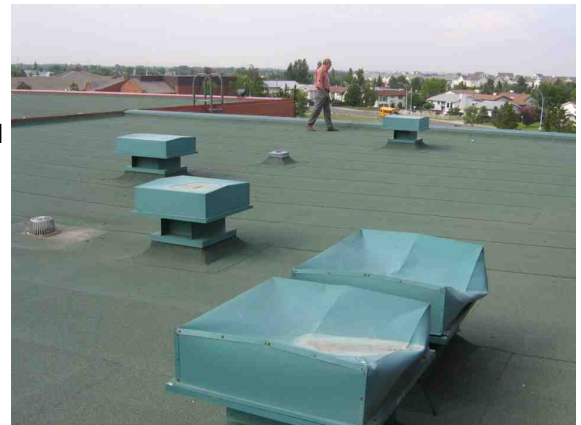
Dented roof caps.

Replace roof caps when the fans are replaced.

<u>Type</u>	<u>Year</u>	<u>Cost</u>	<u>Priority</u>
Lifecycle Replacement	2021	\$16,016	Unassigned

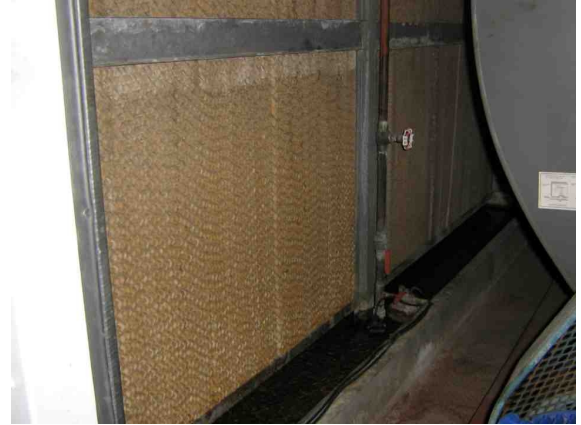
The existing humidifiers are wetted media type that are an indoor air quality concern.

Existing humidifier.

Review the type of humidification in the school and revise it when the air handling units are replaced if not before.

<u>Type</u>	<u>Year</u>	<u>Cost</u>	<u>Priority</u>
Lifecycle Replacement	2016	\$17,160	Unassigned

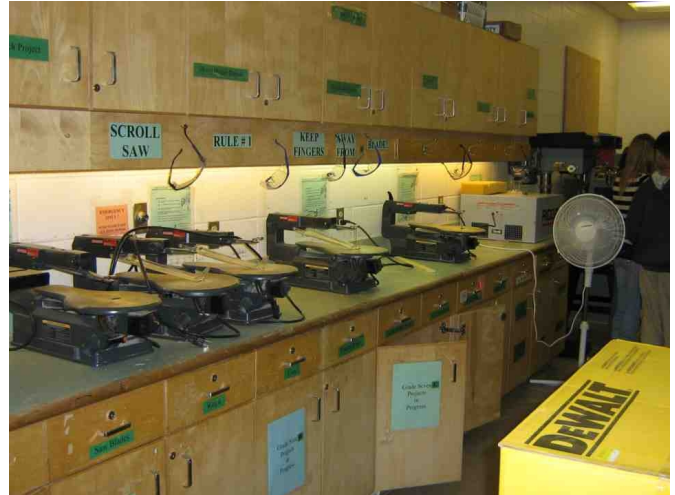
<u>Rating</u>	<u>Installed</u>	<u>Design Life</u>	<u>Updated</u>
3 - Marginal	1991	35	MAR-08

Damage millwork doors and fronts.

Event: Repair 150 linear meters Cabinets
