RECAPP Facility Evaluation Report

Edmonton School District No. 7

Kensington Elementary School

B3181A
Edmonton

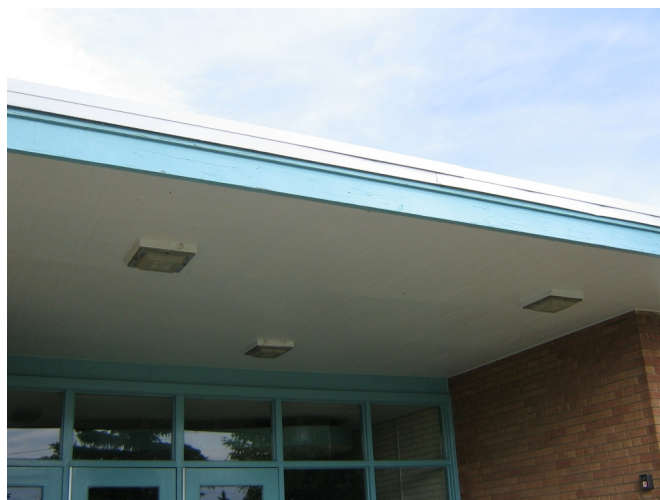
Wood framed painted plywood canopy over main entrance.

<u>Rating</u>	<u>Installed</u>	<u>Design Life</u>	<u>Updated</u>
4 - Acceptable	1958	0	FEB-08

Canopy over front entrance.

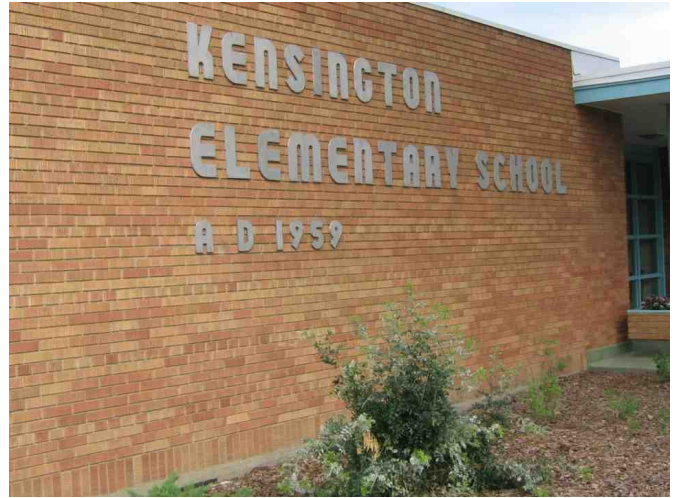
Brick masonry veneer.

<u>Rating</u>	<u>Installed</u>	<u>Design Life</u>	<u>Updated</u>
4 - Acceptable	1958	75	FEB-08

Brick at Main Entrance - 1958 Section.

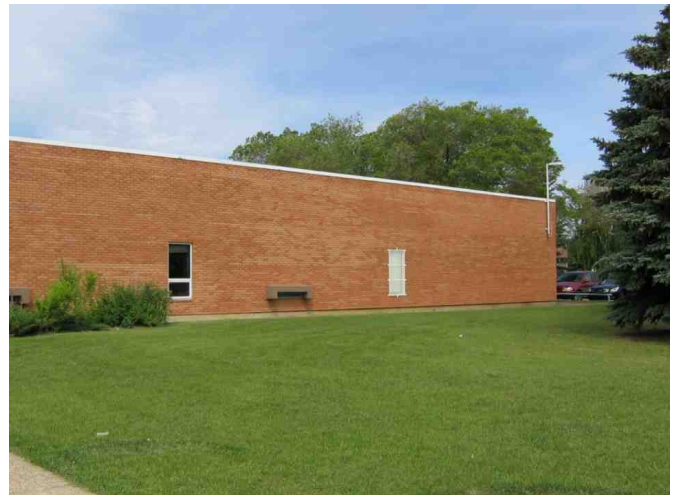
Brick masonry veneer.

<u>Rating</u>	<u>Installed</u>	<u>Design Life</u>	<u>Updated</u>
4 - Acceptable	1970	75	FEB-08

Brick at 1970 Section.

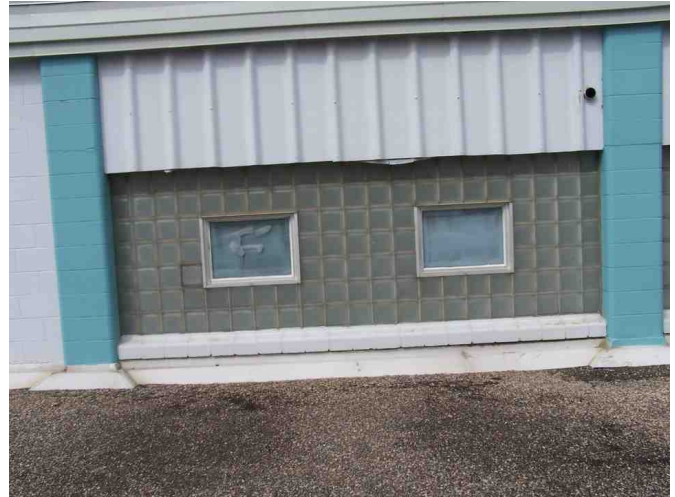
Asbestos corrugated cementitious panels above windows at upper section of gymnasium walls.
 Painted wood fascia board above windows

<u>Rating</u>	<u>Installed</u>	<u>Design Life</u>	<u>Updated</u>
3 - Marginal	1958	40	FEB-08

Siding panel at Gym upper level.

Wood is badly weathered with wood rot.

Event: Install Prefinished Metal Panels**Concern:**

<u>Type</u>	<u>Year</u>	<u>Cost</u>	<u>Priority</u>
Failure Replacement	2008	\$80,080	Low

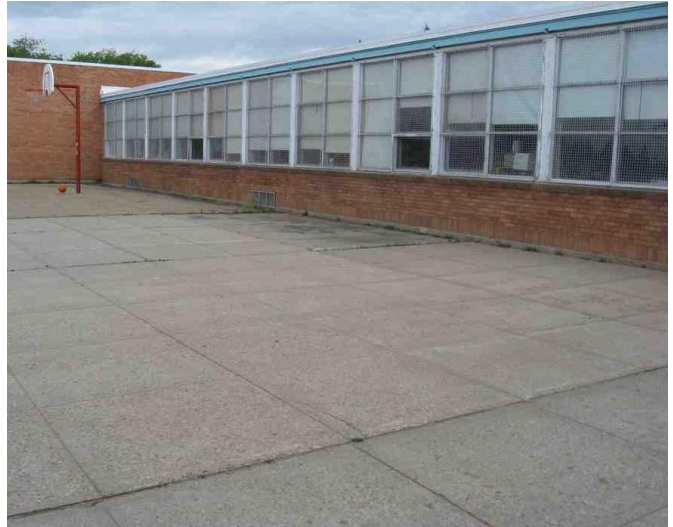
Rating	Installed	Design Life	Updated
3 - Marginal	1963	40	FEB-08

Painted wood fascia board above windows

Wood is badly weathered with wood rot.

Recommendation:Remove existing wood trims and install pre-finished metal panels (approximately 60m²)

Type	Year	Cost	Priority
Failure Replacement	2008	\$22,880	Medium

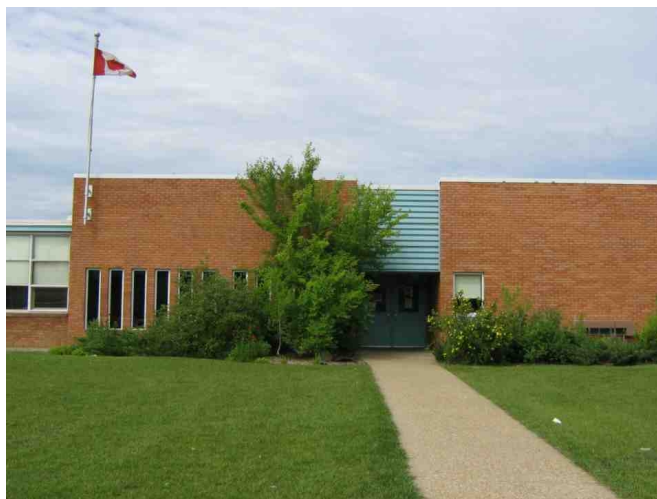
<u>Rating</u>	<u>Installed</u>	<u>Design Life</u>	<u>Updated</u>
3 - Marginal	1970	40	FEB-08

Blue siding panel over Entrance in 1970 section.

Wood is badly weathered with wood rot.

Event: Install Prefinished Metal Panels**Concern:**

<u>Type</u>	<u>Year</u>	<u>Cost</u>	<u>Priority</u>
Failure Replacement	2008	\$45,760	Low

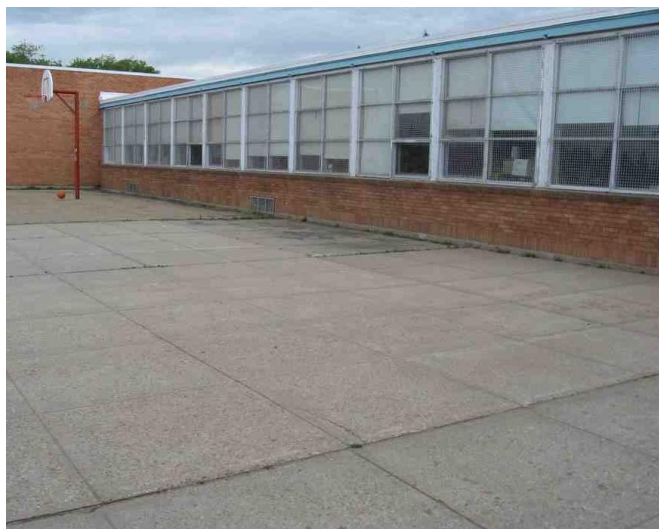
<u>Rating</u>	<u>Installed</u>	<u>Design Life</u>	<u>Updated</u>
3 - Marginal	1995	15	FEB-08

White painted wood between the windows.

Paint is peeling and exposing the wood to weather damage.

Event: Repaint 1715m² Wood in 1958 Section

<u>Type</u>	<u>Year</u>	<u>Cost</u>	<u>Priority</u>
Failure Replacement	2010	\$22,880	Medium

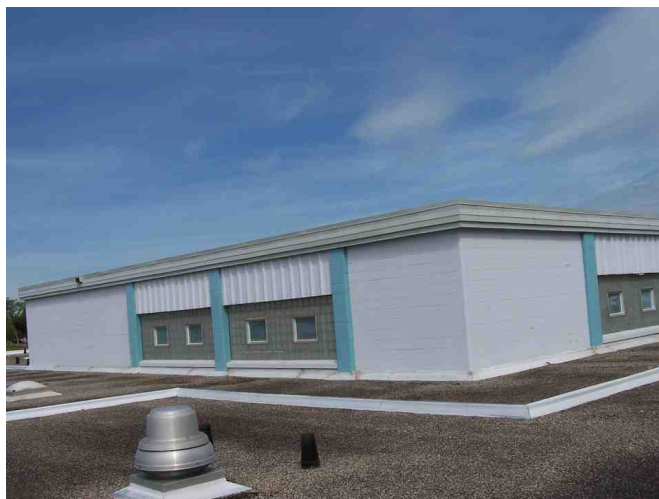
Concrete block construction with masonry brick facade. Gym upper level has a combination of glass block construction and painted corrugated asbestos panels between concrete blocks.

<u>Rating</u>	<u>Installed</u>	<u>Design Life</u>	<u>Updated</u>
4 - Acceptable	1958	0	FEB-08

Upper gym.

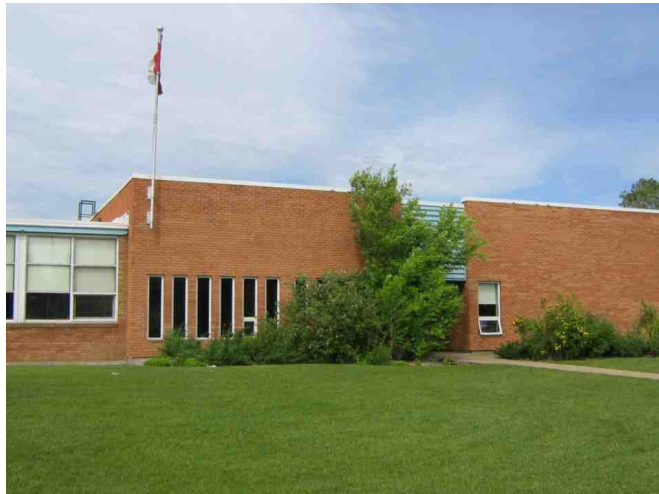
14 aluminum windows with sealed glazed units, 4 with operable vents.

<u>Rating</u>	<u>Installed</u>	<u>Design Life</u>	<u>Updated</u>
4 - Acceptable	1970	40	FEB-08

Windows in the 1970 Section.

Event: Install New Windows with Vents (14)

<u>Type</u>	<u>Year</u>	<u>Cost</u>	<u>Priority</u>
Lifecycle Replacement	2012	\$85,800	Unassigned

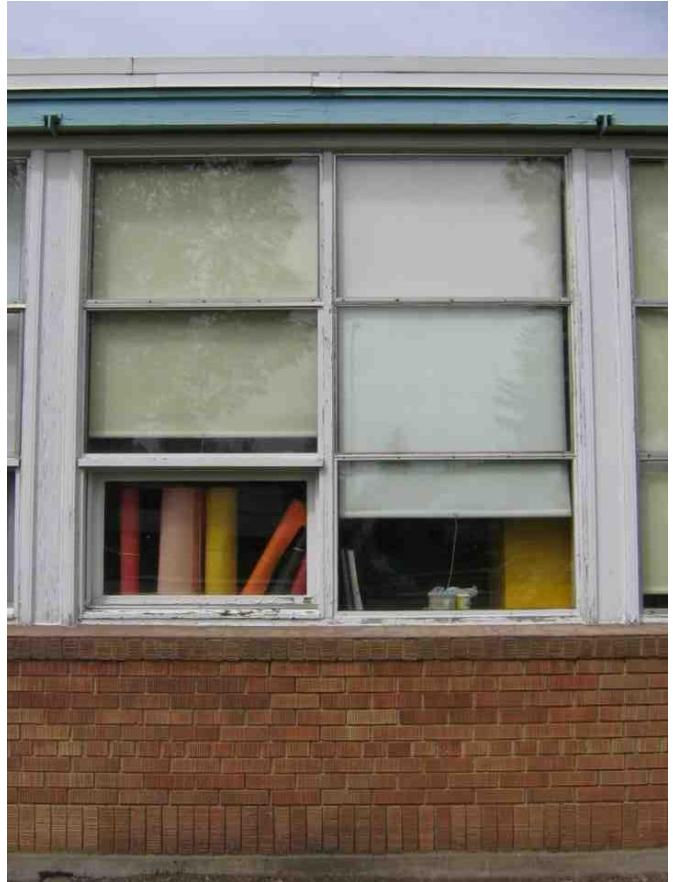
Interior and exterior aluminum single pane windows and frames with vertical sliders. Some wood frames on the outside. No bug screens, but heavy gauge wire screens over windows on the NE side to reduce vandalism.

<u>Rating</u>	<u>Installed</u>	<u>Design Life</u>	<u>Updated</u>
2 - Poor	1958	40	FEB-08

Exterior window - 1958 Section. Paint peeling and frames are damaged.

All windows are original and passed life expectancy. Many windows poor fitting and sliders are inoperable. No bugs screens. Exterior frames are heavily weather damaged. Interior wooden sills between panels are rotting.

Replace all (170) exterior windows and frames with sealed units with at least 2 operable vent units per room.

<u>Type</u>	<u>Year</u>	<u>Cost</u>	<u>Priority</u>
Failure Replacement	2008	\$972,400	High

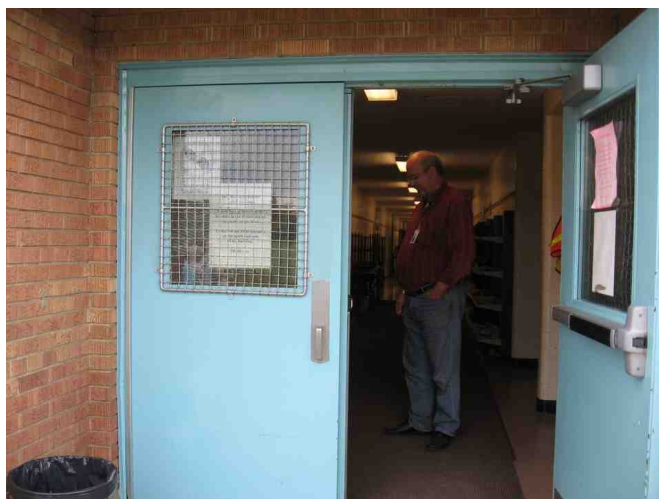
1 set of hollow metal doors in pressed steel frame.

<u>Rating</u>	<u>Installed</u>	<u>Design Life</u>	<u>Updated</u>
3 - Marginal	1995	30	FEB-08

Exterior Doors 1963 Section.

Event: Replace Exterior Entrance Doors - 1963 Section

<u>Type</u>	<u>Year</u>	<u>Cost</u>	<u>Priority</u>
Lifecycle Replacement	2012	\$8,008	Unassigned

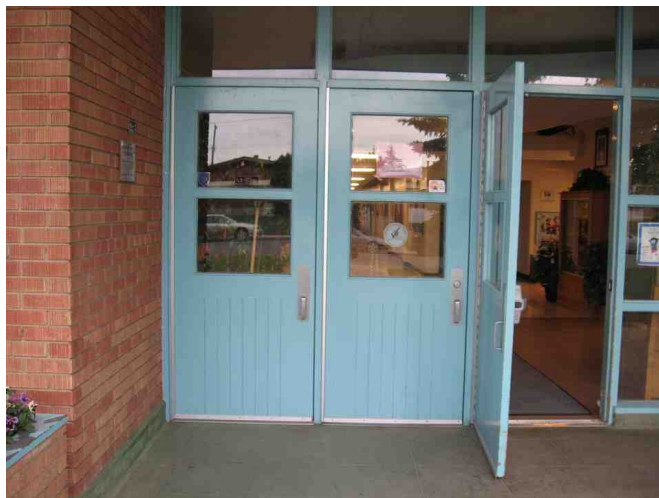
Main Entrance Storefront - three single wood doors in a pressed steel frame with sidelights and upper glass transoms.
 Hardware - closers and push bars.
 Wood framed and wood main entrance doors. Doors are poorly fitting and stick.

<u>Rating</u>	<u>Installed</u>	<u>Design Life</u>	<u>Updated</u>
3 - Marginal	1958	30	FEB-08

Exterior - Main Entrance Doors - 1958 Section.

Event: Install New Main Entrance Doors**Concern:**

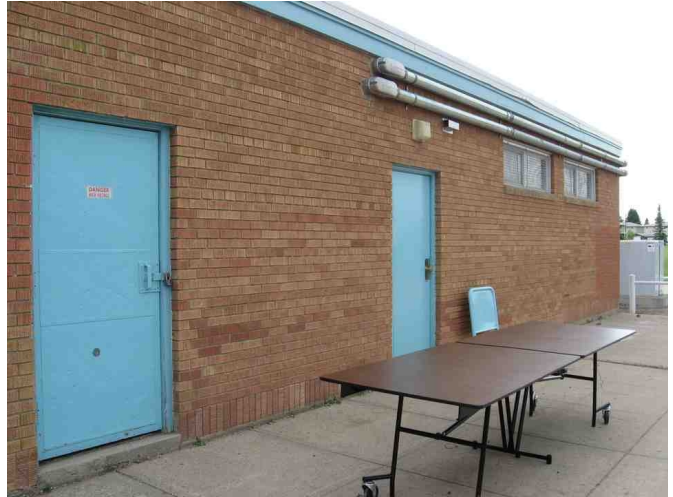
2 wood and wood framed utility doors in Mechanical / Utility Room.

<u>Rating</u>	<u>Installed</u>	<u>Design Life</u>	<u>Updated</u>
4 - Acceptable	1958	40	FEB-08

Exterior Utility Doors to Mechanical Room in 1958 Section.

Event: Replace 2 Exterior Utility Doors - 1958 Section

<u>Type</u>	<u>Year</u>	<u>Cost</u>	<u>Priority</u>
Lifecycle Replacement	2012	\$9,152	Unassigned

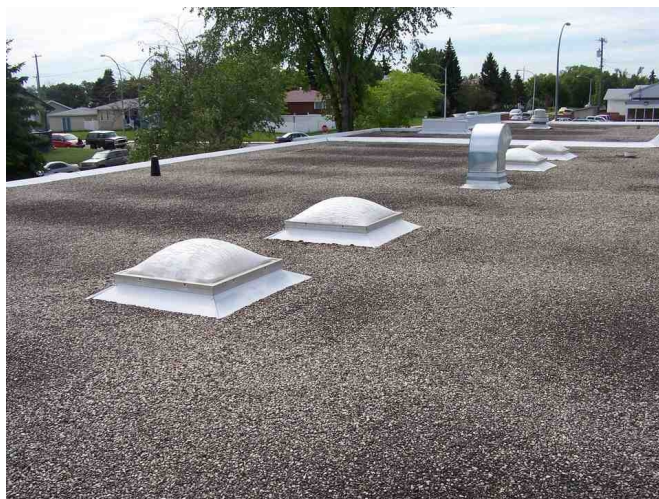
Asphalt and gravel roof over the 1958 section (approx. 2,202m²).

<u>Rating</u>	<u>Installed</u>	<u>Design Life</u>	<u>Updated</u>
2 - Poor	1958	25	FEB-08

Roof - 1958 Section.

This area of roofing has been scheduled for replacement in 2008 . (220m²)

<u>Type</u>	<u>Year</u>	<u>Cost</u>	<u>Priority</u>
Failure Replacement	2008	\$434,720	High

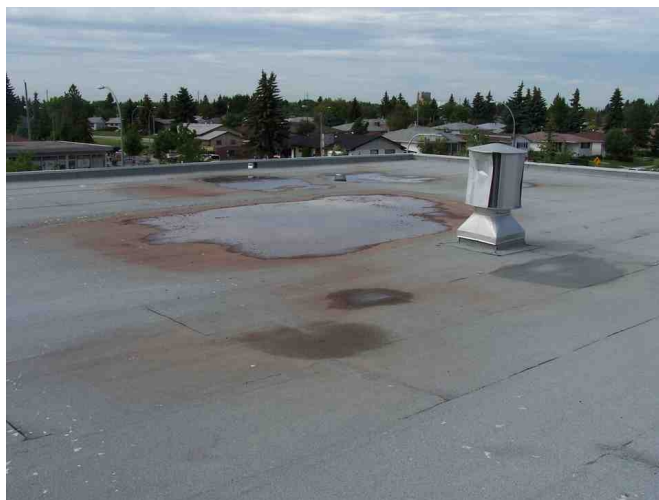
SBS 2 ply membrane installed on the Gym roof in 2005 (approx 397m²).

<u>Rating</u>	<u>Installed</u>	<u>Design Life</u>	<u>Updated</u>
4 - Acceptable	2005	25	FEB-08

SBS Roof on Upper Gym Roof - 1958 Section.

Event: Replace Gym Roof (397m²)

<u>Type</u>	<u>Year</u>	<u>Cost</u>	<u>Priority</u>
Lifecycle Replacement	2030	\$85,800	Unassigned

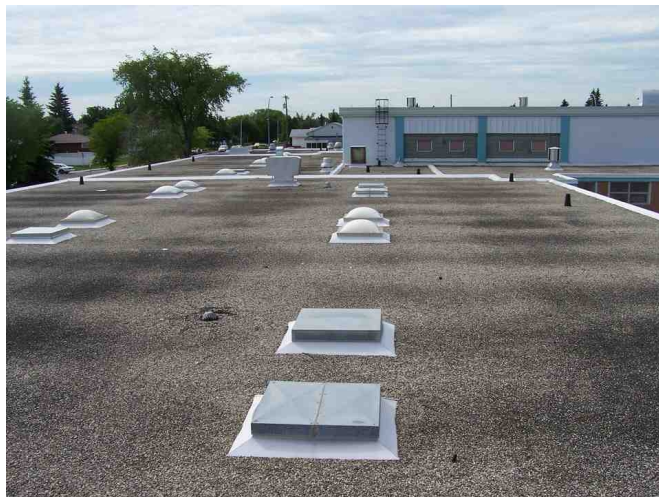
22 domed skylights in the 1958 Section. 15 still have the dome and 7 have been capped.

<u>Rating</u>	<u>Installed</u>	<u>Design Life</u>	<u>Updated</u>
2 - Poor	1958	25	FEB-08

Skylights - 1958 and 1963 Sections.

Event: Replace 22 Skylights**Concern:**

<u>Type</u>	<u>Year</u>	<u>Cost</u>	<u>Priority</u>
Failure Replacement	2008	\$148,720	Medium

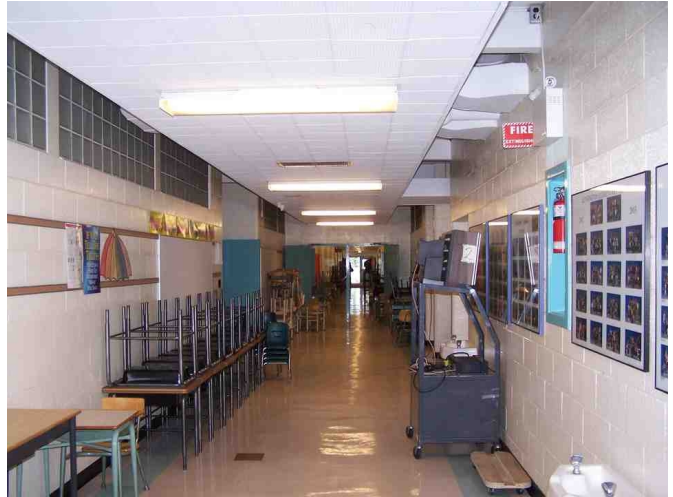
1958 / 1963 / 1970 - all section have painted concrete block. 1958 section has glass blocks on top of the concrete block along the hallways.

<u>Rating</u>	<u>Installed</u>	<u>Design Life</u>	<u>Updated</u>
4 - Acceptable	0	0	FEB-08

Concrete and glass blocks in Hallway - typical.

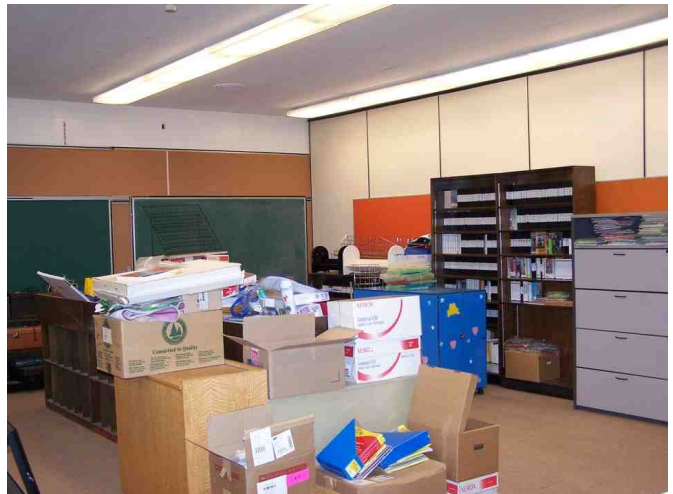
Open concept area around the Library was divided up in 1976 using vinyl covered partitions. Area now has two complete classrooms with doors and one area with two partition walls but open to the library on one side.

<u>Rating</u>	<u>Installed</u>	<u>Design Life</u>	<u>Updated</u>
4 - Acceptable	1976	0	FEB-08

Demountable partitions in 1970 Section.

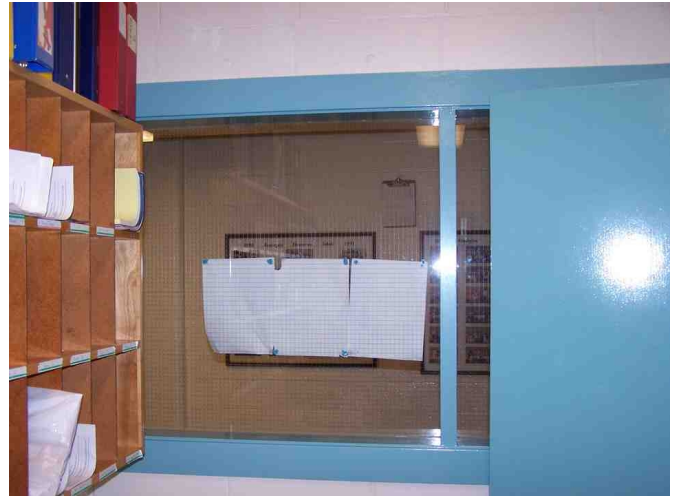
1 large window without GWG in the Custodians Room overlooking the Mechanical Room.

<u>Rating</u>	<u>Installed</u>	<u>Design Life</u>	<u>Updated</u>
3 - Marginal	1958	0	FEB-08

GWG glass in workroom in 1958 Section.

Replace float glass in School Office/Hallway and Custodians Office windows with Safety Glass.

<u>Type</u>	<u>Year</u>	<u>Cost</u>	<u>Priority</u>
Code Upgrade	2008	\$1,716	Medium

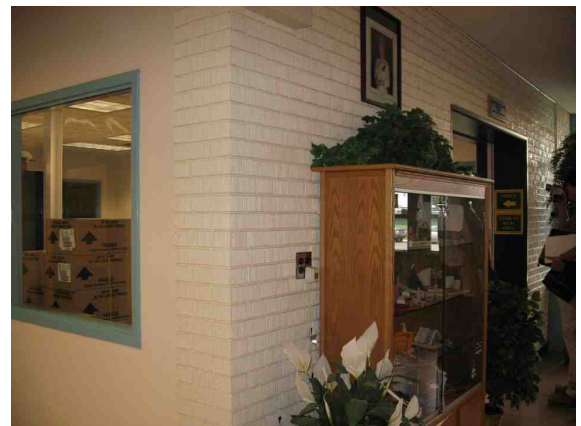
Window between new school office and hallway.

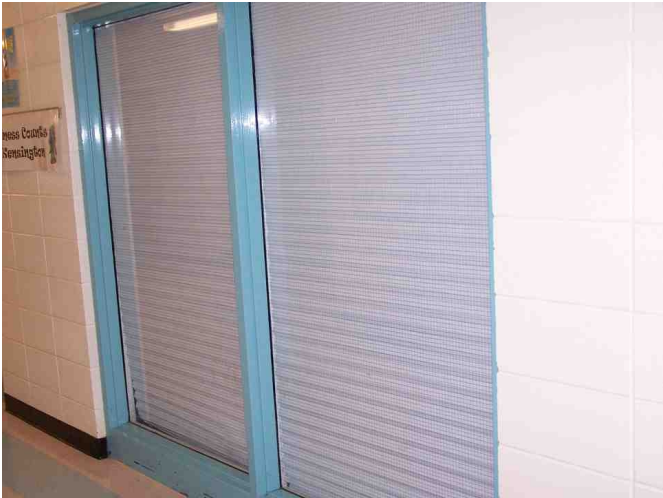
2 sets of tall double windows in pre-2001 school office. One set of windows faces the main hallway, the second set faces the short hallway to the entrance doors.
All windows have GWG.

<u>Rating</u>	<u>Installed</u>	<u>Design Life</u>	<u>Updated</u>
4 - Acceptable	1970	80	FEB-08

GWG windows in old School Office.

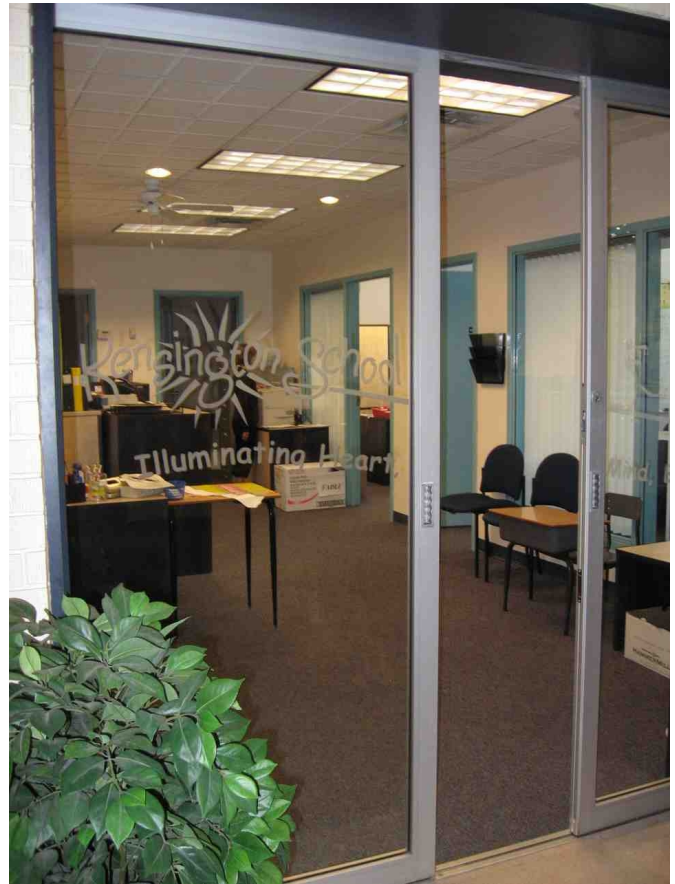
A two-panel sliding storefront entrance at the new school office faces the main entrance lobby. There are etched graphs on each of the aluminum framed panels.

<u>Rating</u>	<u>Installed</u>	<u>Design Life</u>	<u>Updated</u>
3 - Marginal	2001	0	FEB-08

Sliding glass doors at new School Office - 1958 Section.

Event: Replace Interior Glazed Storefront Doors**Concern:**

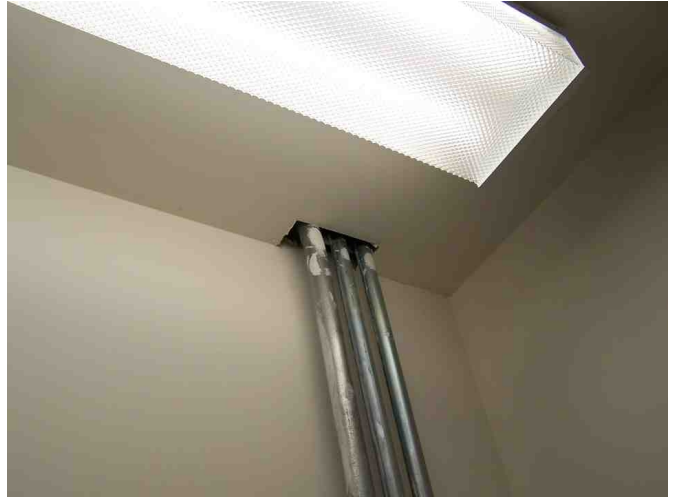
1958 / 1963 / 1970 - pipe and conduit penetration through walls and ceilings.

<u>Rating</u>	<u>Installed</u>	<u>Design Life</u>	<u>Updated</u>
3 - Marginal	1958	0	FEB-08

Unsealed pipe penetrations - typical.

Event: Seal Pipe Penetrations**Concern:**

<u>Type</u>	<u>Year</u>	<u>Cost</u>	<u>Priority</u>
Code Repair	2008	\$3,432	Low

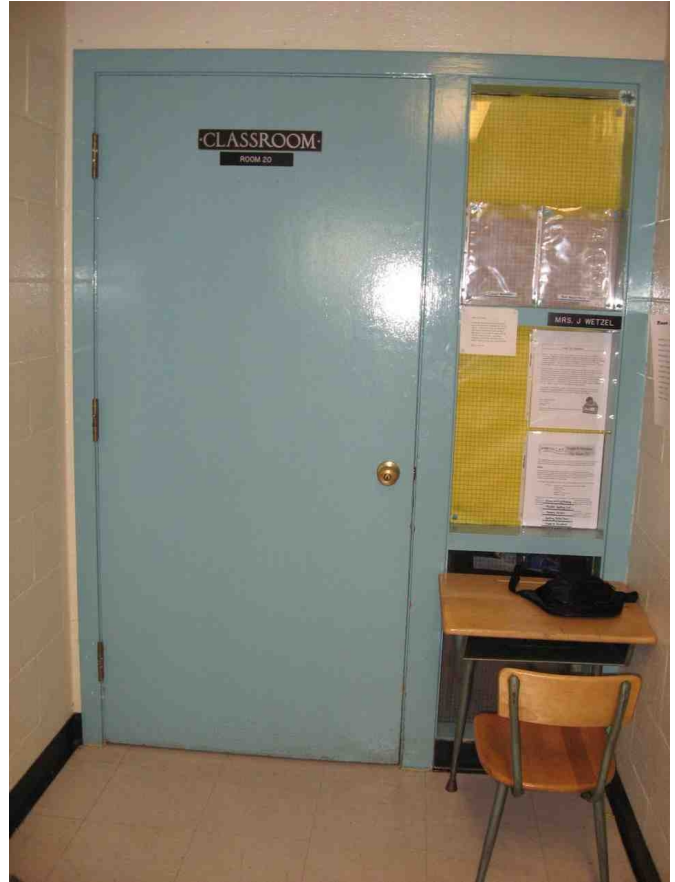
Approx. 60 wood and wood framed doors, some classroom doors have GWG sidelights. Hardware is older round knob type.

<u>Rating</u>	<u>Installed</u>	<u>Design Life</u>	<u>Updated</u>
3 - Marginal	1958	40	FEB-08

Classroom Entrance - typical for 1958 asection.

Event: Replace Interior Swinging Doors (& Hardware) - 1958 Section

<u>Type</u>	<u>Year</u>	<u>Cost</u>	<u>Priority</u>
Failure Replacement	2008	\$34,320	Medium

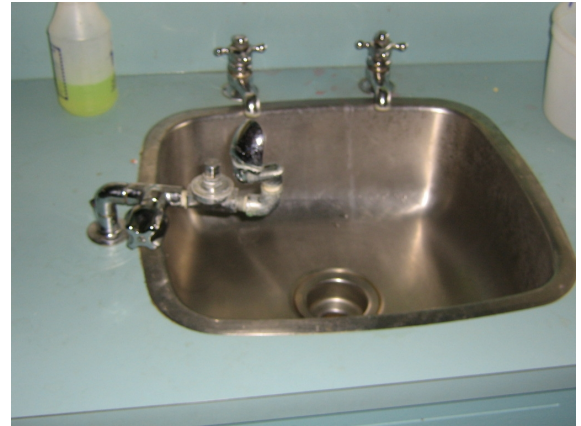
Existing classroom sink with separate supplies.

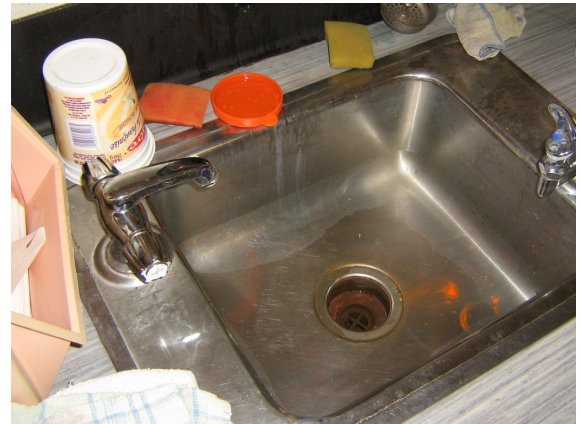
Classroom sinks are not barrier free.

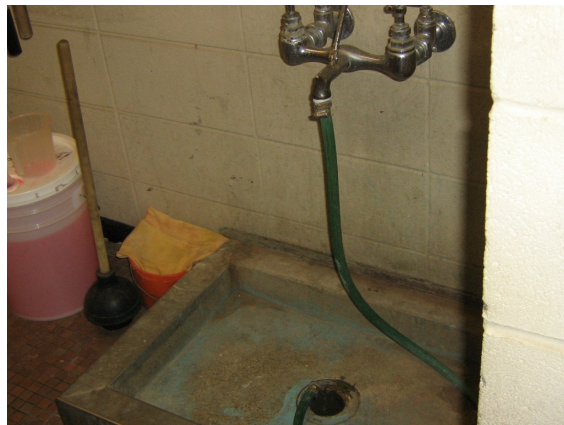
Existing floor mounted service sink.

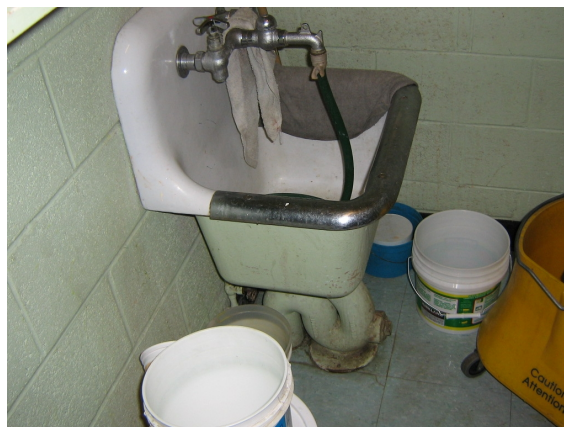
Existing service sink require lifting buckets to empty them.

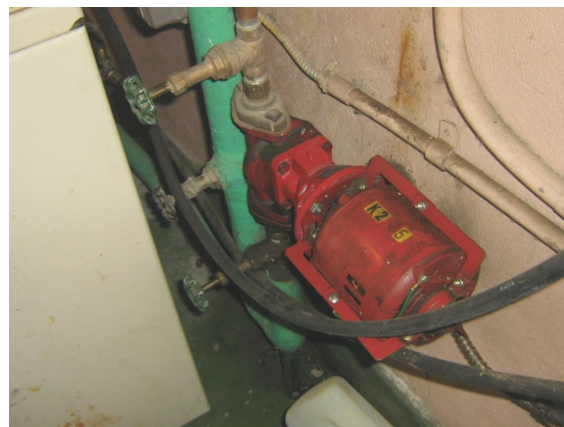
Domestic water pump.

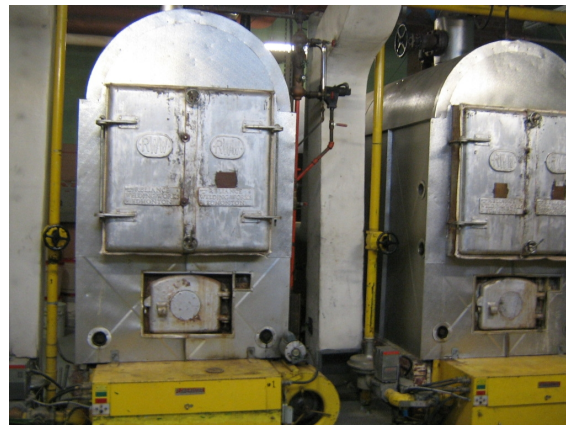
Existing boilers.

Install new boiler plant including 600kW gas fired boilers, two hot water circulation pumps, expansion tanks all associated valves, gauges and glycol injection system. Replace chimneys with type B vents and new combustion air ducts.

<u>Type</u>	<u>Year</u>	<u>Cost</u>	<u>Priority</u>
Failure Replacement	2008	\$114,400	High

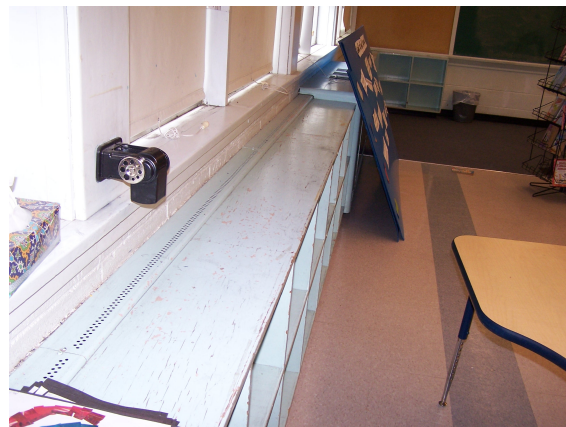
Typical unit ventilator behind shelves.

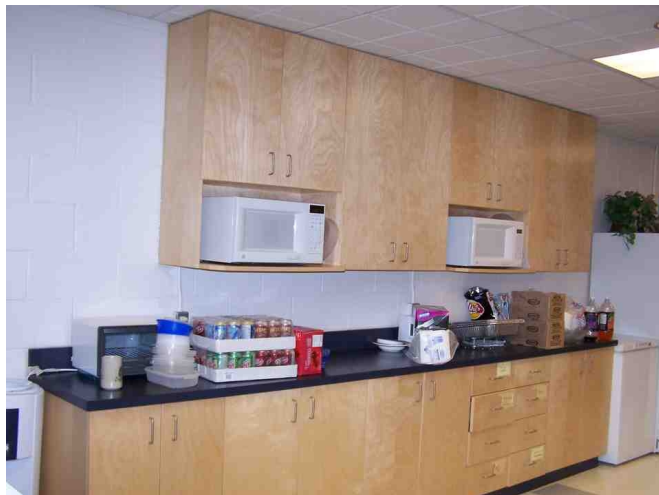
Clear finished kitchen base cabinets and upper cabinets

<u>Rating</u>	<u>Installed</u>	<u>Design Life</u>	<u>Updated</u>
4 - Acceptable	1985	35	FEB-08

Kitchen cabinets

Event: Replace 16 linear meters Kitchen Casework (Staff Room in 1958 section)

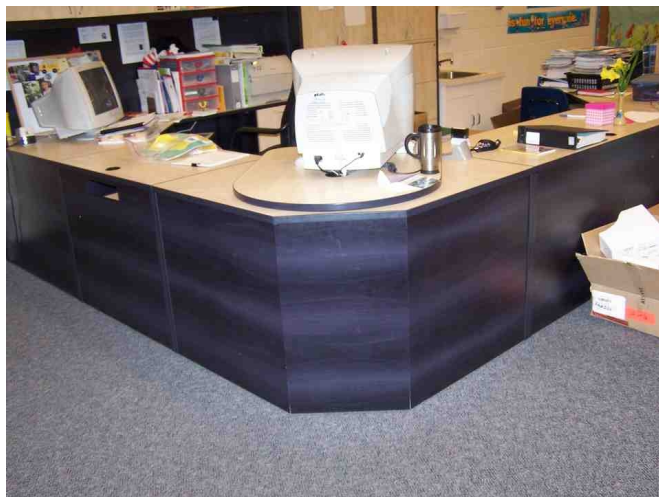
100_8849.JPG

Librarian's charge desk and workspace, varnished library book shelves, painted bookcase and melamine finished units.

<u>Rating</u>	<u>Installed</u>	<u>Design Life</u>	<u>Updated</u>
4 - Acceptable	1970	0	FEB-08

Event: Replace Library Casework in 1970 section (12m).

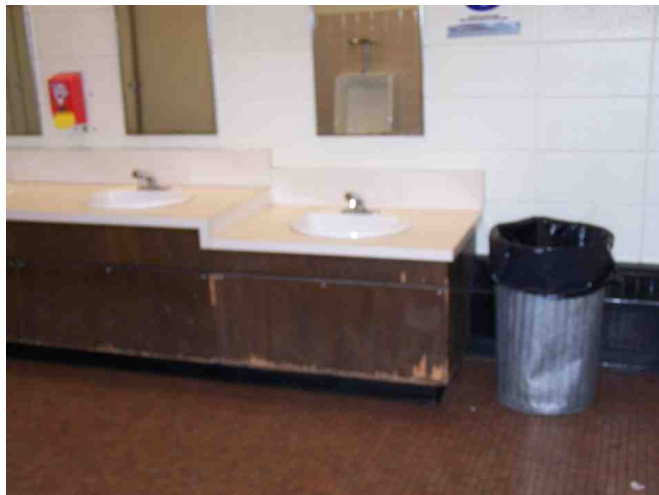
100_8805.JPG

Wood vanities in washrooms

<u>Rating</u>	<u>Installed</u>	<u>Design Life</u>	<u>Updated</u>
2 - Poor	1963	35	FEB-08

Event: Install New Laminate (finished fronts and sides)**Concern:**

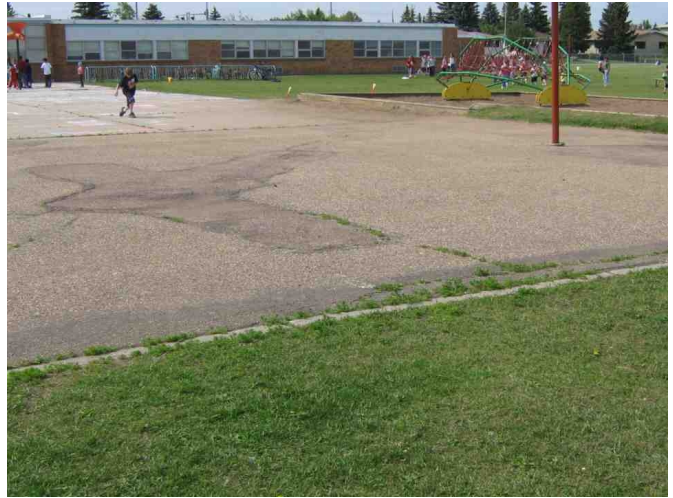
<u>Rating</u>	<u>Installed</u>	<u>Design Life</u>	<u>Updated</u>
4 - Acceptable	1958	25	FEB-08

Fire lane / play area

Event: Replace 1700m² Asphalt Roadway

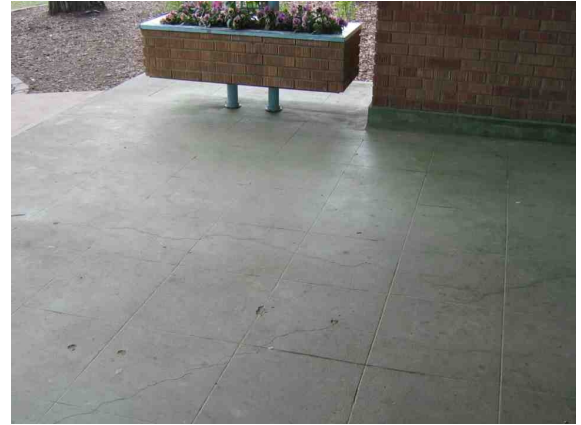
Walkways have cracks

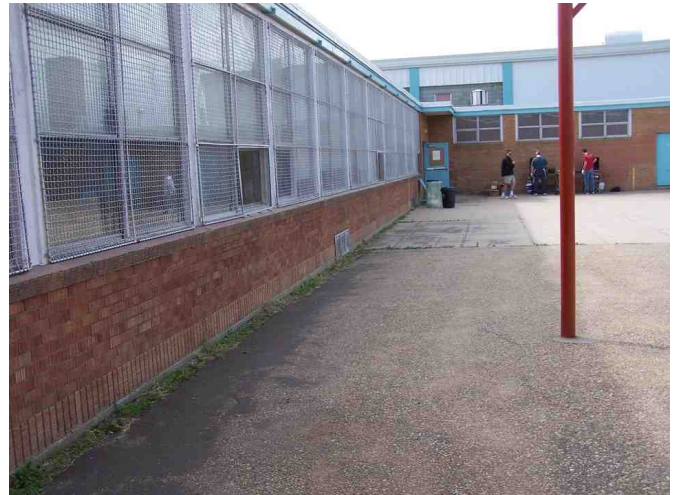
100_8822.JPG

Main entrance on grade, back entrance has asphalt ramp.

<u>Rating</u>	<u>Installed</u>	<u>Design Life</u>	<u>Updated</u>
4 - Acceptable	1958	0	FEB-08

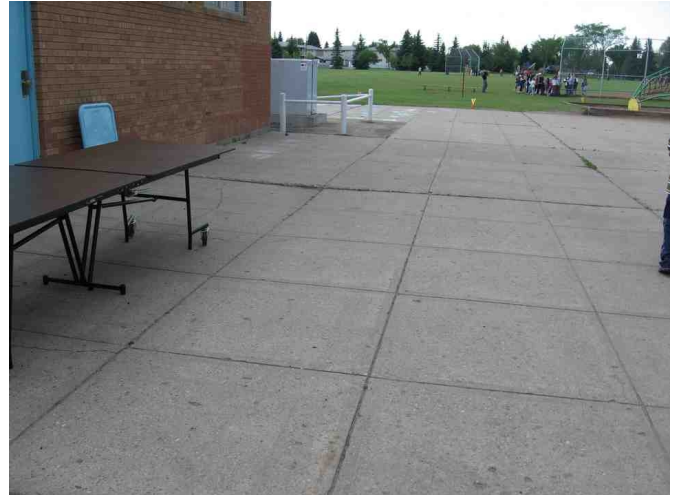
<u>Rating</u>	<u>Installed</u>	<u>Design Life</u>	<u>Updated</u>
4 - Acceptable	1985	25	FEB-08

View looking north - asphalt surfaced play area doubles as fire lane in concert with concrete patio area

Event: Replace 1550m² Athletic and Recreational Surfaces

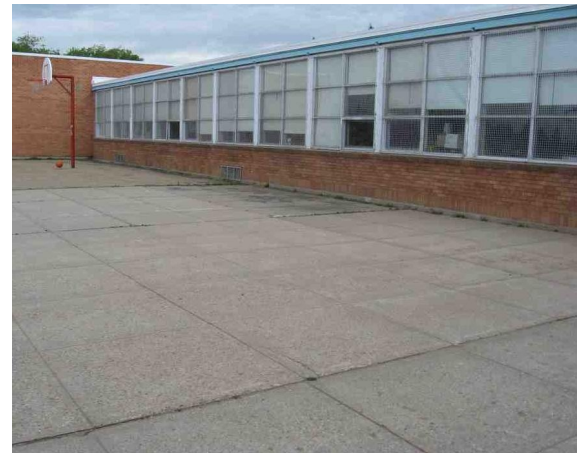
View looking east - asphalt surfaced play area doubles as fire lane in concert with concrete patio area

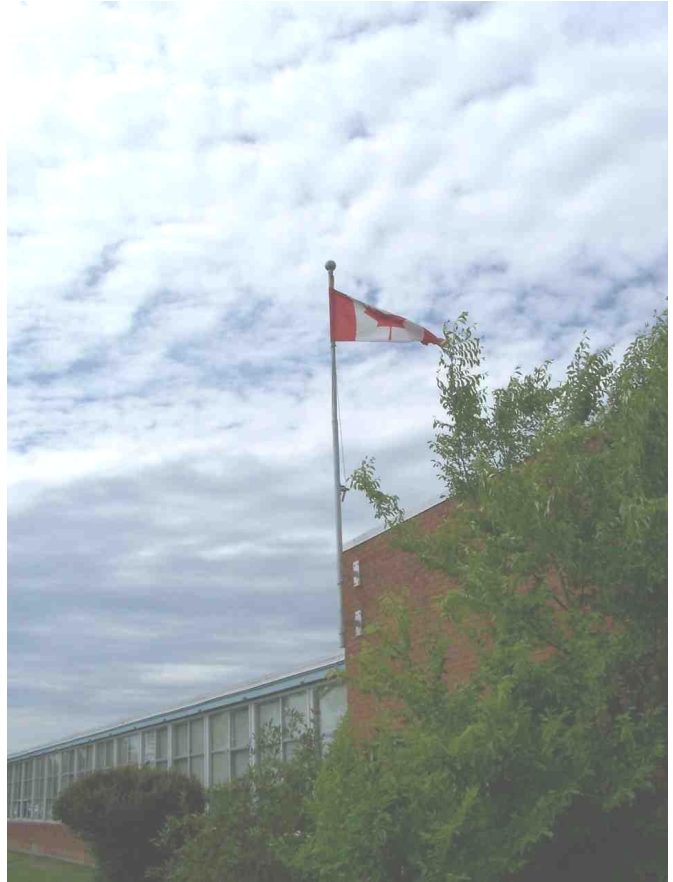
<u>Rating</u>	<u>Installed</u>	<u>Design Life</u>	<u>Updated</u>
3 - Marginal	1958	0	FEB-08

Wall mounted flag Pole

Event: Install New Flagpole and Base**Concern:**

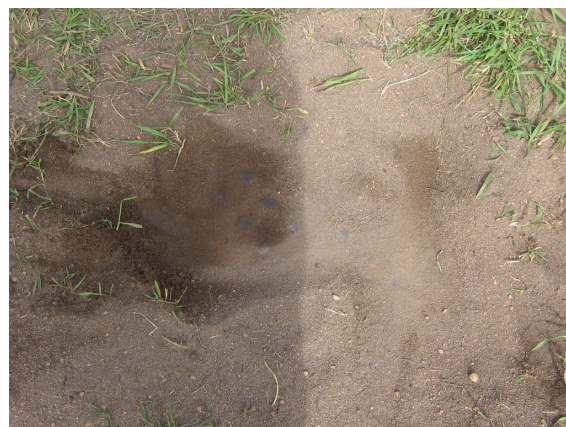
Catch basin covered with sand.
