# **RECAPP Facility Evaluation Report**

**Edmonton School District No. 7**

**Killarney Junior High School**

**Evaluation Company:** Koliger Schmidt architect engineer  
**Evaluation Date:** June 28 2007  
**Evaluator Name:** Mario Macchione

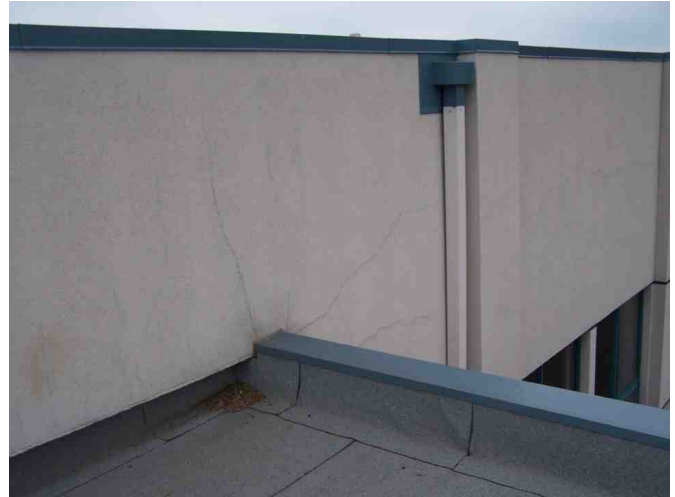
Stucco cracks

Sections of stucco are damaged.

Repair damage EIFS product (3 locations totaling 24m<sup>2</sup>).

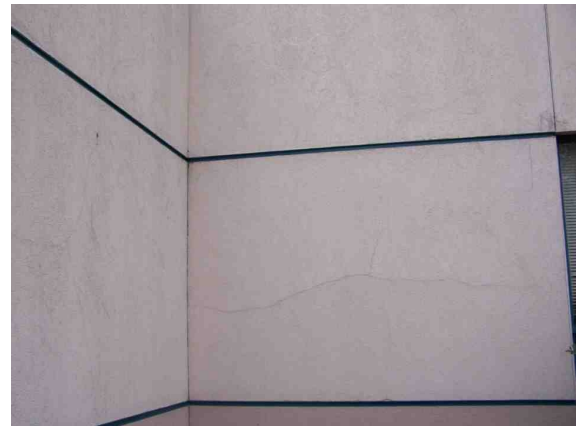
Cracked stucco

Stucco finish is cracked at a number of locations.

Co-ordinate work with stucco repairs.

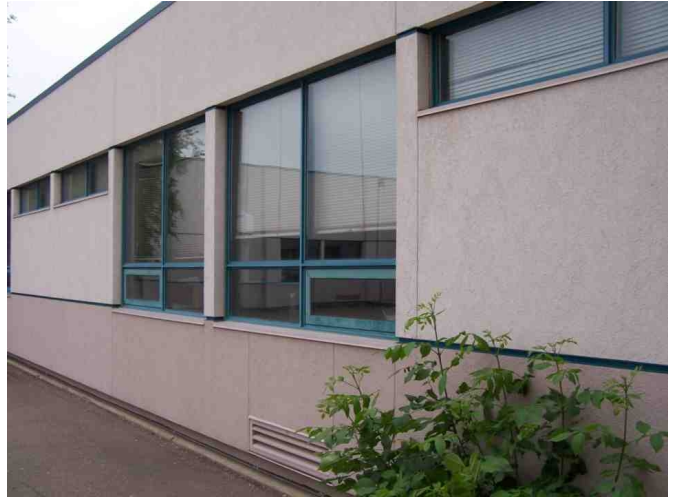
Aluminum Windows installed in 1993.

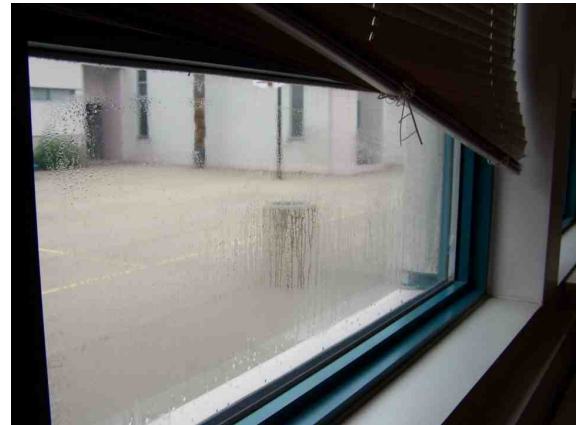
Sealed glazing as failed; moisture build-up between panes.

Moisture build-up between glass panes.

Remove existing failed glazing and install new.

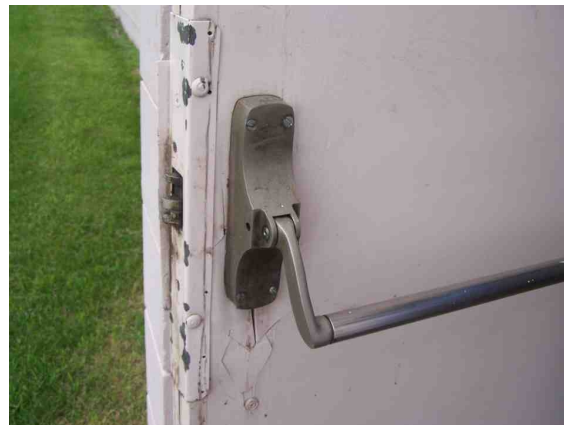
Doors have been vandalized.

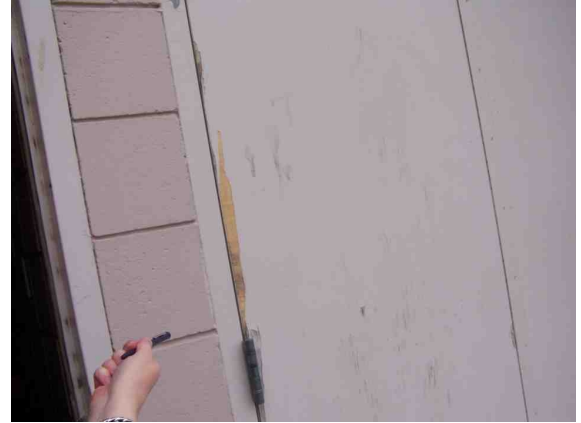
Doors are in poor condition.

Wood door- delaminating.

Replace one set of double doors complete with frame and hardware.

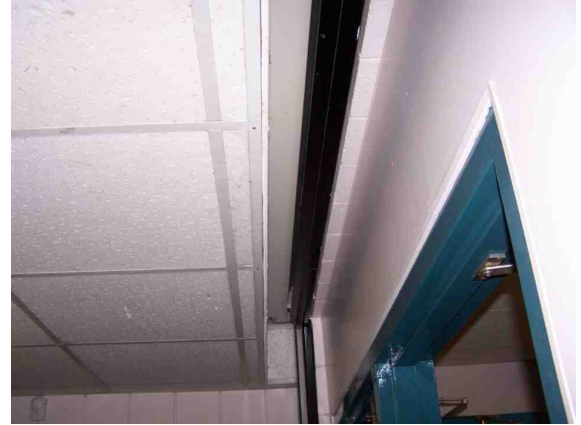
2 rolling shutters- one at each side of wall; door swings will not permit shutters to close.

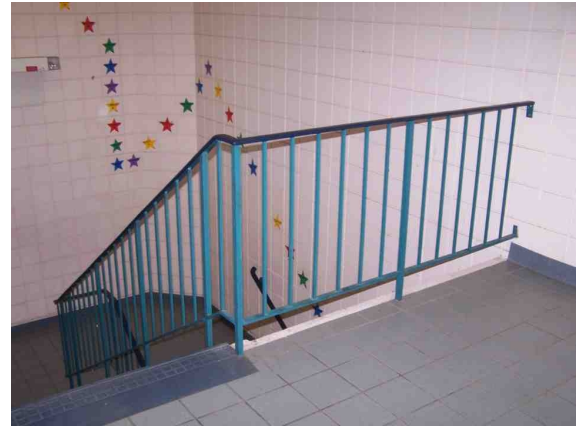
Guardrails are too low.

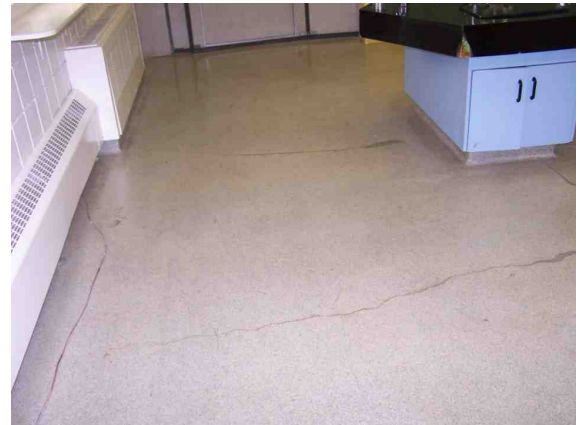
Excessive cracking; unsightly appearance.

Cracks in epoxy flooring.

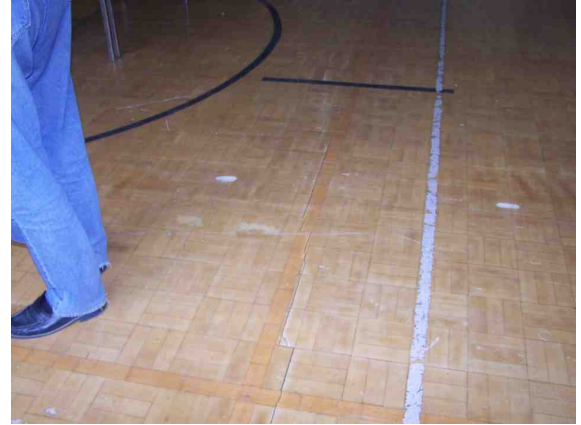
Flooring is damaged and a hard surface.

Gymnastics - flooring is crack, and various surface damaged areas.

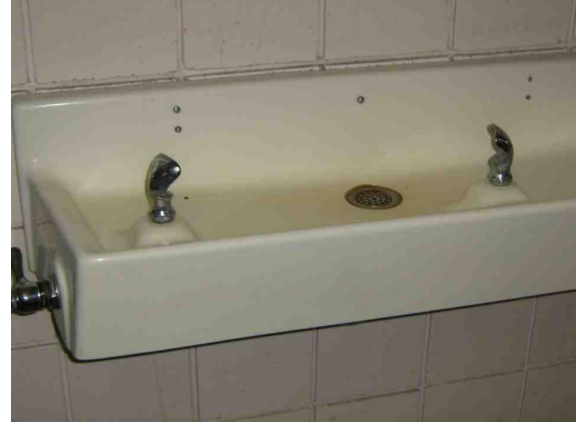
Typical existing drinking fountain. Notice the screws in the back holding it to the wall.

Replace 8 drinking fountains with wall hung, stainless steel, non-refrigerated drinking fountains.

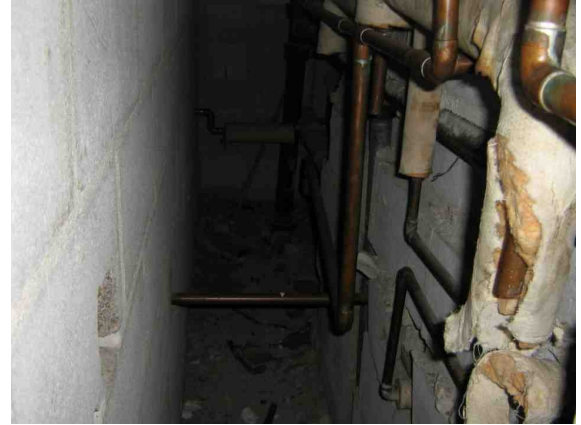
Damaged insulation.

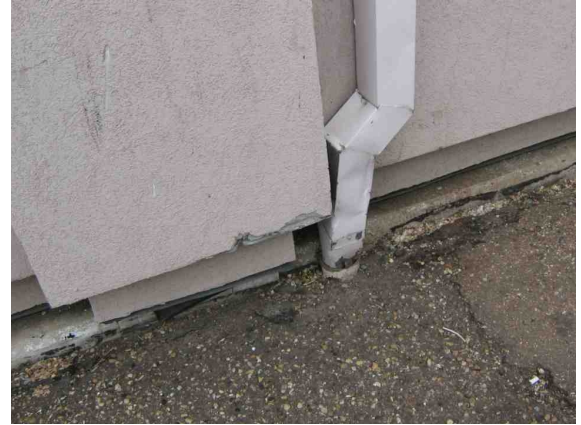
Damaged rain water leader.

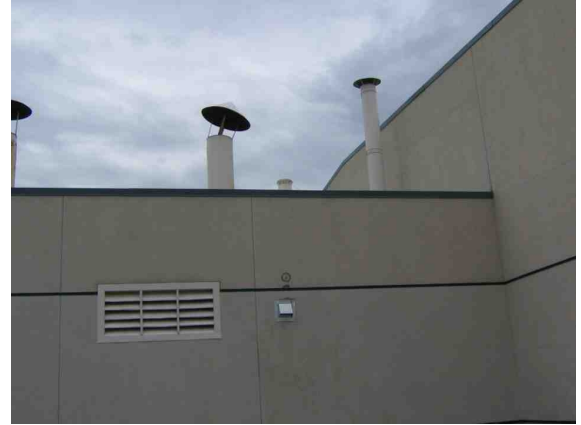
Chimney cap is damaged.

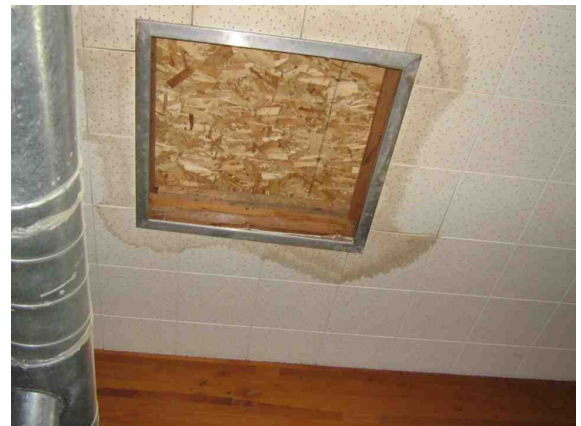
Roof opening that has been boarded over.

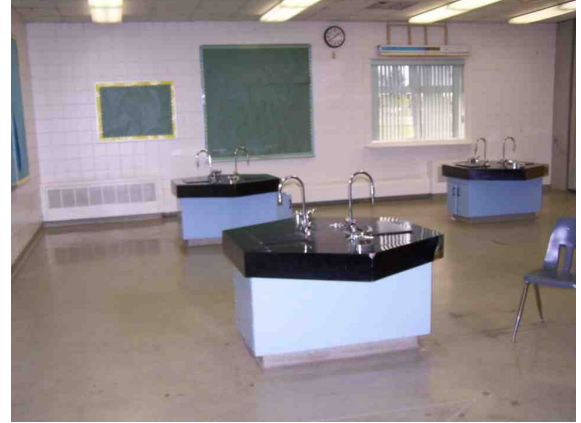
Damaged countertops and fronts - workstations.

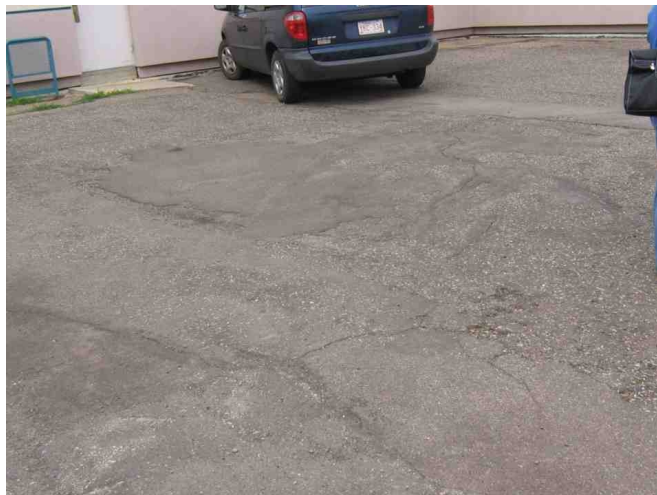
Some deterioration in parking asphalt

Asphalt surface has cracks and a number of potholes are expanding.

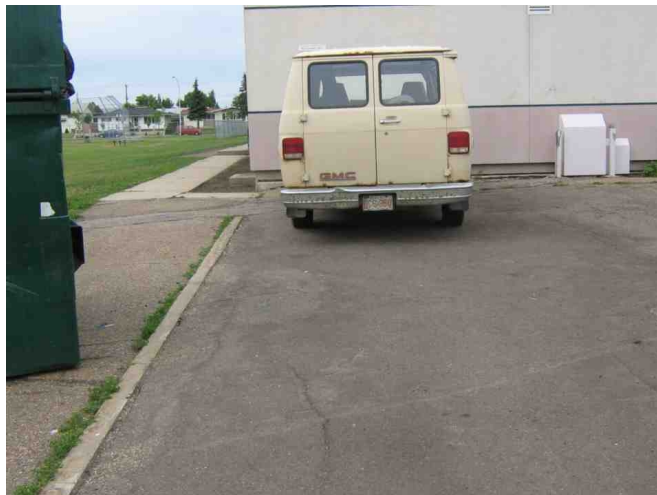
Tops of concrete curbs are in many instances at the same elevation as the asphalt surface

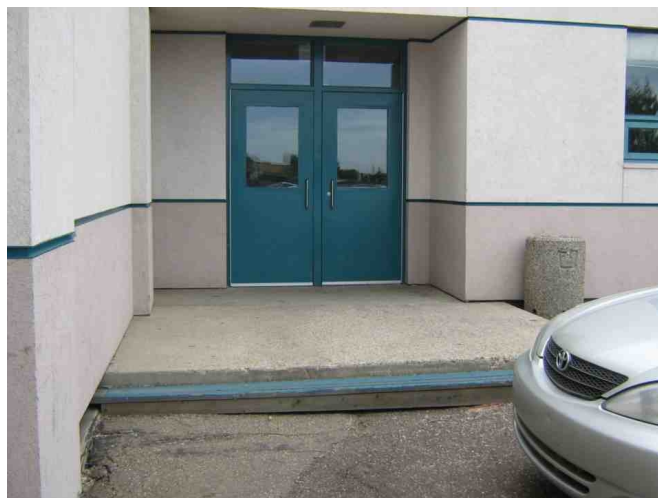
Concrete aprons at entrances/exits are worn and are more than 200mm high in areas

Concrete aprons at entrances/exits are worn and are more than 200mm high from grade in areas
