# **RECAPP Facility Evaluation Report**

### **Kirkness Elementary School**

B3185A  
Edmonton

**Evaluation Company:** A&E Architectural & Engineering Group Inc.  
**Evaluation Date:** November 7 2007  
**Evaluator Name:** Vic Maybroda

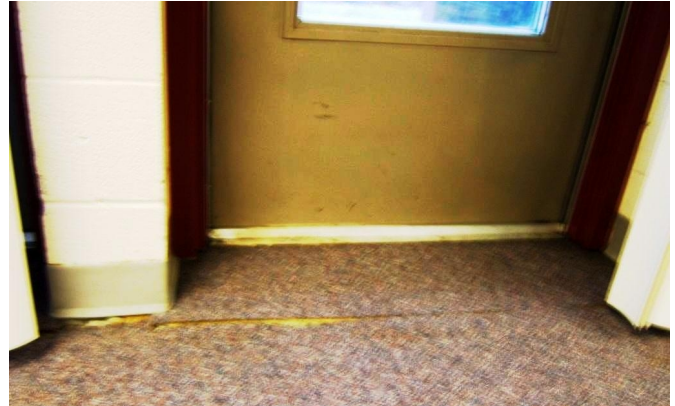
Concrete slab on grade exhibiting settlement in south east corner of the school.

<u>Rating</u>	<u>Installed</u>	<u>Design Life</u>	<u>Updated</u>
3 - Marginal	1982	0	MAR-08

Floor crack at exterior access to music room.

Settlement cracks causing concern to building occupants.

Serious concrete slab-on-grade induced building separation cracks in certain areas of the school.

"Mud-jack" effected concrete slab on grade areas and make good floor finishes

Consultant to be engaged to review design and construction issues leading to settlement concerns.

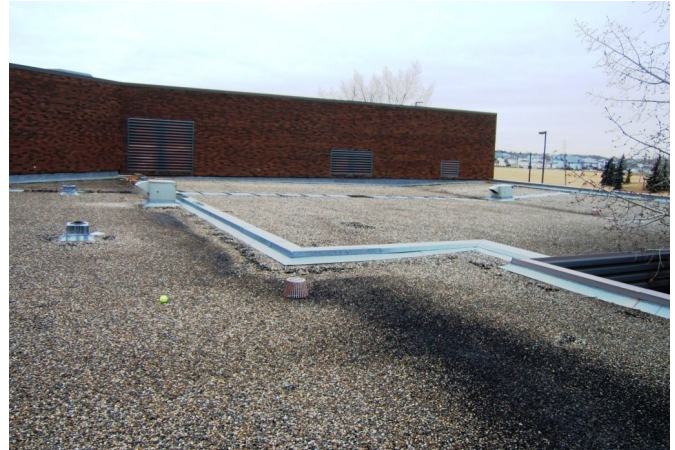
Picture 012.jpg

Asphalt built-up roof over majority of facility.

<u>Rating</u>	<u>Installed</u>	<u>Design Life</u>	<u>Updated</u>
4 - Acceptable	1982	25	MAR-08

**Event: Replace 3,500 sq. M Asphalt Built-up Roofing.**

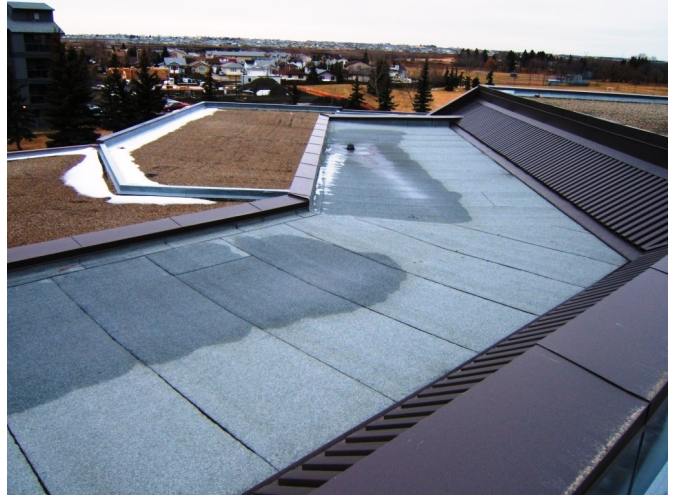
Approximately 150 sq. M SBS membrane roofing.

<u>Rating</u>	<u>Installed</u>	<u>Design Life</u>	<u>Updated</u>
5 - Good	2001	25	MAR-08

SBS membrane roofing.

**Event: Replace 150 sq. M SBS Membrane Roofing**

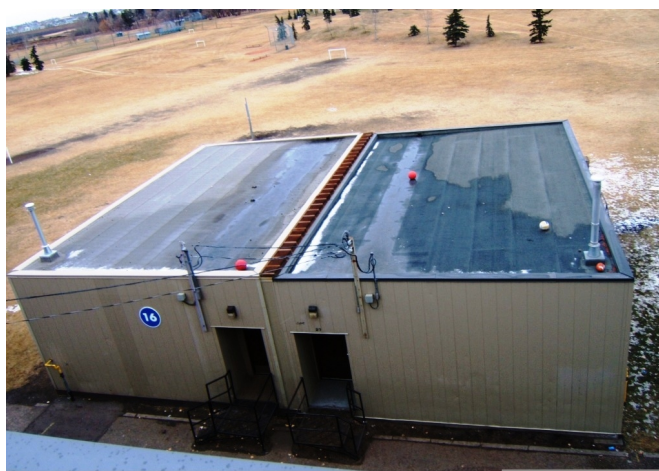
Two attached stand alone units added in 1988/89..  
 Wood frame on wood blocking with stained wood skirting.  
 SBS membrane roofing: Acceptable condition.  
 Painted metal access stairs and handrails. Acceptable condition.  
 Prefinished metal vertical siding. Acceptable condition.  
 Sealed fixed and opening glazing units in prefinished frames. Acceptable condition.  
 Painted insulated metal doors and painted frames. Acceptable condition.  
 Vinyl coated wall finish. Acceptable condition.  
 Carpeted flooring. Acceptable condition.  
 VCT flooring. Acceptable condition.  
 Suspended acoustical tile ceilings. Acceptable condition. 190 sq. M  
 Visual Display Boards. Acceptable condition.  
 Painted wood fixed casework. Acceptable condition.  
 Vertical louvred blinds. Acceptable condition.

Mechanical and electrical: Acceptable condition.

Arial view of portables.

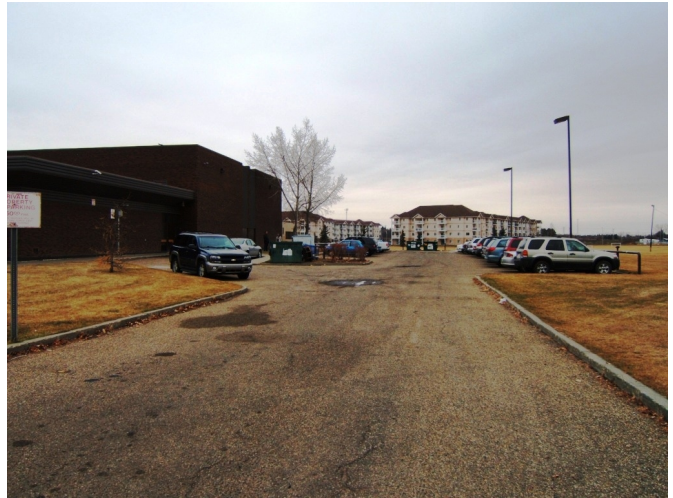
Laneway between municipal street and parking lot.

<u>Rating</u>	<u>Installed</u>	<u>Design Life</u>	<u>Updated</u>
4 - Acceptable	1982	25	MAR-08

**Event: Replace 100 sq. M Flexible Pavement Roadway (Asphalt)\*\***

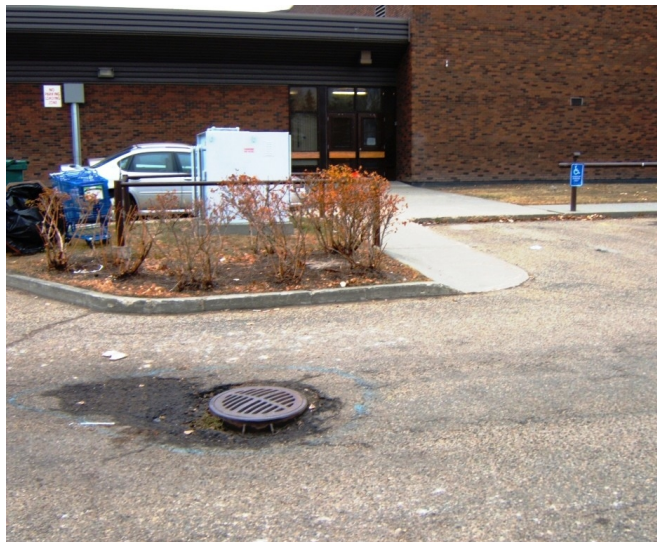
Areas around catch basins require repaving.

<u>Rating</u>	<u>Installed</u>	<u>Design Life</u>	<u>Updated</u>
4 - Acceptable	1982	25	MAR-08

**Event: Repair Flexible Paving Parking Lots(Asphalt)\*\***

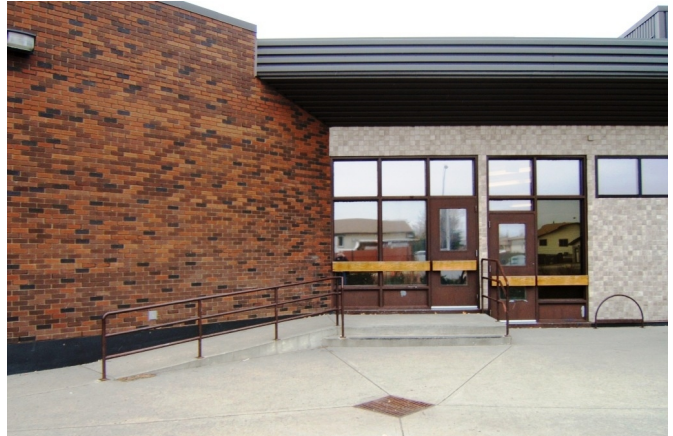
Concrete step and ramp accessing kindergarten space.

<u>Rating</u>	<u>Installed</u>	<u>Design Life</u>	<u>Updated</u>
5 - Good	1982	0	MAR-08

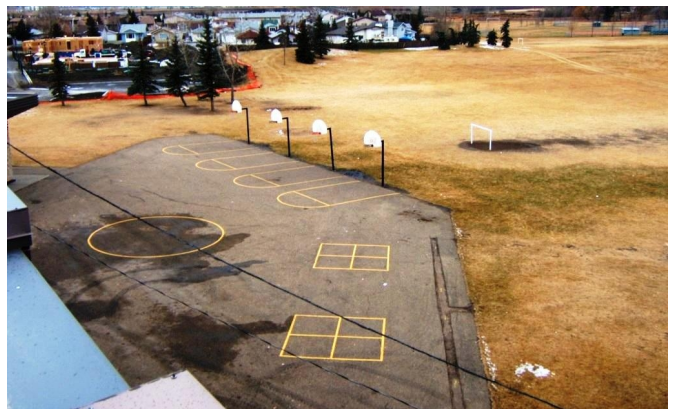
Asphalt surfaced play area at north side of school.

<u>Rating</u>	<u>Installed</u>	<u>Design Life</u>	<u>Updated</u>
4 - Acceptable	1982	25	MAR-08

**Event: Replace 110 sq. M Athletic and Recreational Surfaces\*\***
