# RECAPP Facility Evaluation Report

## Edmonton School District No. 7

### L. Y. Cairns School

**Evaluation Company:** A&E Architectural and Engineering Group Inc.

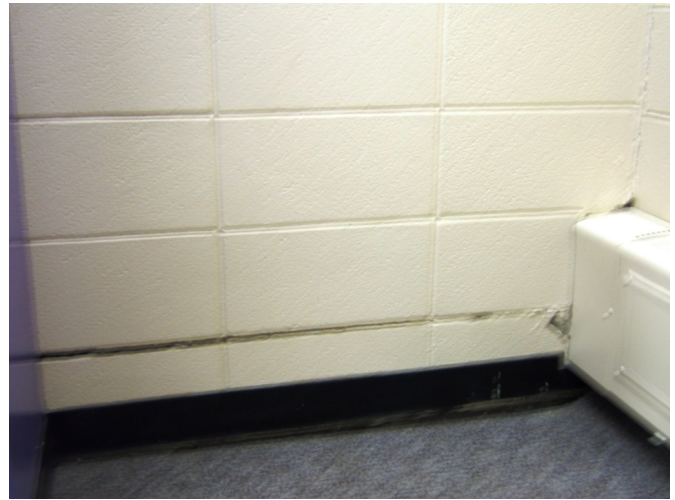
Floor settlement has resulted in isolated wall cracks. Requires monitoring to verify movement.

Settlement crack in southwest corner of Room 28 on main floor.

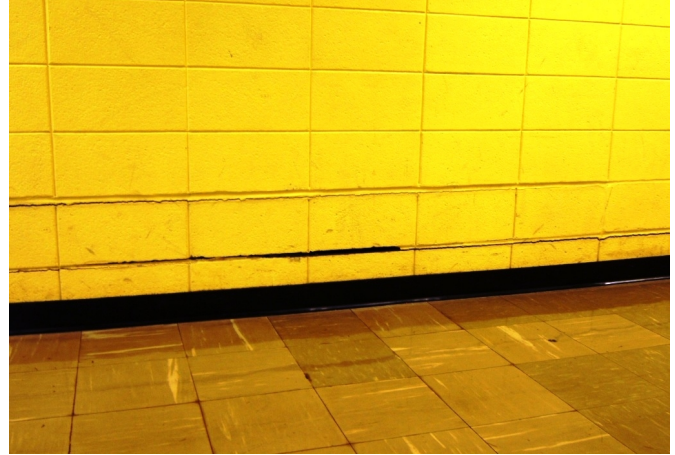
Second floor concrete slab with isolated settlement wall cracks.

Settlement crack in Corridor C-5 on second floor between Auto Repair and Metal Working Shop.

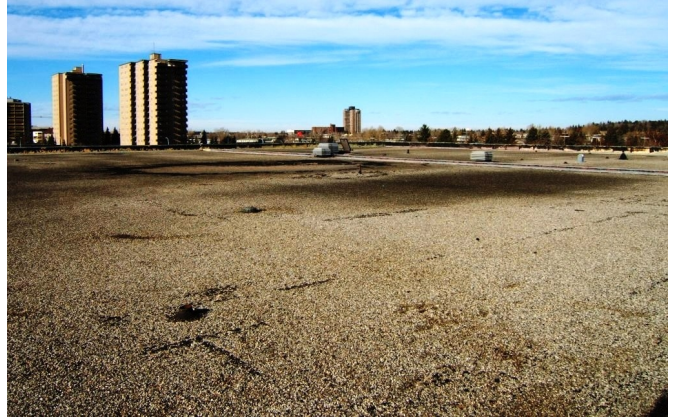
An area of approximately 2,750 remains as a built-up roof assembly.

View of built-up roof assembly.

**Event: Replace 2,750 Sq. M of Built-up Roofing.**

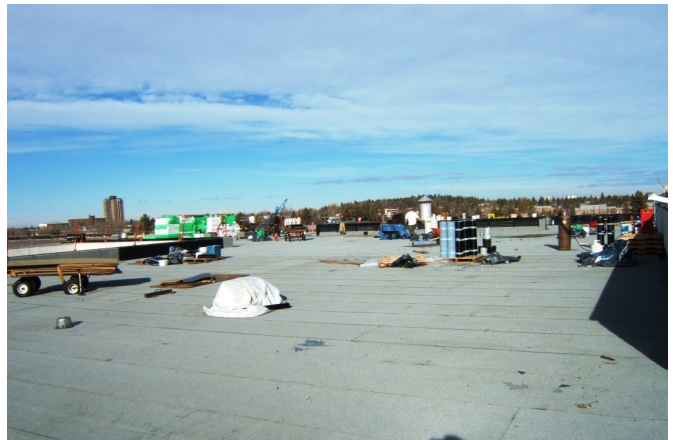
Approximately 4,000 sq. M of SBS membrane roofing replaced during site visit.

View of SBS assembly being installed.

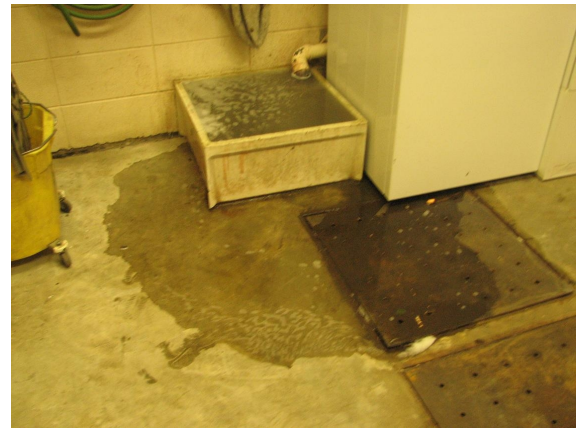
A mop sink is broken in the Custodial Room on the second floor as a result of which water discharging from the washer overflows and drains into a sump pit.

Water overflowing from mop sink as washer discharges water into broken sink.  
Location: Custodial.

Repair the piping serving the mop sink.

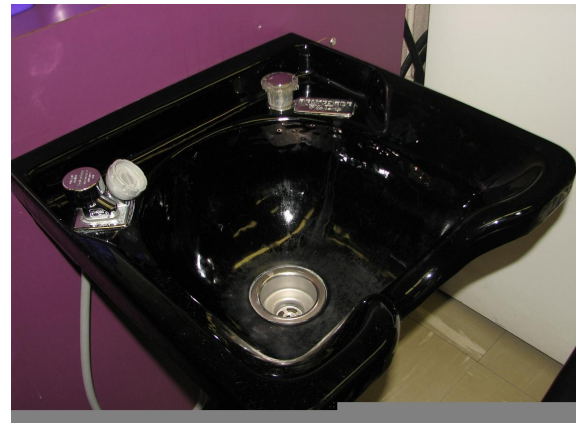
Belvedere Sink1.jpg

Sink is leaking

Replace sink, or sink component that is causing the water to leak.

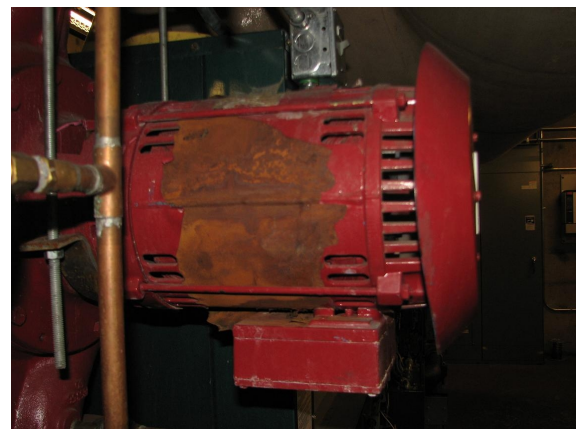
One of the Boiler Circulating pumps is corroded, vibrates, and is noisy.

Circulating Pump serving Boiler.

Replace the Circulating Pump with a new one.

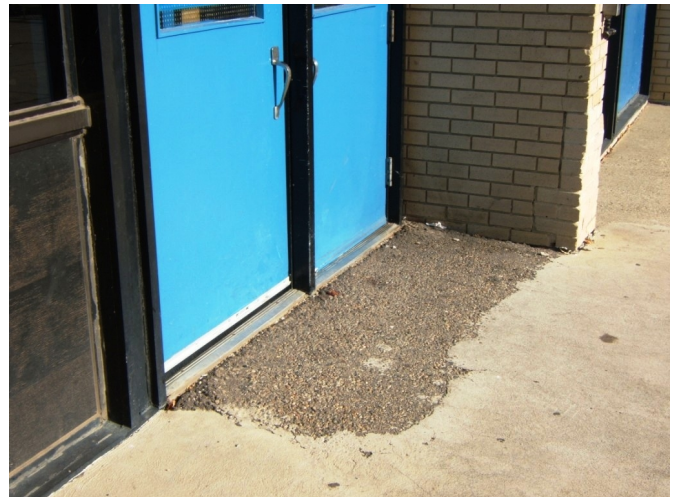
Main entry concrete paved area  
Walkway along west and south sides of school.

Main entry concrete area slopes back to entry doors.  
Walkway along west side of school cracked and worn presenting tripping hazard.

**Event: Replace 180 sq. M Rigid Pedestrian Pavement (Concrete)\*\* - ]****Concern:**
