RECAPP Facility Evaluation Report

La Perle Elementary School

B3188A
Edmonton

Evaluation Company: A&E Architectural & Engineering Group Inc.
Evaluation Date: October 29 2007
Evaluator Name: Vic Maybroda

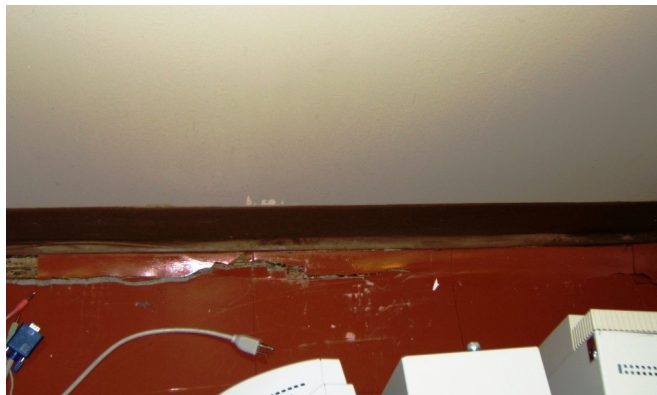
Cast-in-place concrete.
Isolated areas of settlement.

<u>Rating</u>	<u>Installed</u>	<u>Design Life</u>	<u>Updated</u>
3 - Marginal	1982	0	MAR-08

Floor settlement in corridor space.

Uneven floor finishes causing flooring finish failure and tripping hazard.

Floor slab and support walls exhibiting settlement issues.

Mud-jack effected areas and make good floor finishes.

Commission consultant to review site, design and construction conditions with respect to settlement problems.

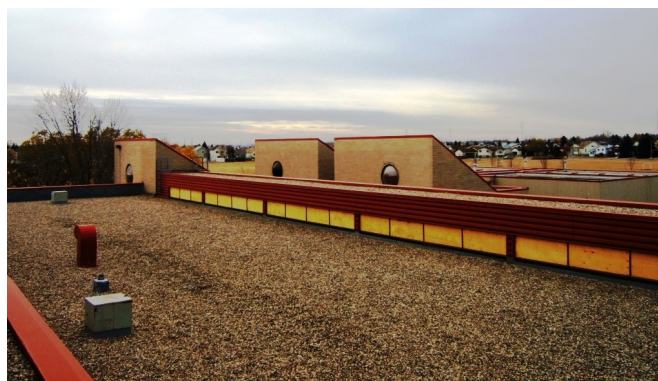
Partial view of roof with boarded up clearstory windows.

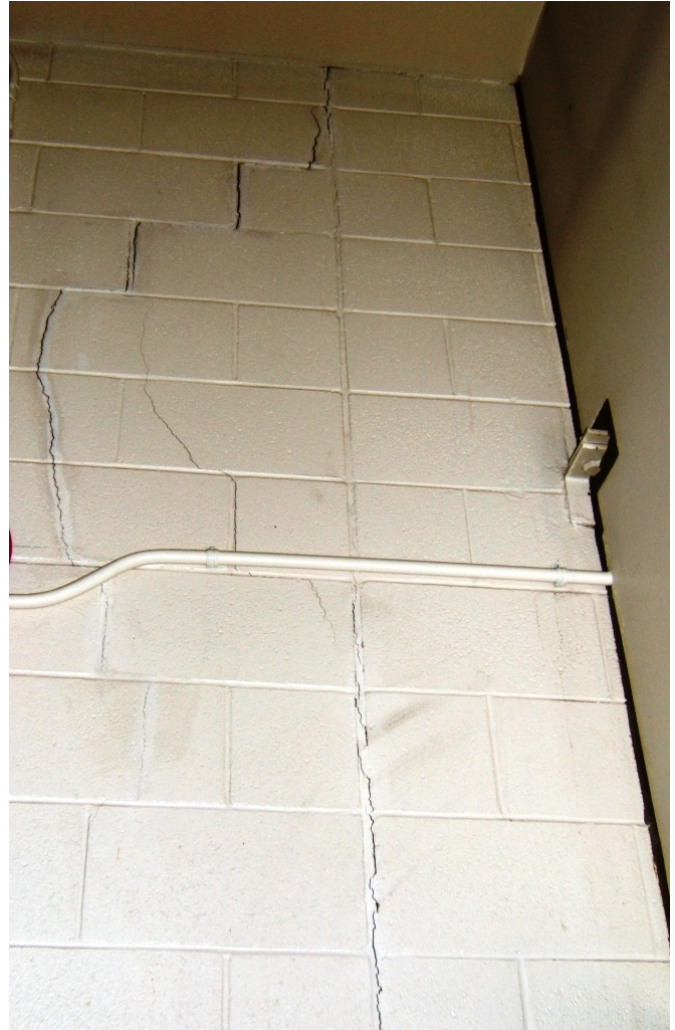
Concrete block.
Isolated settlement cracks.

Wall crack in main floor storage space.

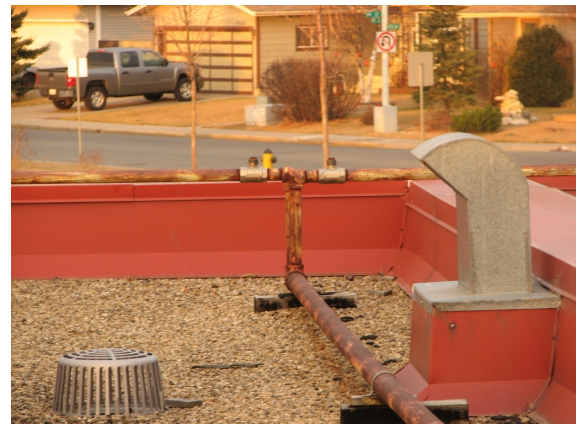
Portables B - 1.JPG

Gas lines run on roof to portables and show extremely large amount of corrosion.

Gas lines supplying gas to furnaces in portables are extremely corroded.

Replace gas lines on roof.

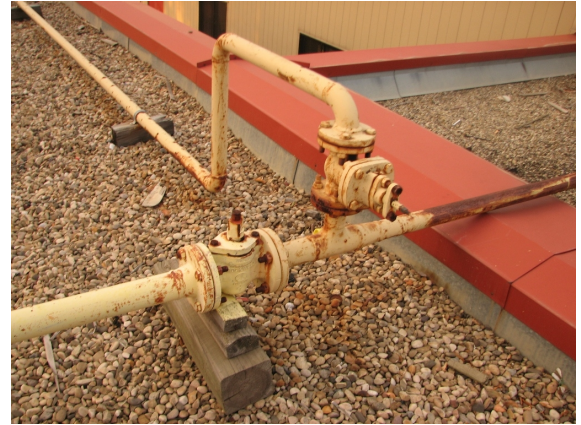
Portables A - 1.JPG

Gas lines run on roof to portables and show extremely large amount of corrosion.

Gas lines supplying gas to furnaces in portables are extremely corroded.

Replace gas lines on roof.

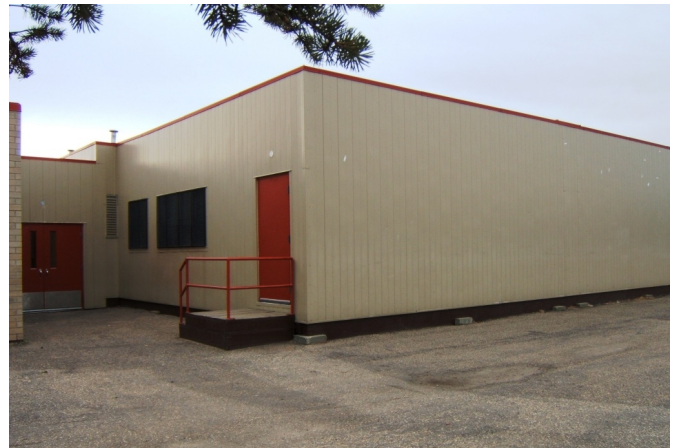
Exterior view of leased out unit.

Replace (8) Palm Aire furnaces model PAG105AH with an input of 94,500 BTUH and an output of 75,600 BTUH.

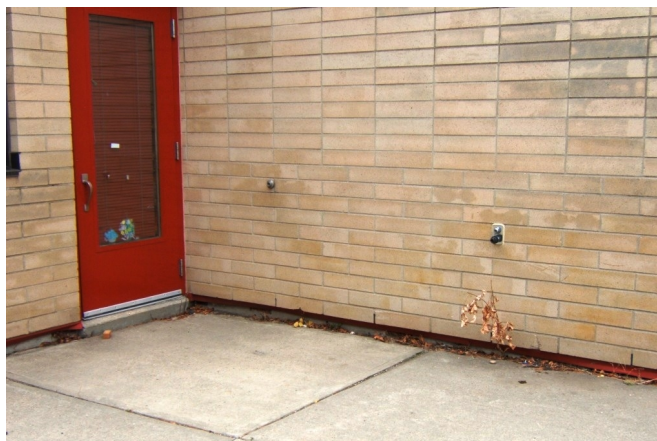
Generally the concrete walkways are in acceptable condition but are constructed so that the main entry walkway slopes back to school entry and settlement has caused similar conditions around the remaining walkways.

<u>Rating</u>	<u>Installed</u>	<u>Design Life</u>	<u>Updated</u>
3 - Marginal	1982	25	MAR-08

Existing concrete walkways slope back to building foundation causing moisture entry at entry doors and settlement concerns.

Replace effected concrete walkways.
