RECAPP Facility Evaluation Report

Lago Lindo Elementary School

B3189A
Edmonton

Evaluation Company: A&E Architectural and Engineering Group Inc.
Evaluation Date: October 30 2007
Evaluator Name: Vic Maybroda

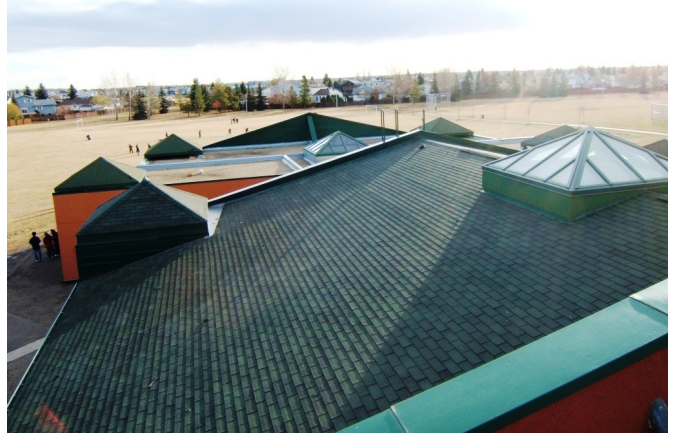
Asphalt shingles over sloped roof area.

<u>Rating</u>	<u>Installed</u>	<u>Design Life</u>	<u>Updated</u>
4 - Acceptable	2000	25	MAR-08

Partial view of asphalt shingled roof.

Event: Replace 2200 sq M. Shingles and Roofing Tiles

<u>Type</u>	<u>Year</u>	<u>Cost</u>	<u>Priority</u>
Lifecycle Replacement	2025	\$114,400	Unassigned

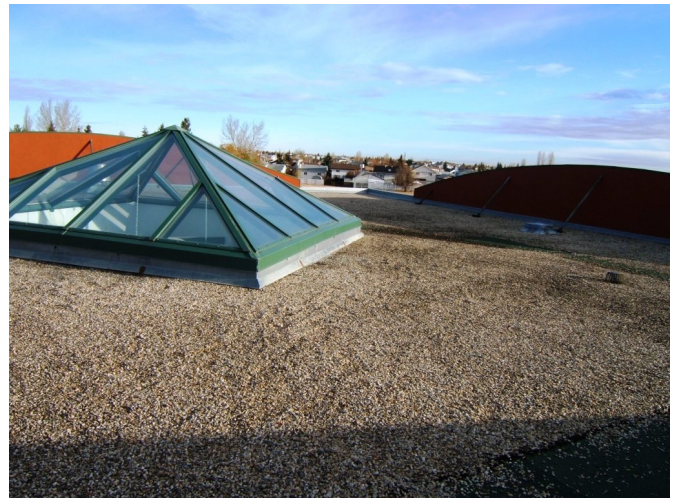
5 pyramidal glazed skylights located on sloped and flat roof sections.

<u>Rating</u>	<u>Installed</u>	<u>Design Life</u>	<u>Updated</u>
4 - Acceptable	1989	25	MAR-08

Typical glazed skylight.

Event: Rplace 5 glazed ss skylights

<u>Type</u>	<u>Year</u>	<u>Cost</u>	<u>Priority</u>
Lifecycle Replacement	2014	\$57,200	Unassigned

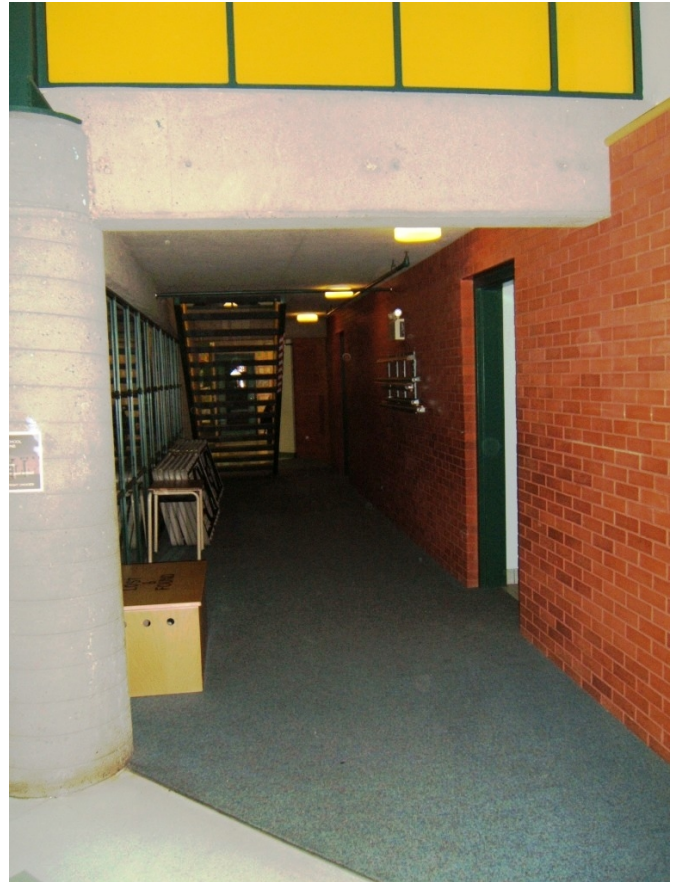
Concrete block and face brick cladding.

<u>Rating</u>	<u>Installed</u>	<u>Design Life</u>	<u>Updated</u>
4 - Acceptable	1989	0	MAR-08

Face brick cladding over concrete block substrate.

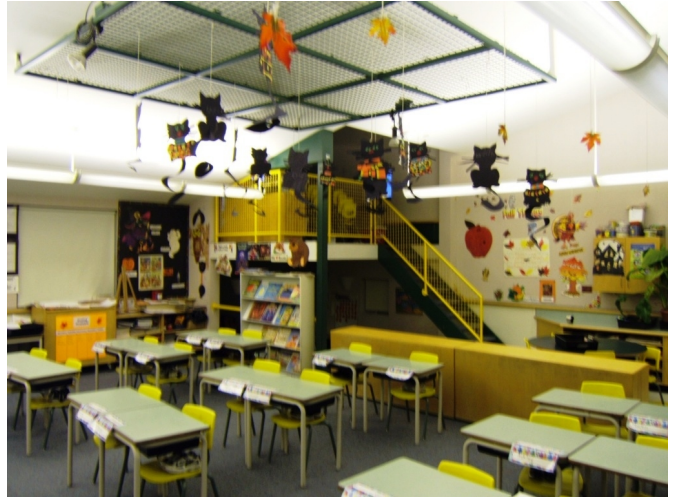
Painted metal balustrades and handrails.

<u>Rating</u>	<u>Installed</u>	<u>Design Life</u>	<u>Updated</u>
5 - Good	1989	0	MAR-08

Painted metal balustrades and handrail to classroom study space.

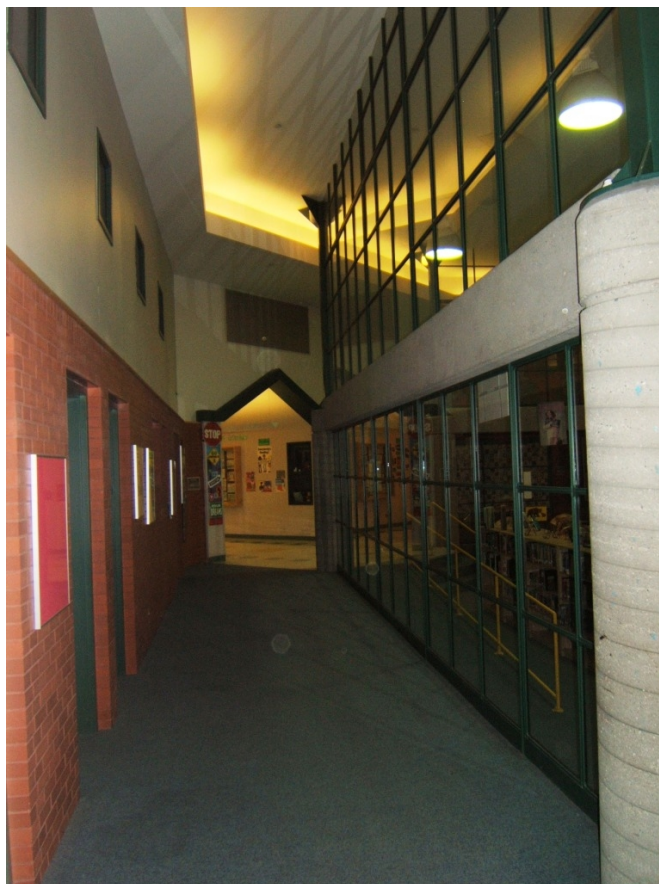
Glazed partitions between corridors and central library and around library mezzanine study spaces.

<u>Rating</u>	<u>Installed</u>	<u>Design Life</u>	<u>Updated</u>
5 - Good	1989	0	MAR-08

View of corridor adjacent to library.

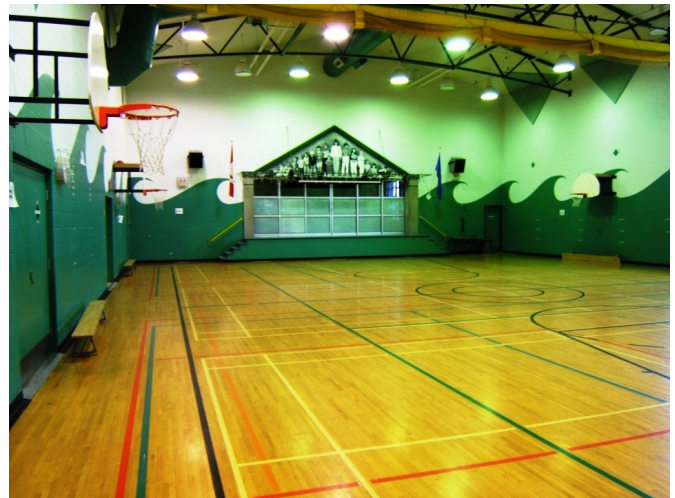
Wood strip flooring located in gymnasium.

<u>Rating</u>	<u>Installed</u>	<u>Design Life</u>	<u>Updated</u>
4 - Acceptable	1989	30	MAR-08

View of gymnasium

Event: Replace 396 sq. M. Wood Strip Flooring

<u>Type</u>	<u>Year</u>	<u>Cost</u>	<u>Priority</u>
Lifecycle Replacement	2019	\$126,870	Unassigned

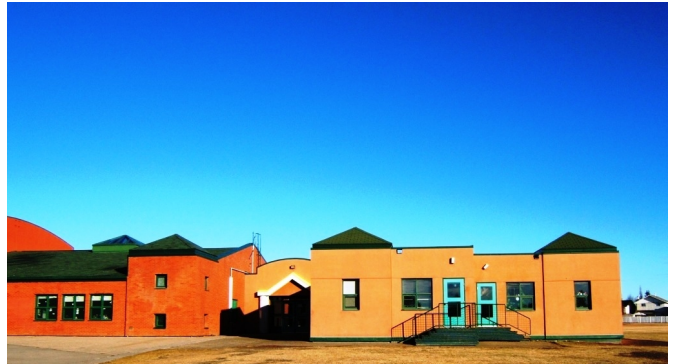
Wood structure on stabilized foundations with built-up roof in acceptable condition.

Exterior is clad in textured stucco finish in good condition complete with vertical expansion control joints.

Windows are sealed fixed and opening units in prefinished metal frames in acceptable condition.

Doors are insulated painted metal clad in painted metal frames complete with sealed glazing units in acceptable condition.

<u>Rating</u>	<u>Installed</u>	<u>Design Life</u>	<u>Updated</u>
4 - Acceptable	1992	0	MAR-08

South elevation view of portable units.

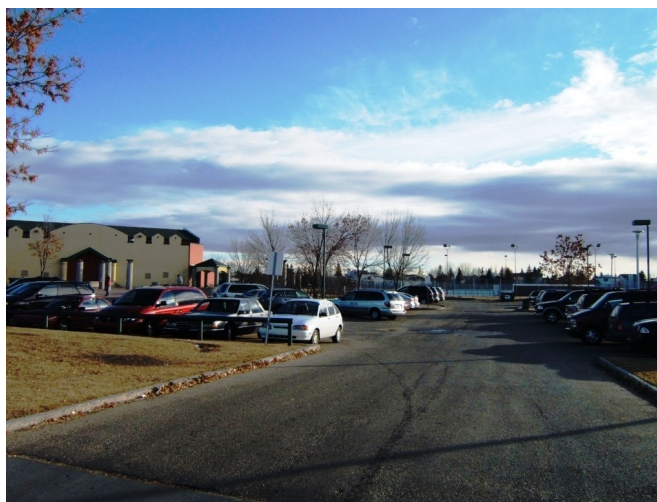
G2020.02.02 Flexible Paving Parking Lots(Asphalt) - **

<u>Rating</u>	<u>Installed</u>	<u>Design Life</u>	<u>Updated</u>
4 - Acceptable	1989	25	MAR-08

Event: Replace 1200 sq. M Flexible Paving Parking Lots(Asphalt)**

<u>Type</u>	<u>Year</u>	<u>Cost</u>	<u>Priority</u>
Lifecycle Replacement	2014	\$89,461	Unassigned
