# RECAPP Facility Evaluation Report

## Lansdowne Elementary School

B3190A  
Edmonton

**Evaluation Company:** A&E Architectural & Engineering Group Inc.  
**Evaluation Date:** November 9 2007  
**Evaluator Name:** Vic Maybroda

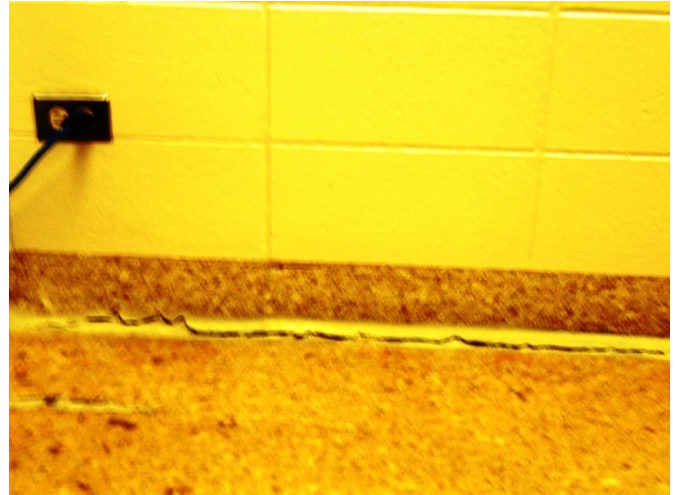
<u>Rating</u>	<u>Installed</u>	<u>Design Life</u>	<u>Updated</u>
3 - Marginal	1968	0	MAR-08

Floor settlement in girls wash room.

Settlement of sections of concrete slab impacting health and safety concerns of occupants.

"mud-jack" effected areas of concrete slab and make good floor finishes.

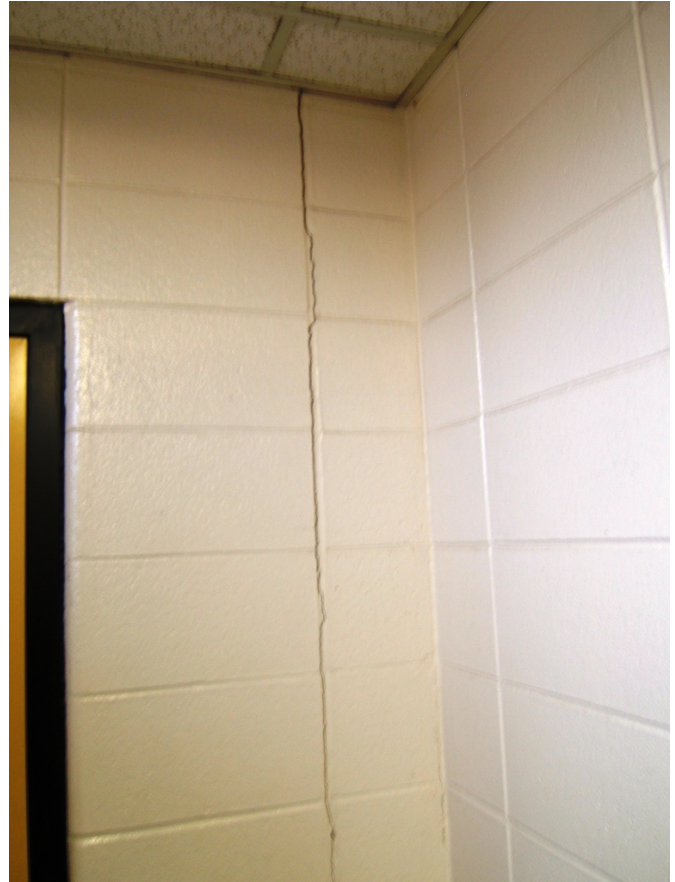
Wall crack adjacent to music room entry.

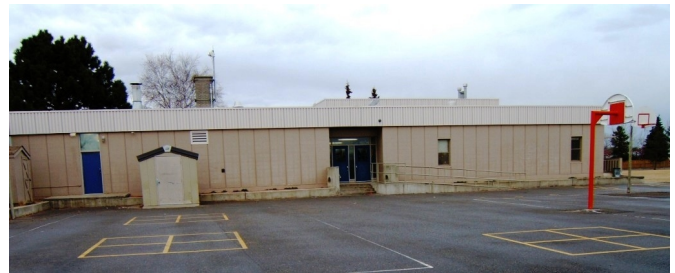
View of concrete ramp, steps and metal railing at south entry.

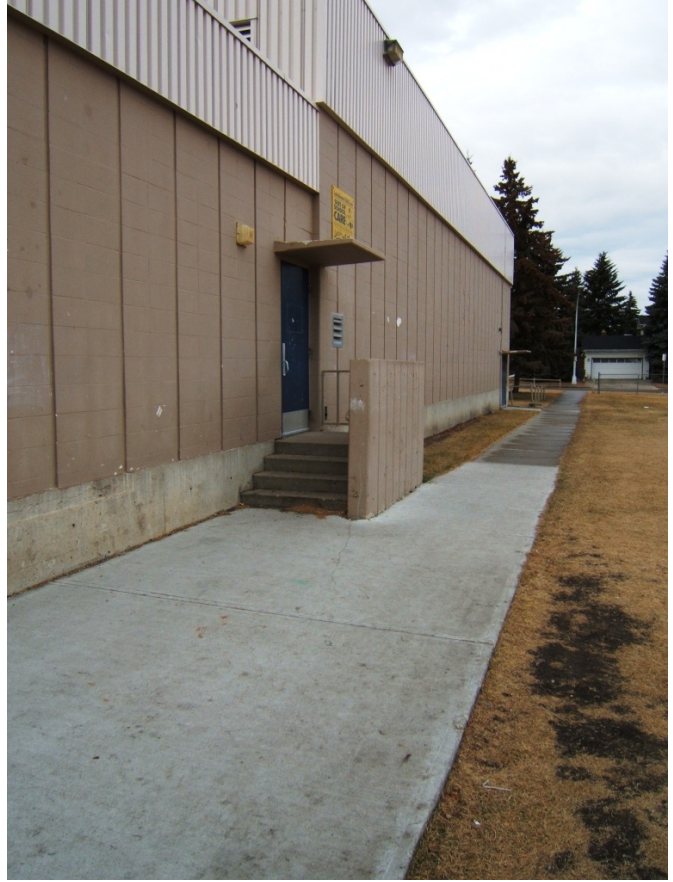
Concrete steps from leased space adjacent stage area.

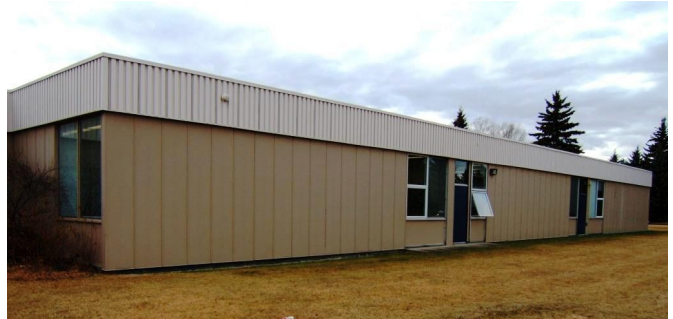
View of exterior window units.

**Event: Replace 49 Exterior Standard Windows**

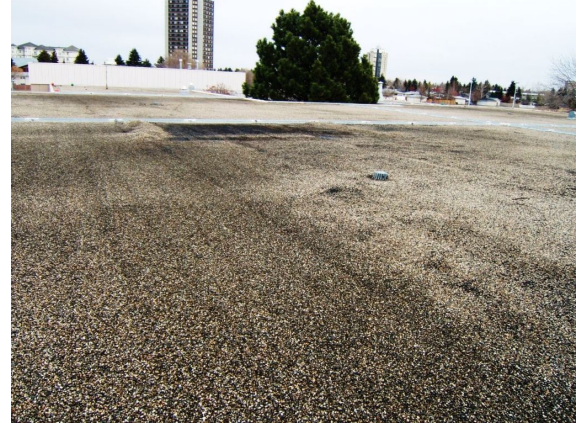
Roofing causing expensive repairs and poor thermal protection.

Partial view of roof with visible roof patch, area divisions and metal flashing.

Replace roofing complete with vapour barrier, insulation and metal flashing.

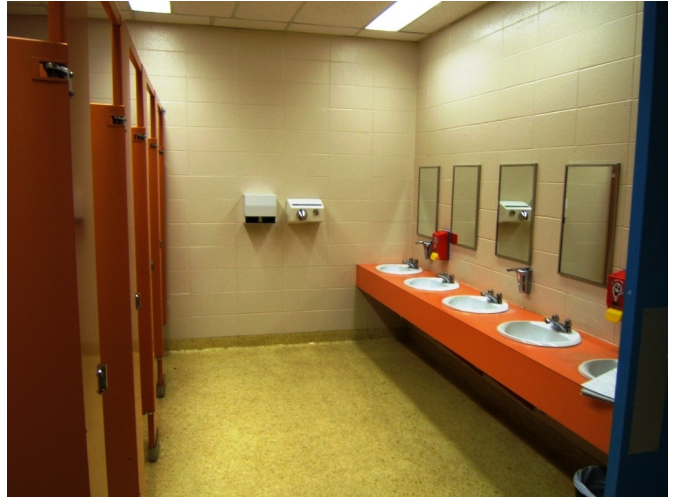
Partial view of typical wash room accessories.

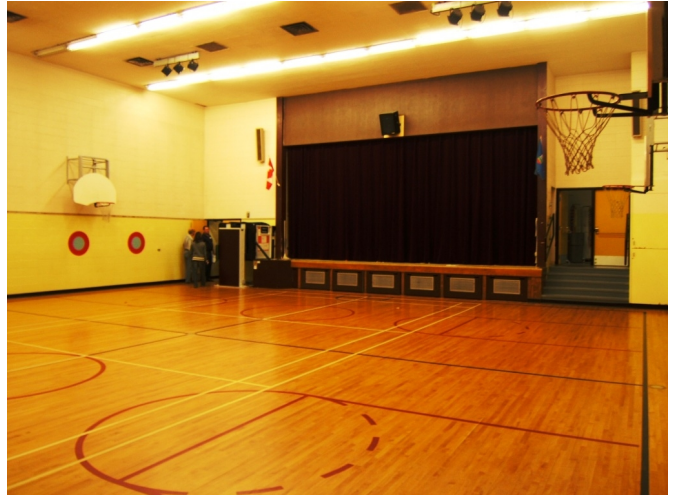
<u>Rating</u>	<u>Installed</u>	<u>Design Life</u>	<u>Updated</u>
3 - Marginal	1989	30	MAR-08

View of gymnasium.

Separation cracks between board units present tripping hazard.

Replace wood strip flooring to eliminate cracks between strip flooring.

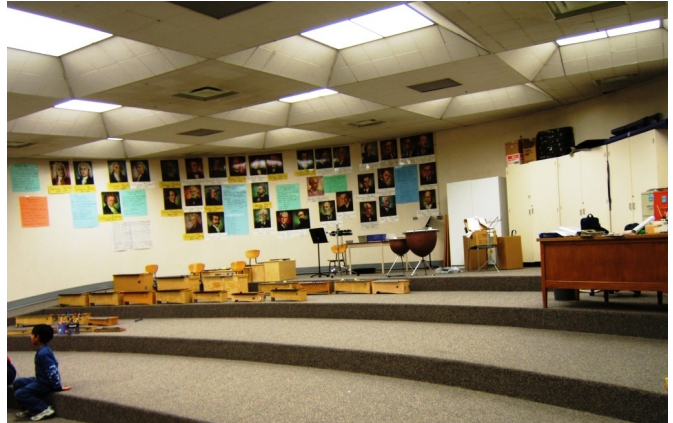
View of music room finishes.

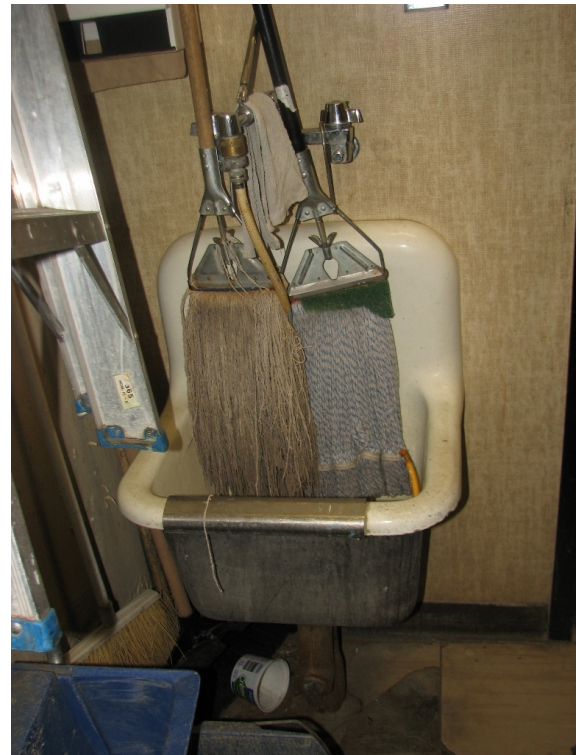
Mop sink in Daycare Storage Room is leaking, corroded and rusted.

Wall hung mop sink in need of failure replacement.

Replace with floor mounted molded stone mop sink complete with valve breakers.

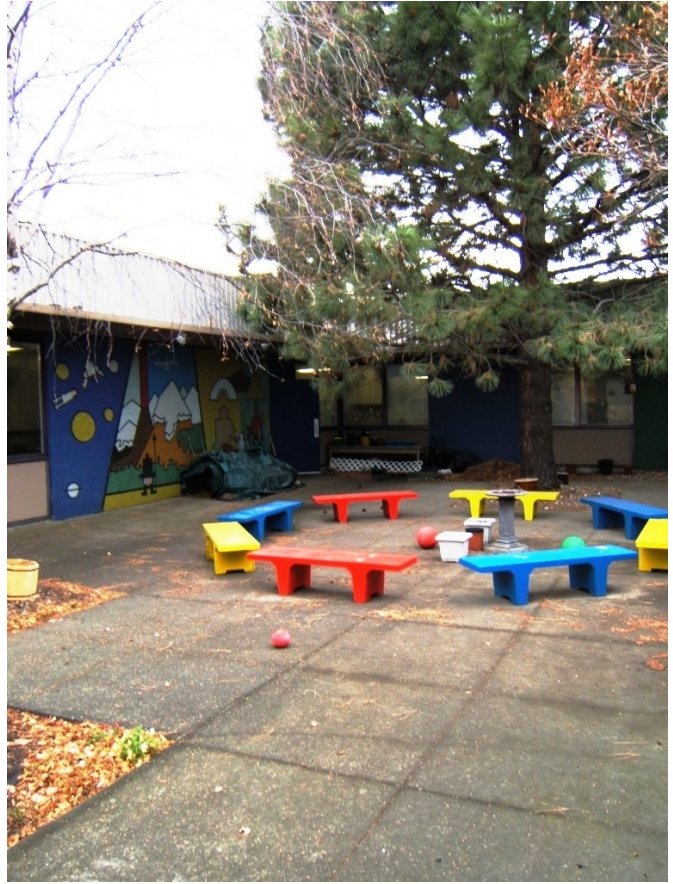
Partial view of internal courtyard.
