RECAPP Facility Evaluation Report

Lauderdale Elementary School

B3191A
Edmonton

Evaluation Details	
Evaluation Company:	A&E Architectural & Engineering Group Inc.
Evaluation Date:	October 30 2007
Evaluator Name:	Vic Maybroda

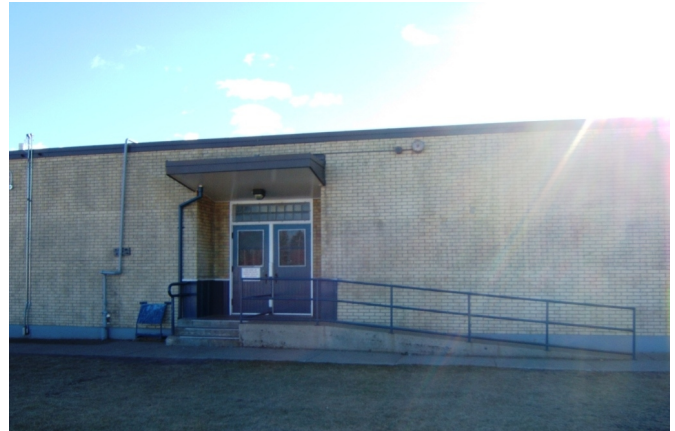
Concrete ramp located at north entry of 1953 Section.

Concrete ramp and stairs.

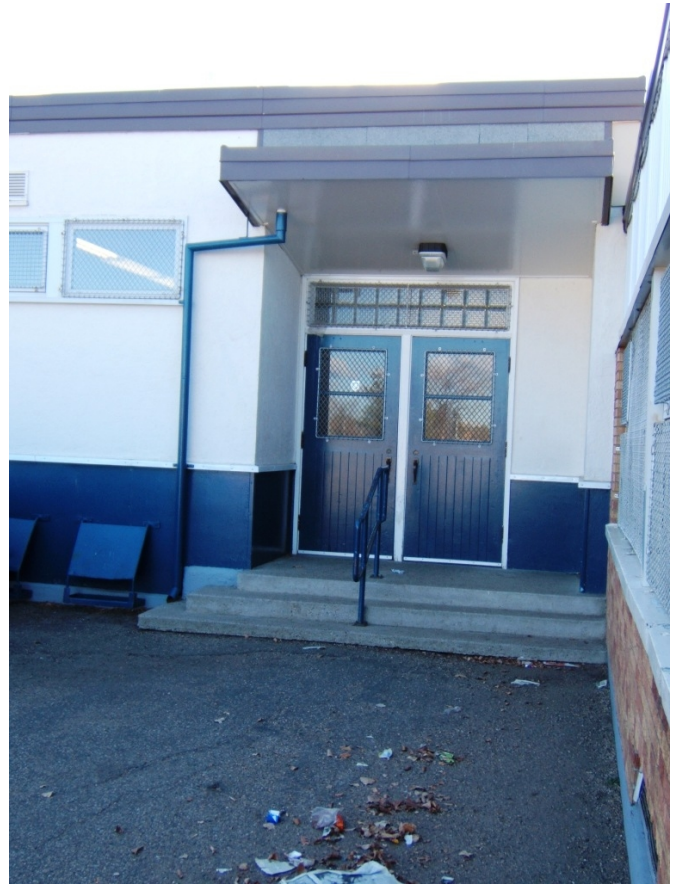
Concrete stairs at north entry of 1953 Section.
Concrete stair to vestibule between 1953 and 1964 Sections.

Concrete stair to vestibule.

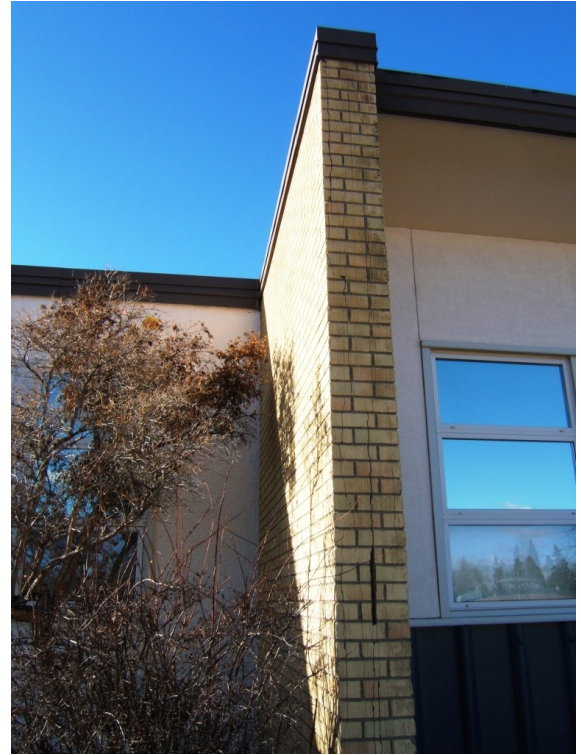
<u>Rating</u>	<u>Installed</u>	<u>Design Life</u>	<u>Updated</u>
3 - Marginal	1953	75	MAR-08

Weather causing separation cracks in face brick of wing walls.

Typical brick clad wing wall.

Repoint effected face brick joints of wing walls.

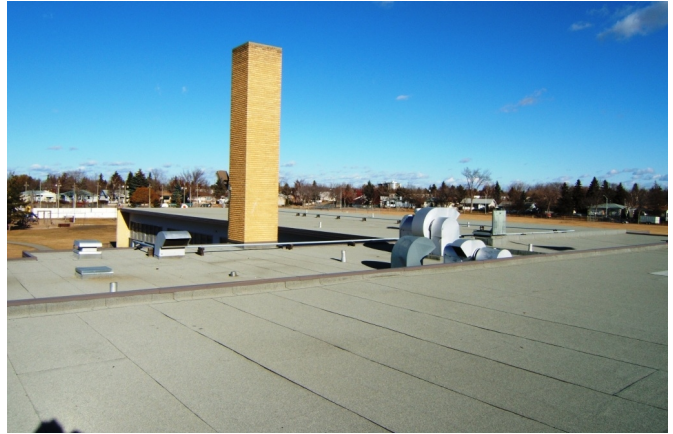
2 ply SBS roofing.

View of roofing elements.

Event: Replace 2,220 sq. M SBS Roofing - All Sections

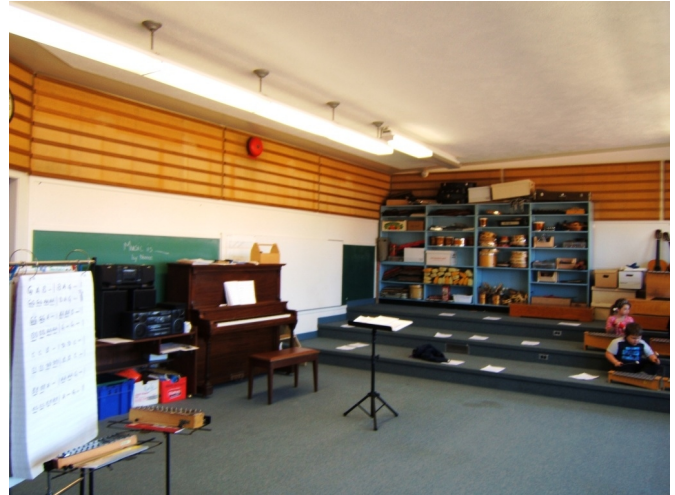
Horizontal wood strip paneling in music room.

Music room finishes.

Event: Replace 30 sq. M Wall Paneling**

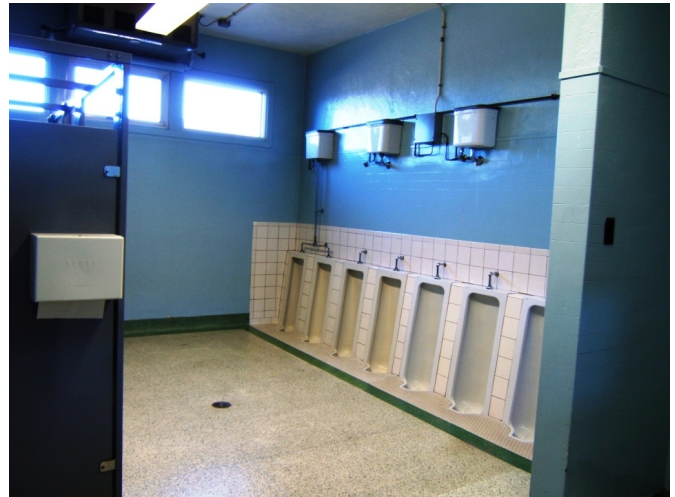
Ceramic tile dado walls in boys wash room urinals in 1953 section and at water fountains in 1964 section.

Boys wash room finishes.

Event: Replace Tile Wall Finishes**

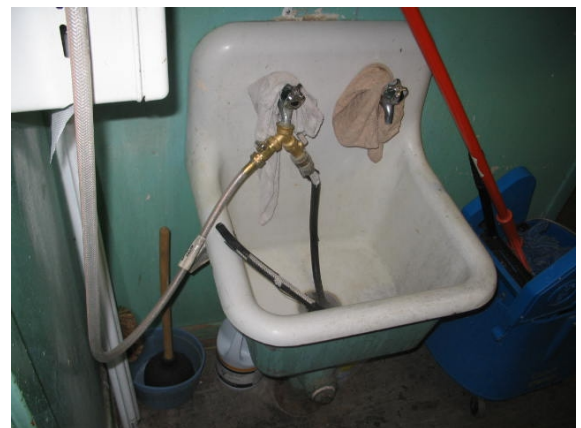
IMG_6306.JPG

Finishes are worn off. Elevated sinks are difficult and potentially hazardous to use.

Replace existing mop sink with floor mounted model.

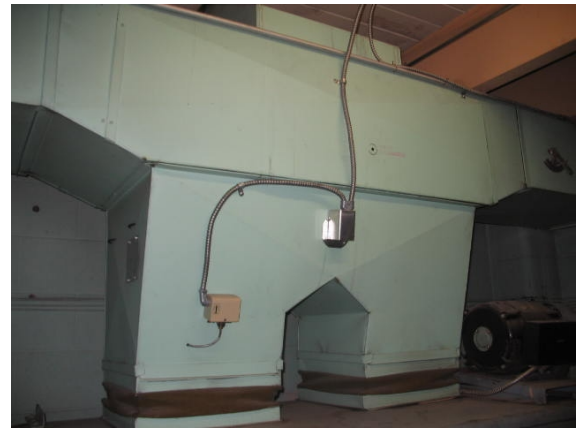
Unit Serving Gymnasium

Unit ventilators serving classrooms are worn and deteriorate.
 Units
 Temperature in school is not consistent and difficult to control.
 Existing ventilation units create cold drafts.

Install new ventilation system, that includes two air handling units (gymnasium and core school), overhead ductwork distribution, new grilles and diffusers.

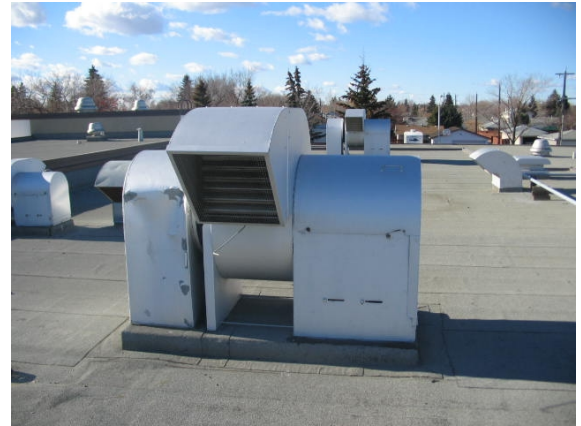
Exhaust fans are worn and deteriorate. They run continuously at constant volume during occupied time. The fans are automatically shut off when the outdoor temperature is below or about zero, significantly reducing ventilation rates.

Install new exhaust fans serving washrooms and storage rooms. New exhaust fans should be interlock with new ventilation system. See section D3040.01.01 for more details.
