RECAPP Facility Evaluation Report

Lawton Junior High School

B3193A
Edmonton

Evaluation Company: A&E Architectural & Engineering Group Inc.
Evaluation Date: November 8 2007
Evaluator Name: Vic Maybroda

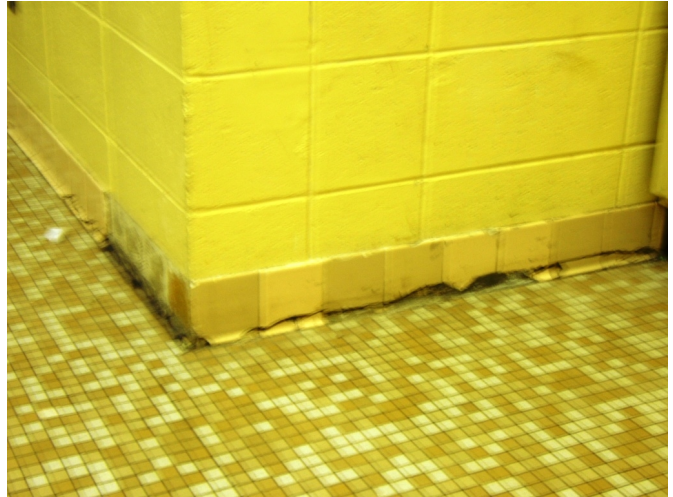
Minor settlement in boys gymnasium change room.

<u>Rating</u>	<u>Installed</u>	<u>Design Life</u>	<u>Updated</u>
4 - Acceptable	1957	0	MAR-08

Floor settlement in boys change room.

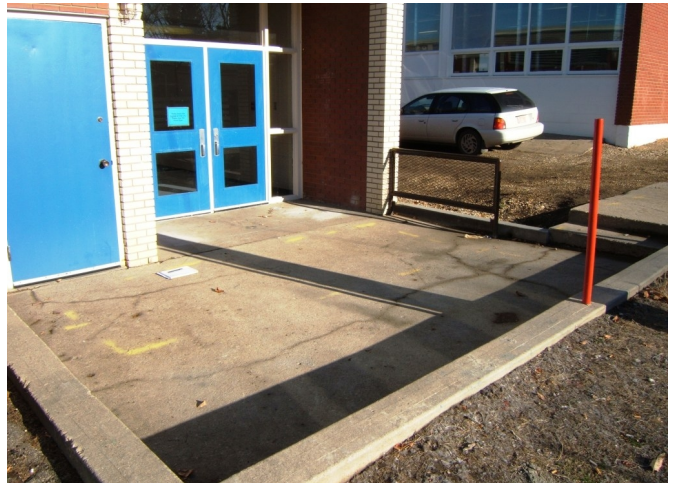
Stair to south entry pad.

South entry area 1967 section.

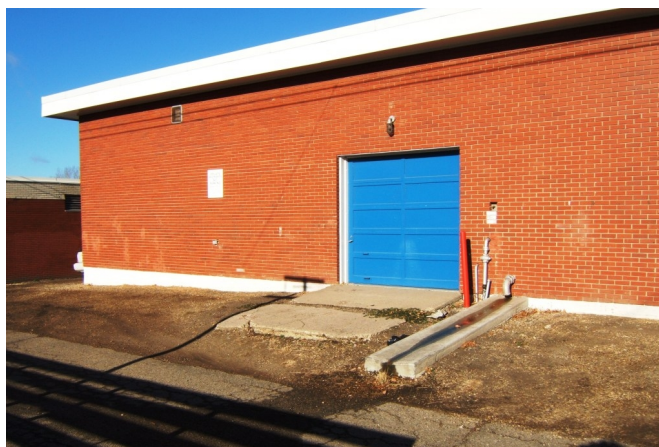
Wood overhead door in wood frame from Industrial Arts area.

<u>Rating</u>	<u>Installed</u>	<u>Design Life</u>	<u>Updated</u>
4 - Acceptable	1957	30	MAR-08

Overhead door.

Event: Replace 1 2.4 x 2.2 Overhead Door - 1957 Section

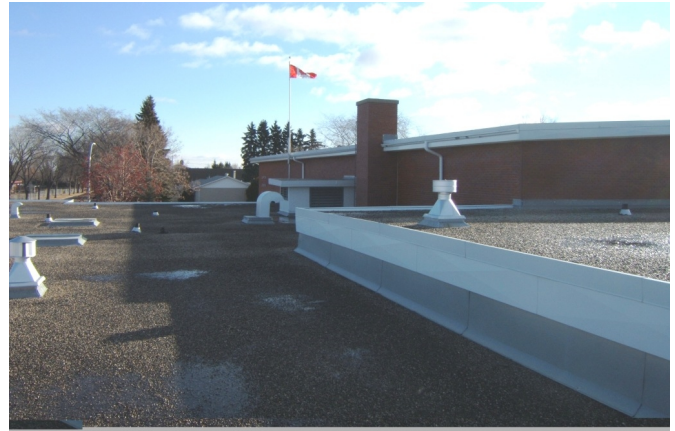
B3010.04.01 Built-up Bituminous Roofing (Asphalt & Gravel) - 1957 Section**

<u>Rating</u>	<u>Installed</u>	<u>Design Life</u>	<u>Updated</u>
4 - Acceptable	1957	25	MAR-08

Partial view of Built-up Roof and gutters and Downspouts.

Event: Replace 2,350 Sq. M Built-up Asphalt Roof - 1957 Section

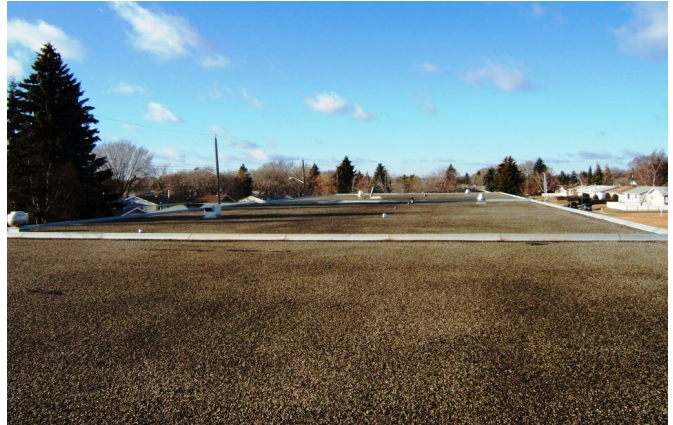
B3010.04.01 Built-up Bituminous Roofing (Asphalt & Gravel) - 1967 Section**

<u>Rating</u>	<u>Installed</u>	<u>Design Life</u>	<u>Updated</u>
4 - Acceptable	1967	25	MAR-08

Roofing of 1967 Section.

Event: Replace 2,200 Sq. M Built-up Asphalt Roof - 1967 Section

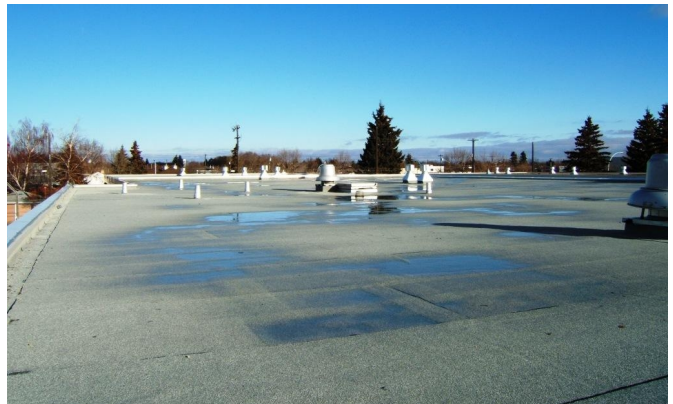
<u>Rating</u>	<u>Installed</u>	<u>Design Life</u>	<u>Updated</u>
5 - Good	2003	25	MAR-08

Membrane Roof of 1960 Section.

Event: Replace 1,000 sq. M SBS Roofing - 1960 Section

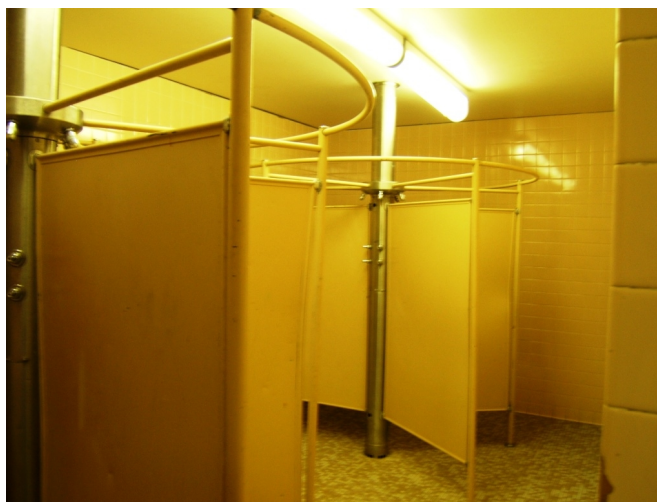
Metal toilet and shower partitions located in wash rooms of all sections.

<u>Rating</u>	<u>Installed</u>	<u>Design Life</u>	<u>Updated</u>
4 - Acceptable	1957	30	MAR-08

Typical shower partitions.

Event: Replace 31 Fabricated Compartments(Toilets/Showers) -]**

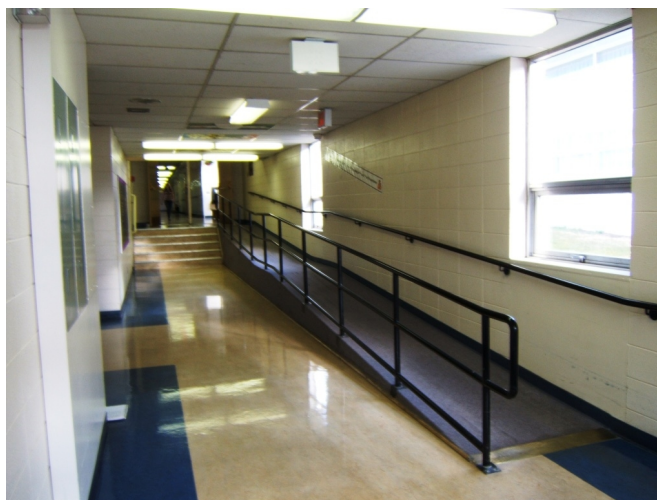
Wood framed ramp located in corridor adjacent to south entry of 1967 section with carpet finish.

<u>Rating</u>	<u>Installed</u>	<u>Design Life</u>	<u>Updated</u>
4 - Acceptable	1991	0	MAR-08

Ramp and stair located in south entry corridor of 1967 section.

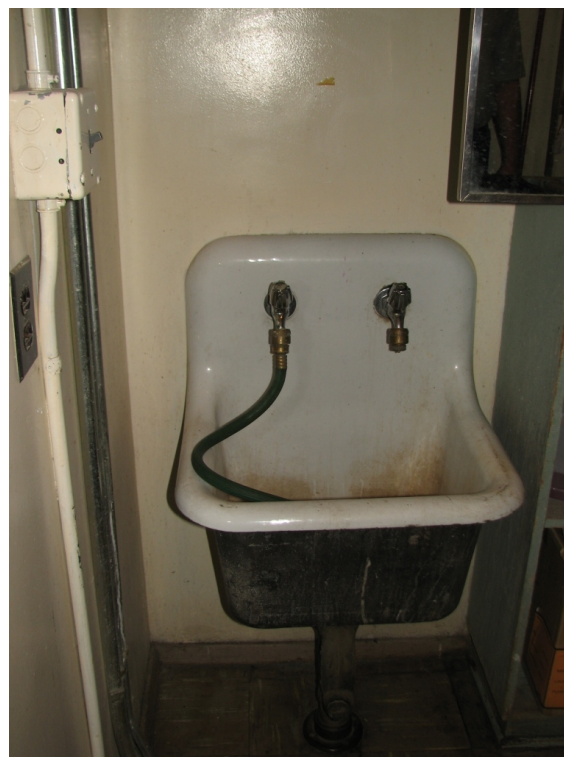
Mop sinks are corroded, leak, and no replacement parts are available.

Mop sinks have separate hold/cold taps serve as a scolding hazard, are corroded and replacement parts cannot be found.

Event: Replace Two (2) Mop Sinks - 1956 Original

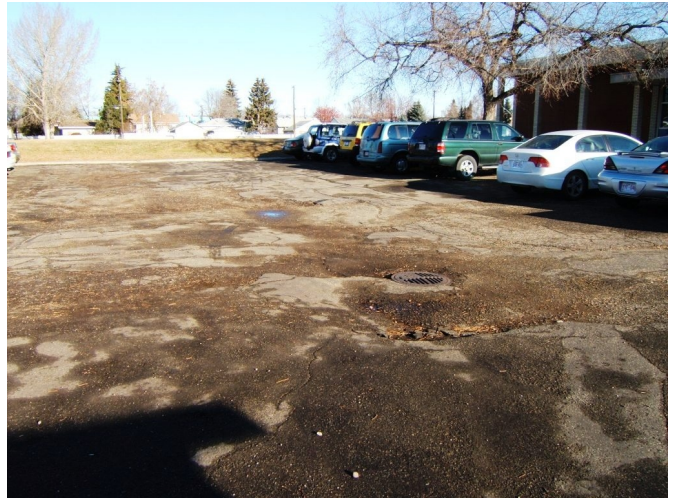
Deteriorated asphalt surface.

<u>Rating</u>	<u>Installed</u>	<u>Design Life</u>	<u>Updated</u>
3 - Marginal	1967	25	MAR-08

Event: **Replace 575 sq. M Flexible Paving Parking Lots(Asphalt)****

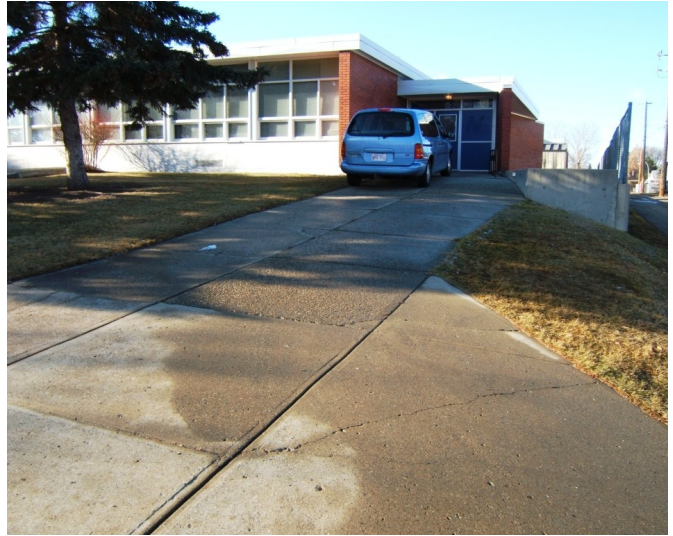
Concrete surfaced walkways and driveway access to Industrial Arts area.

<u>Rating</u>	<u>Installed</u>	<u>Design Life</u>	<u>Updated</u>
4 - Acceptable	1957	25	MAR-08

**Event: Replace 128 sq. M Rigid Pedestrian Pavement (Concrete)****
