RECAPP Facility Evaluation Report

Lendrum School

B3195A
Edmonton

Evaluation Company: R.Saunders Architects Ltd.
Evaluation Date: July 10 2007
Evaluator Name: Raghbir Jagdev MRAIC MAAA MAIBC

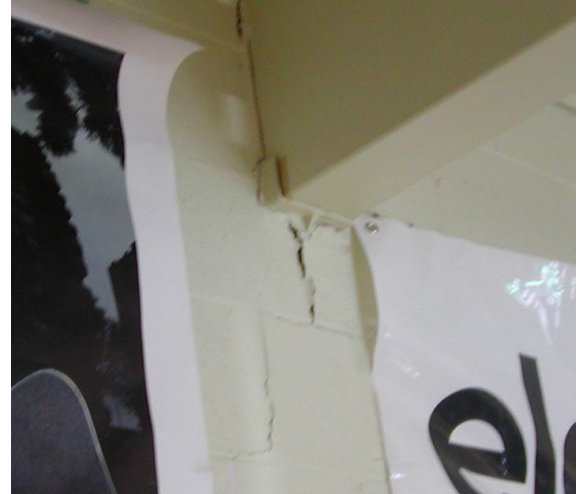
Classroom #13

Concrete block wall in corridors are developing cracks at classrooms #13, #43 and other areas.

Patch and repaint cracks.

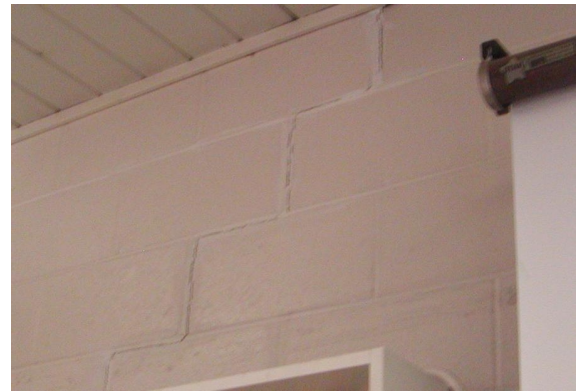
crack-84.JPG

Cracks developing in exterior block walls in library #1, classrooms #42, #43 and other areas.

Patch and repaint cracks.

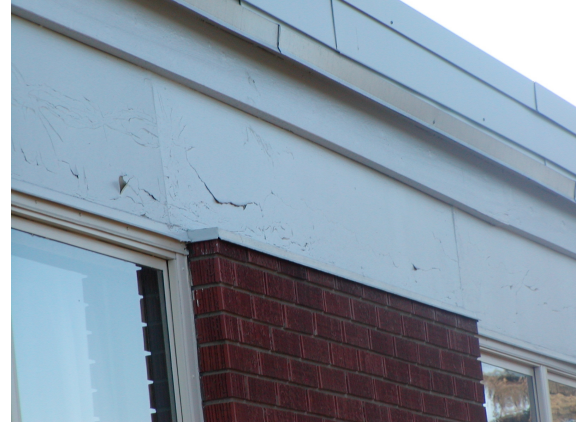
Window headers

Paint and crezon plywood is deteriorating at classroom window headers.

Refinish with prefinished metal.

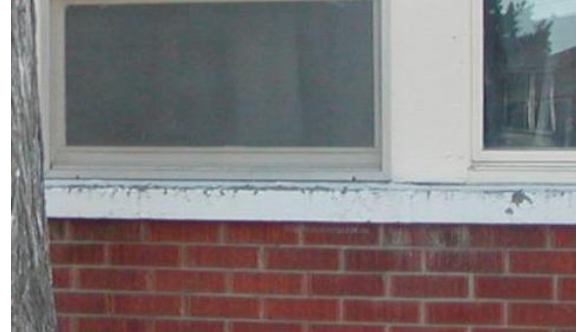
Window sill

Paint is deteriorating on precast concrete window sills.

Refinish window sills with prefinished metal flashing.

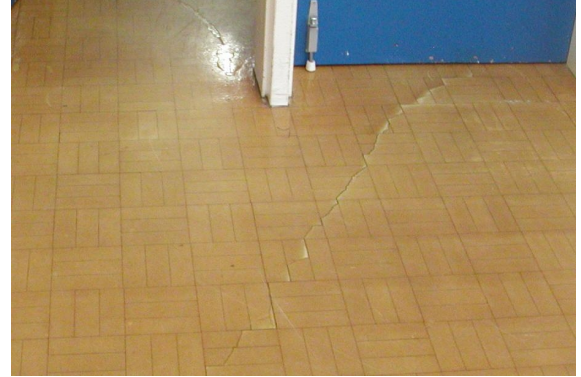
Quarry tile in gymnasium and stage is old and cracking in some areas. There are complaints that the surface is too hard for recreational activity.

Replace quarry tile with wood flooring in gymnasium and stage

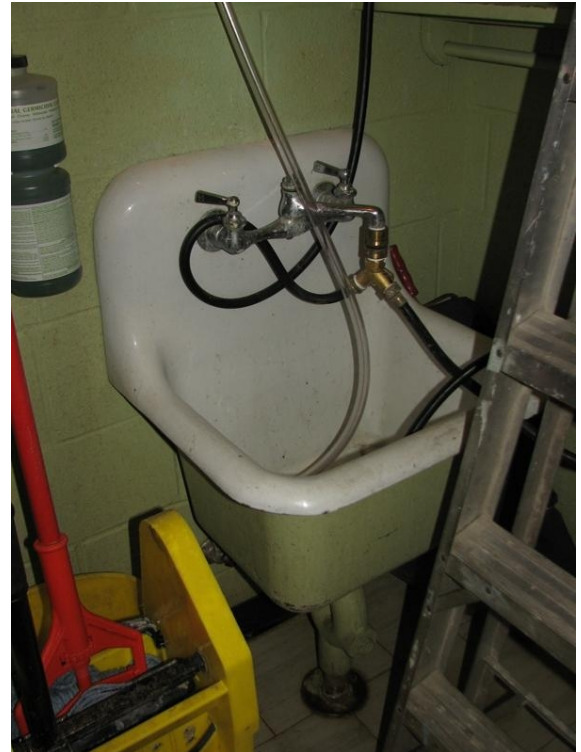
Mop Sink

Wall hung mop sink shows signs of corrosion and leaks.

Replace mop sink with floor mounted molded stone mop sink complete with valve breakers.

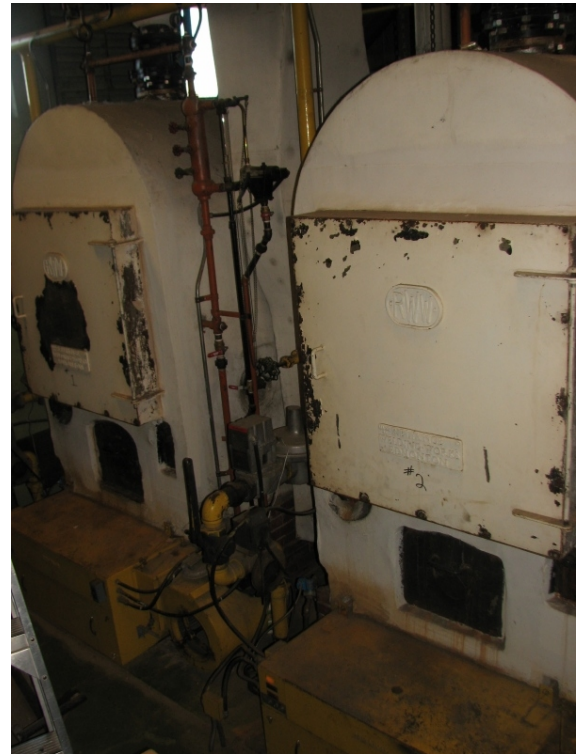
Boilers are frequented with failures and repairs. They are inefficient, have exceeded their life expectancy and are in poor shape.

Boilers show signs of corrosion.

Replace boilers with new hot water boilers.

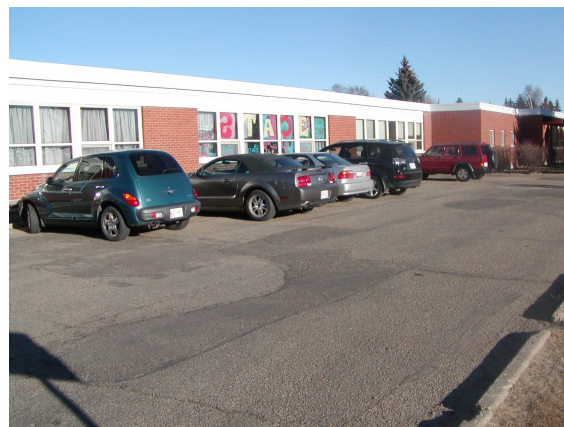
Staff parking lot is old and worn and needs repaving.
