RECAPP Facility Evaluation Report

Edmonton School District No. 7

Londonderry Junior High School

B3196A
Edmonton

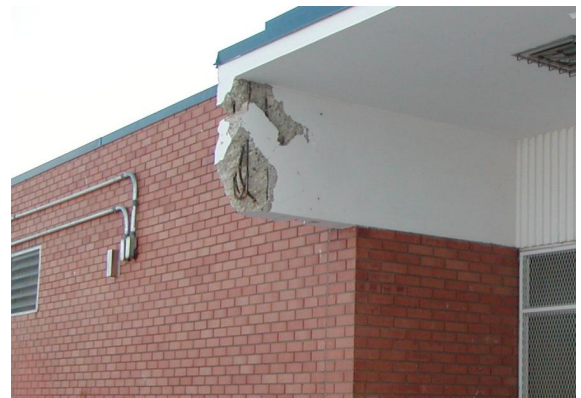
Exposed cast in place concrete overhang at northwest entrance is damaged.

Cast in place concrete overhang at north west entrance.

Repair damaged area. It is recommended to move the asphalt driveway near this entrance farther away from the building to provide more clearance for loading trucks. This would help to avoid collision with overhang.

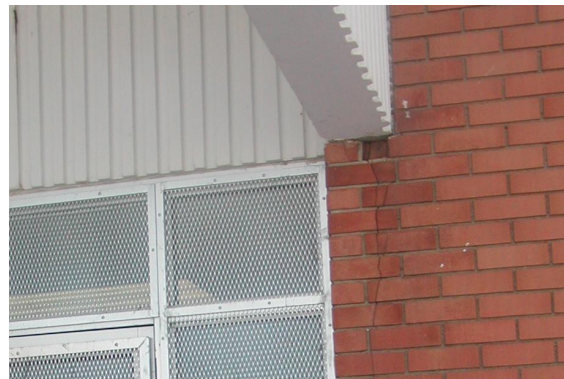
Stress cracks in brick veneer under the exposed tee structure at some entrances.

Stress crack at brick/tee at rear entrance.

Replace damaged brick. Provide expansion joint at the top course underneath the tee.

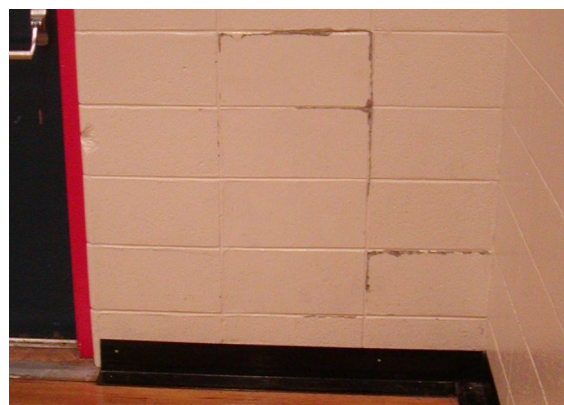
Cracks in exterior wall concrete block mortar in gymnasium south/west corner, classroom #71 in south/west corner and along top course in east wall. Crack in block at entrance F7.

Cracks in south/west wall of gymnasium.

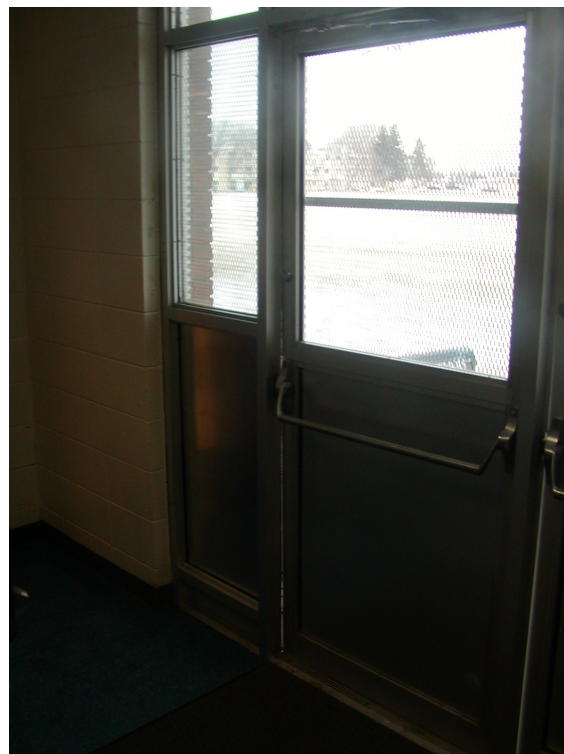
Further wear and leaking doors.

Aluminum entrance door.

Replace all doors (20 doors). Replace sidelights and transoms (approx. 23 m2).

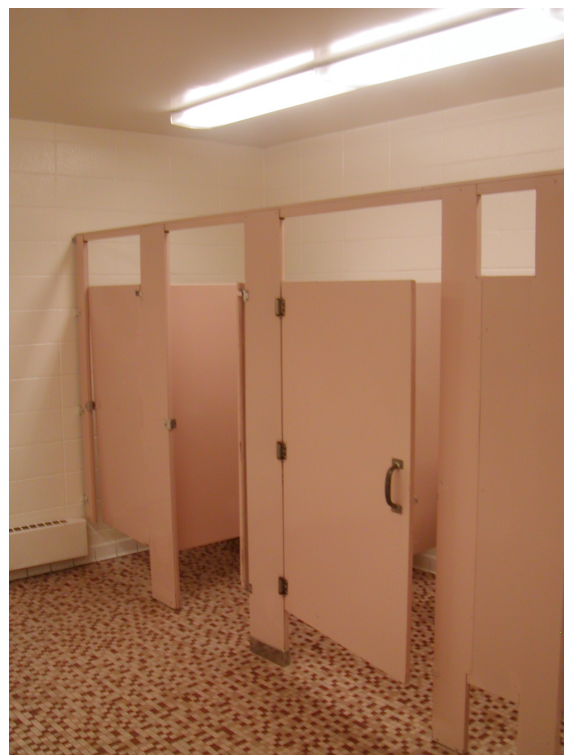
Metal toilet partitions in boys and girls washrooms are old, worn and damaged. Metal toilet partitions in staff washrooms are old.

Toilet partitions in girls washroom #23

Replace metal toilet partitions in boys and girls washrooms #22, 23, 8, 10, 45, 47. Replace metal toilet partitions in staff washrooms #57 and 58. 26 compartments.

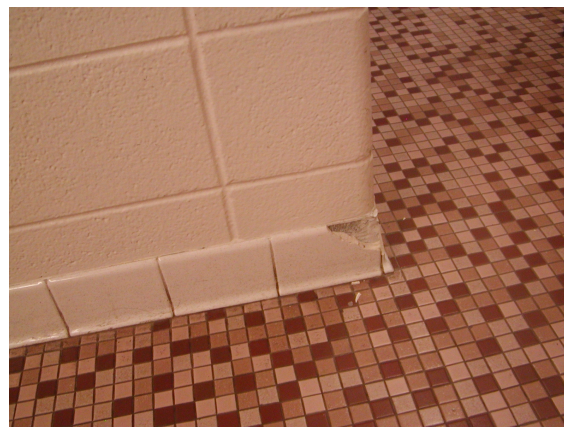
Tile base is chipped and cracking near entranc in boys and girls washrooms #8, 10, 22, 23.

Damaged tile in boys washroom #22

Remove and replace damaged tiles.

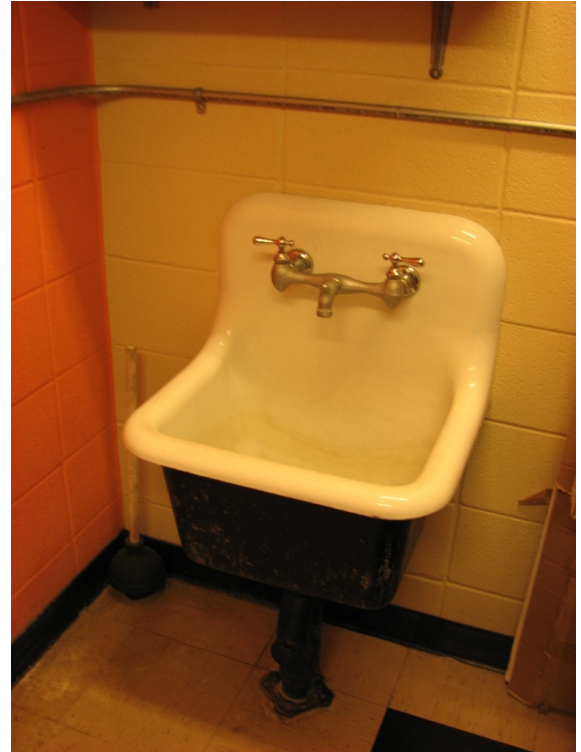
Wall hung mop sink that does not comply with the current Building Code.

Replace original wall hung sink with a floor mounted, molded stone mop sink.

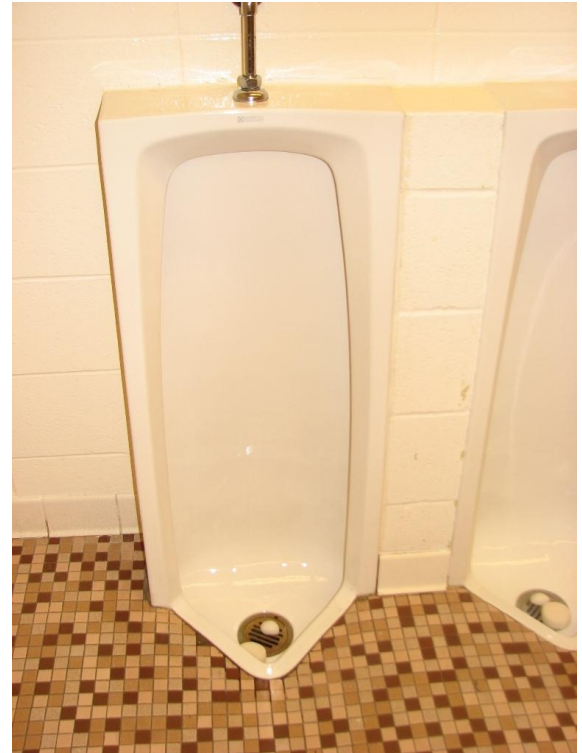
Two of the stall type, American Standard, flush tank urinals are cracked on the bottom right corner in Washroom # 125.

Typical American Standard, tank type urinals.

Replace urinals.

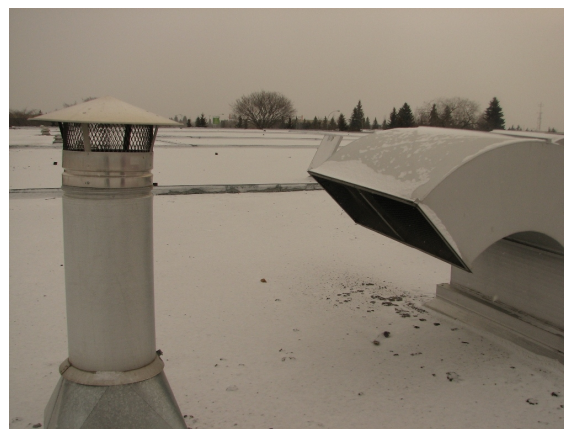
Proximity of Vent serving DWH to F/A intake.

Extend the chimneys another ten to fifteen feet so that fumes expelled from the chimneys do not get transferred into the Air Handling Units.

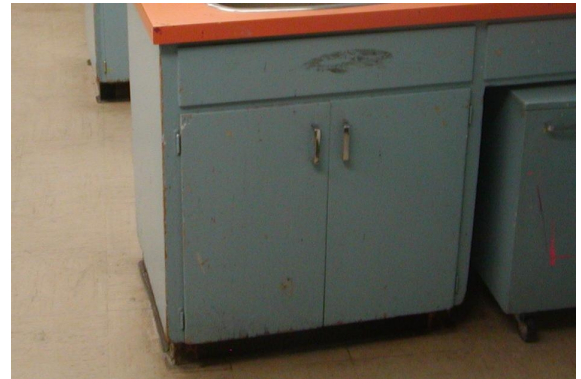
Counters and cabinets in ancillary(art), classrooms are old and very worn. In the washrooms the counter fronts are very worn and damaged, counter tops are also old.

Cabinets in ancillary(art) #29.

Replace counters and cabinets in ancillary(art) approx. 42'.
 Replace counters in boys and girls washrooms approx. 46'.
 Replace counters in staff washrooms approx. 8'. It is recommended to have wall mounted counters in the washrooms with no millwork underneath counter. Replace counters in ancillary(drama) approx. 8'. Replace counters, sink and cabinets in office in industrial arts area approx. 8'. Teachers storage in classrooms approx. 60' (4'/classroom)

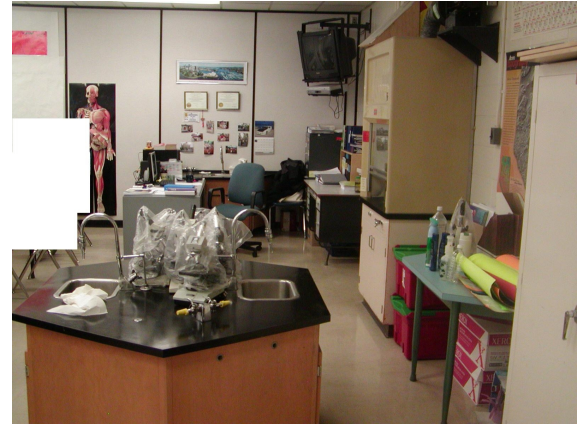
Not very functional classroom setting.

Typical island in science rooms.

Replace islands (18).

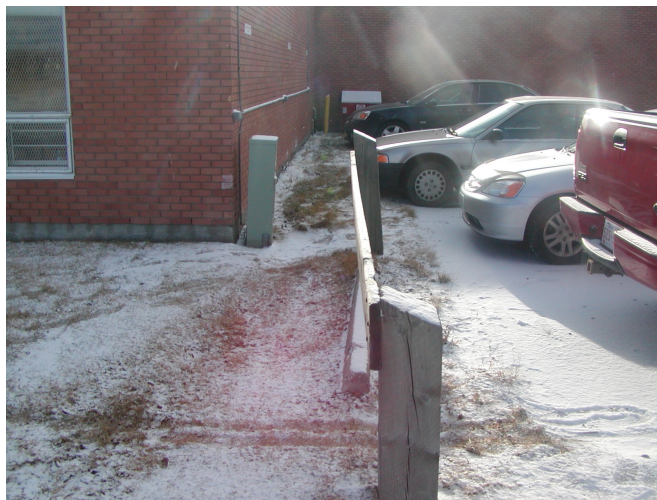
Grade around the building is depressed in some areas.

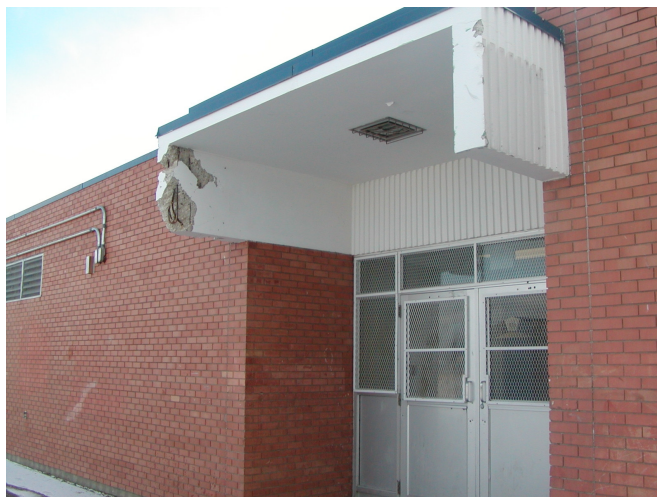
Loading trucks could hit the overhang and damage the building.

Provide bollards in front of entrance F3 to prevent loading vehicles using the roadway from running into the overhang.

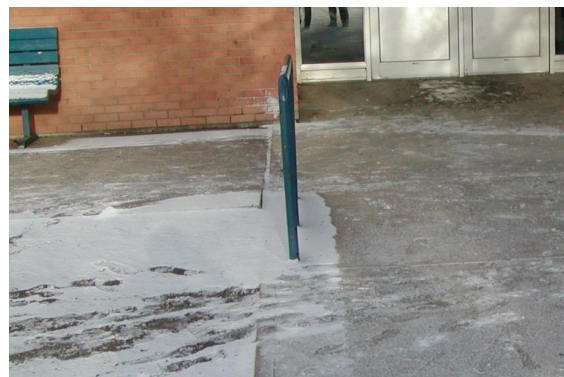
Complaints of icy conditions at the front entrance F2 in the winter.

Icy conditions during winter freeze/thaw.
