# **RECAPP Facility Evaluation Report**

## **Edmonton School District No. 7**

### **Lorelei Elementary School**

B3197A  
Edmonton

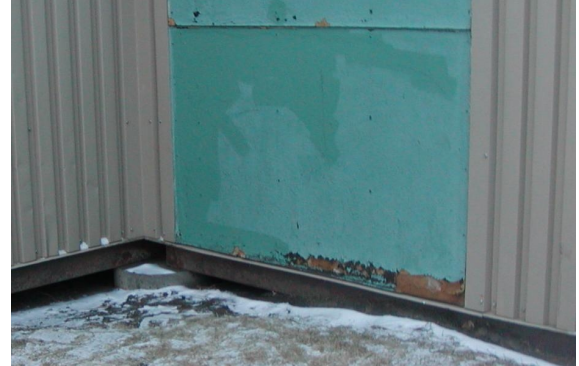
South/west pod.

Painted plywood under and over windows, doors and mechanical room grilles is worn and deteriorating.

Replace plywood panels with metal siding. Approx. 64 m2

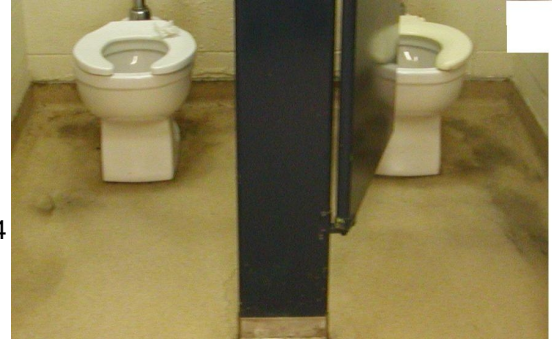
Boys washroom #41

Heavy staining and random cracks.

Refinish epoxy coating in boys and girls washrooms #30 (10m2),#31(10m2),#40 (17.5 m2),#41(12.8 m2),#44 (11.5m2),#45 (17.5 m2). Refinish epoxy coating in caretakers storage #15 (19.60m2). Total approximate area = 98.9m2. Fill crack in boys change room #23.

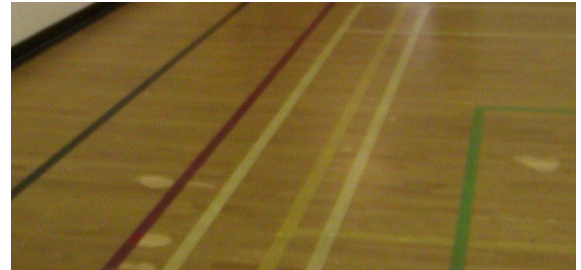
The finish on the wood strip flooring in the gymnasium is worn.

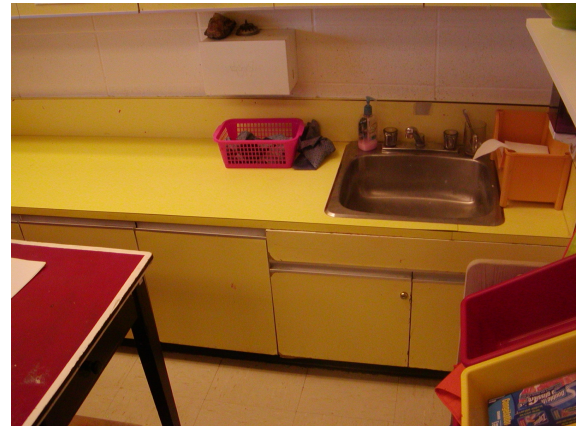
Counter in kindergarten #11

Replace counters and sinks in kindergarten #11 (5.5m), caretakers office (1.5m), c3 (0.762) , c10 (0.762)

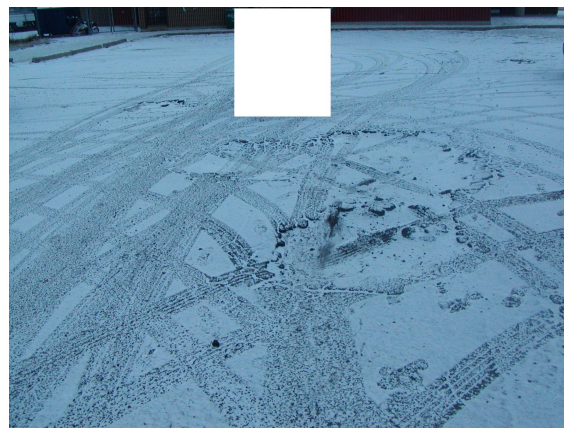
Further deterioration and driving hazard.

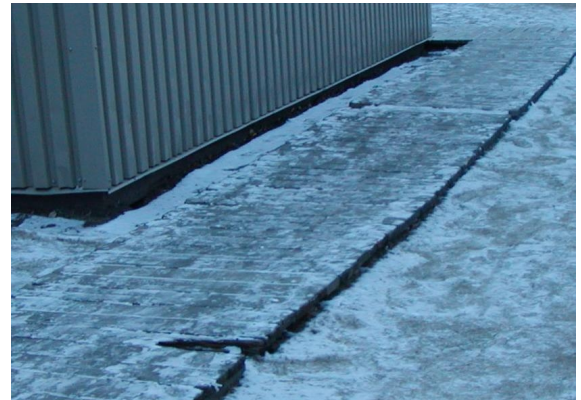
Some boards are missing or damaged from the boardwalk.

Trip hazard.

Replace missing or damaged boards.

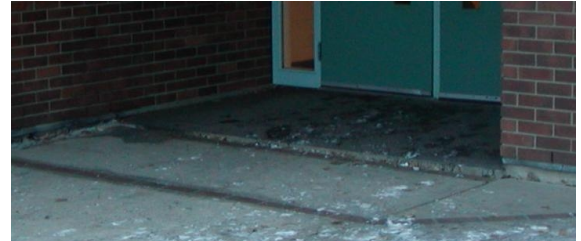
Further sinking, trip hazard and a barrier for handicap access.

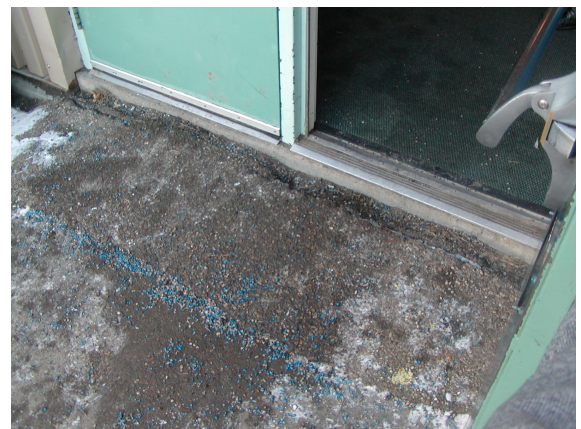
The sinking stoop is a trip hazard and a barrier for handicap access. Further sinking and poor drainage along the building in the paved recreational areas.

Replace the stoop at entrance f3 with a concrete stoop. Approx. 3 m2 Provide positive slope for drainage along the building in the paved recreational areas. Approx. Perimeter = 205'
