# **RECAPP Facility Evaluation Report**

**Lyburn Elementary School**

B3199A  
Edmonton

**Evaluation Company:** R.Saunder Architects Ltd.  
**Evaluation Date:** July 10 2007  
**Evaluator Name:** Raghbir Jagdev MRAIC MAAA MAIBC

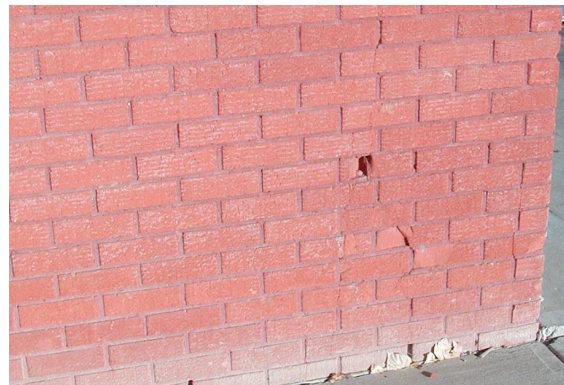
Brick is damaged and cracking in various locations around the building.

Brick near main entrance.

Replace damaged brick.

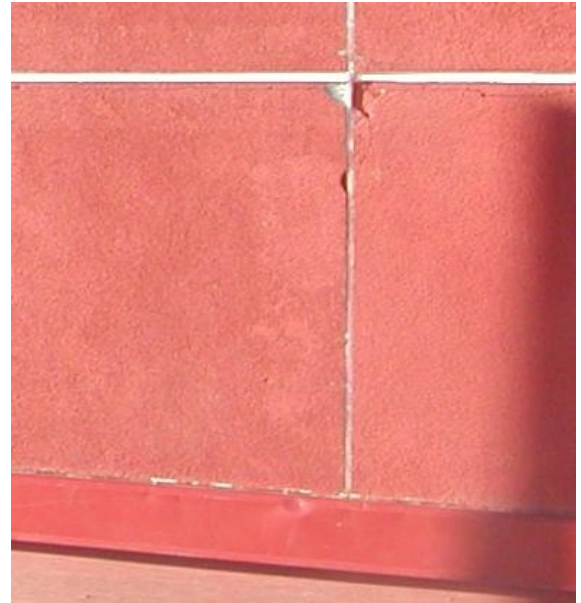
Stucco is damaged in various places on 1992 pod.

Stucco damage on east wall of 1992 pod.

Patch and repair stucco.

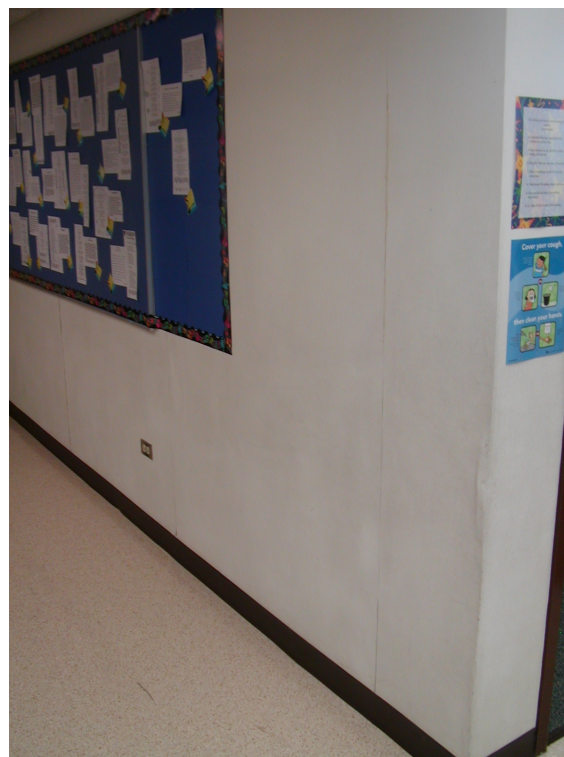
Vinyl wall coverings are peeling and damaged in corridors c10,c11 and c14 in classroom wings.

Vinyl wall coverings in corridor c10.

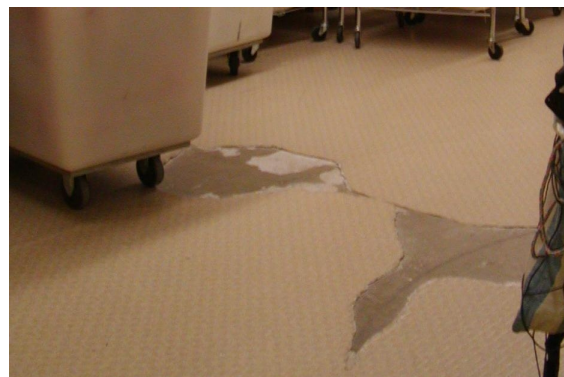
Gymnasium storage #5.

Sheet vinyl flooring is old, worn and damaged in some areas.

Replace sheet vinyl flooring in storage #1 (14.6m2), storage #2 (12.5m2), janitors office #8 (12.2m2), janitor room #9 (3.4m2), gym storage #5 (36.7m2), gym storage #6 (17.6m2), physical education office #13 (10.4m2), storage #15 (8.6m2), science room #21 (68.2m2), janitor room #26 (4.3m2), storage #59 (10.5m2), janitor room #62 (3.6m2).

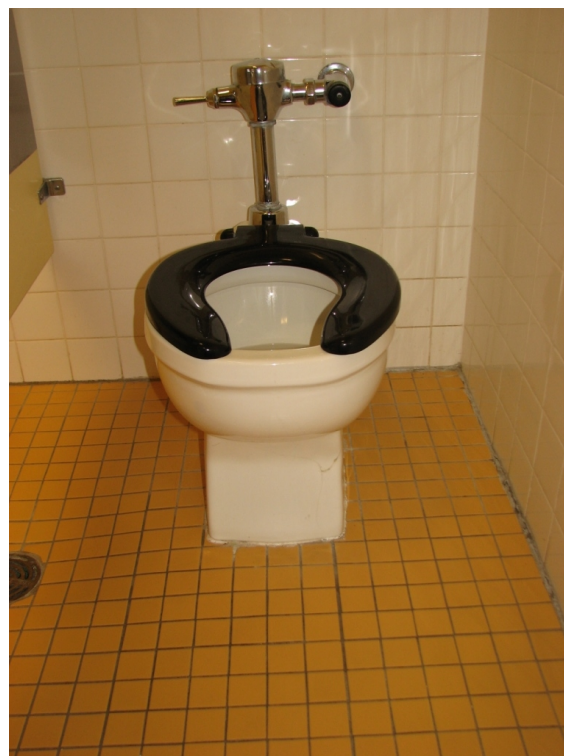
One of the flush valve water closets is cracked.

Water Closet is cracked.

Replace the cracked water closet.

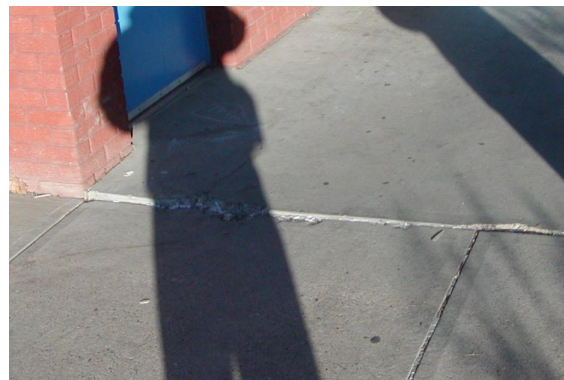
**Event:** Repair concrete slab front entrance (2 m2)
