RECAPP Facility Evaluation Report

Edmonton School District No. 7

M. E. Lazerte Composite High School

B3201A
Edmonton

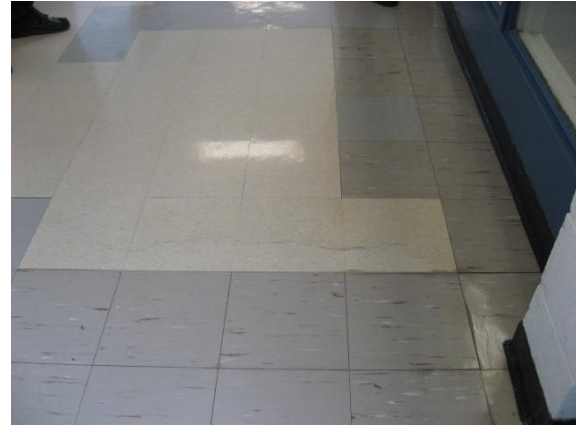
The floors are aged and deteriorated in several locations.

Vinyl floor tile on the second floor corridors

Replace all original vinyl tiles.

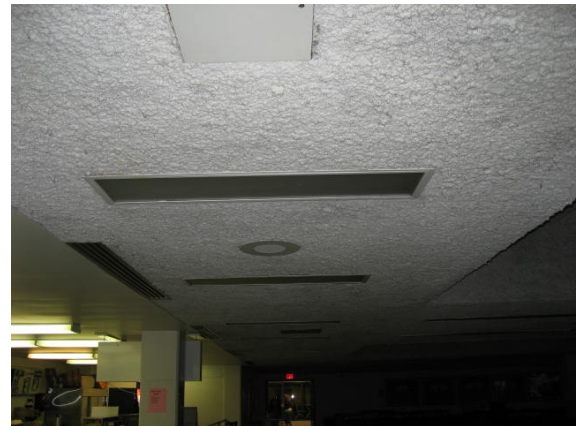
The texture finish is deteriorating in the cafeteria.

Sprayed textured ceiling in the cafeteria.

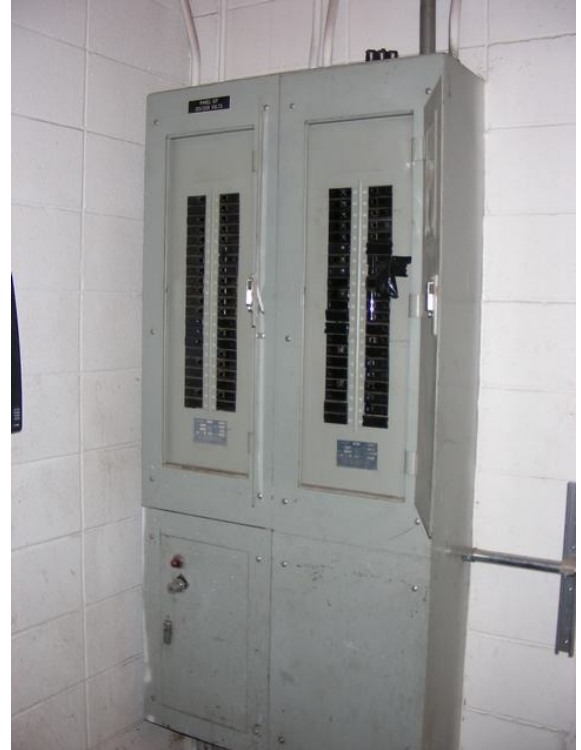
Over the life of the panel, breaker contacts become worn and the breakers will no longer operate correctly and may trip unnecessarily. Older panels do not readily accept newer style breakers.

Deferring replacement could lead to partial power outages and intermittent tripping of breakers as well as increased maintenance costs.

Aged electrical branch circuit panels.

Replace aged panelboards and reconnect branch circuit wiring.

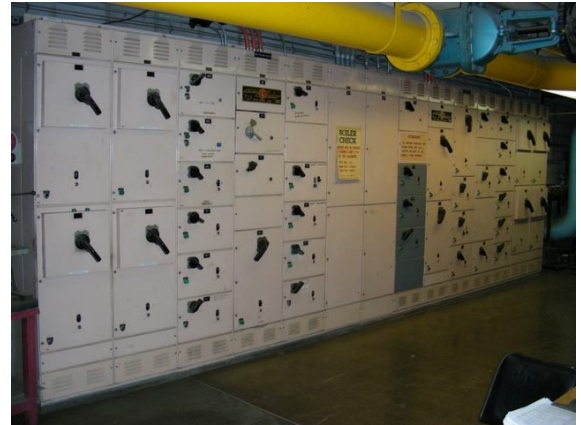
The Motor Control Centres have exceeded their theoretical life expectancy. Starter replacement parts are not readily available

Aged MCC #3 and MCC #4

Replace the existing five CCL Motor Control Centres.

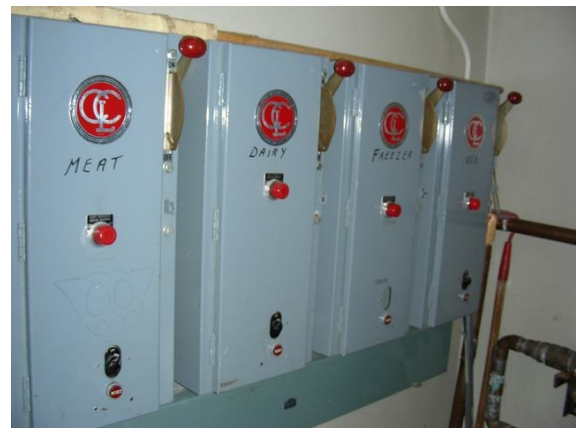
The individual motor starters have exceeded their theoretical life expectancy. Replacement parts are not readily available.

Aged individual motor starters

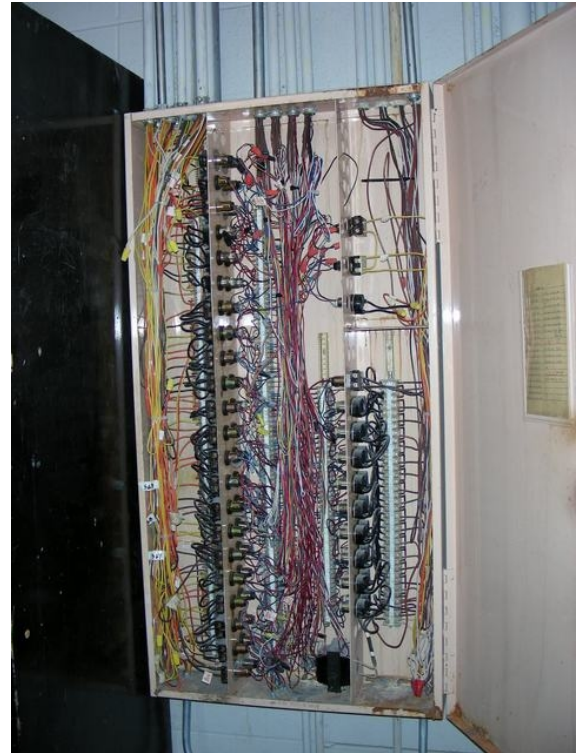
Low voltage relay cabinet

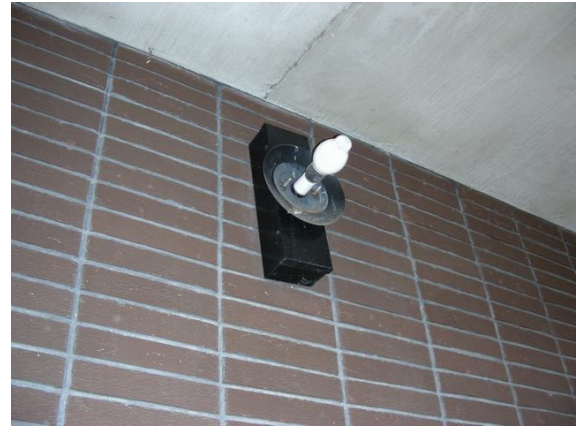
Damaged globe type fixture

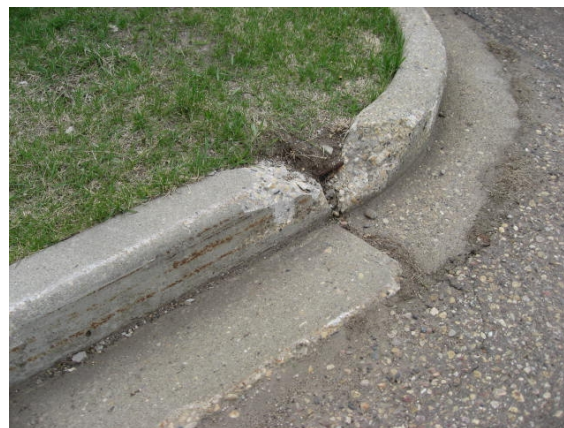
Damaged roadway curbs observed in several isolated areas.

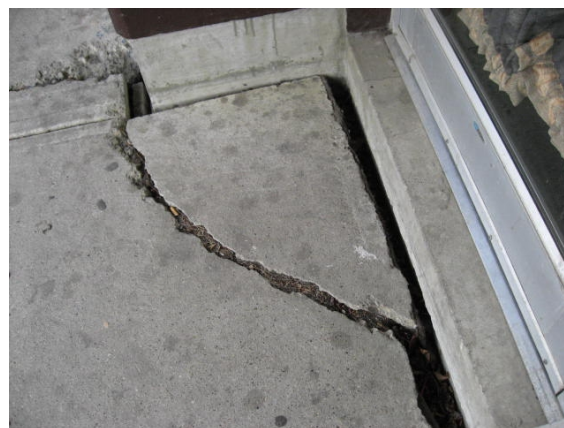
Settlement of concrete observed in several locations around the school.
