# **RECAPP Facility Evaluation Report**

**Edmonton School District No. 7**

**Malcolm Tweddle Elementary School**

B3202A  
Edmonton

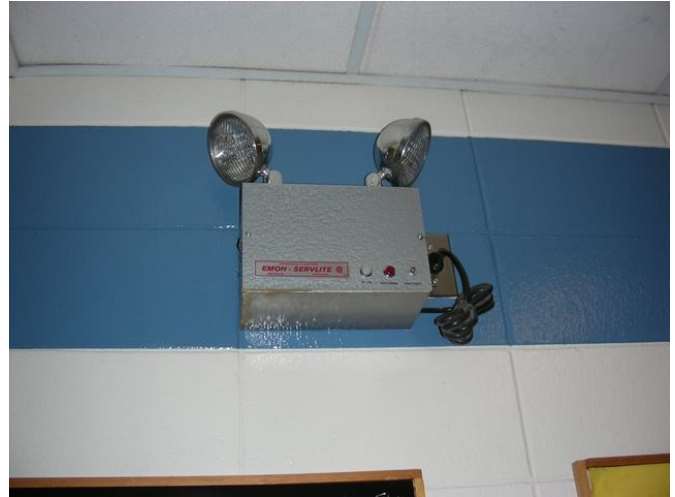
The majority of the emergency lighting battery packs are older Emoh-Servlite units. Several of the units were not operational.

<u>Rating</u>	<u>Installed</u>	<u>Design Life</u>	<u>Updated</u>
2 - Poor	1975	20	NOV-07

Aged emergency lighting battery pack.

Replace emergency lighting battery packs with new units.

<u>Type</u>	<u>Year</u>	<u>Cost</u>	<u>Priority</u>
Failure Replacement	2008	\$8,580	High

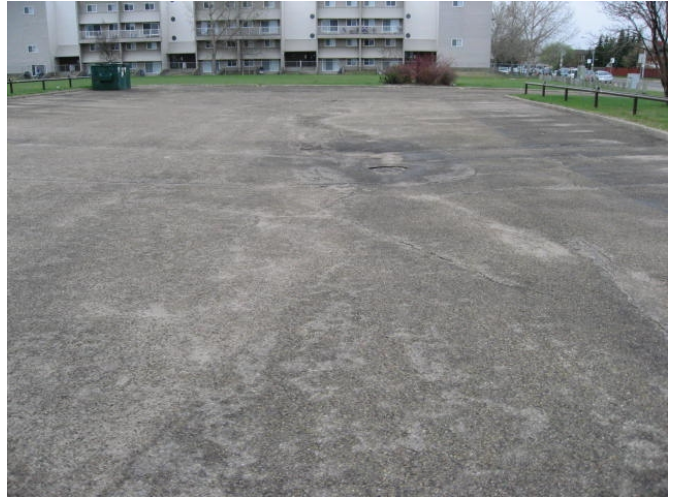
<b><u>Rating</u></b>	<b><u>Installed</u></b>	<b><u>Design Life</u></b>	<b><u>Updated</u></b>
3 - Marginal	1975	25	NOV-07

Asphalt paved parking area with extensive cracks and settlement.

The asphalt paved surface is deteriorated and settlement is located around the catch basins.

**Event:** **Resurface asphalt paved parking area - Area-1000SM**

<b><u>Type</u></b>	<b><u>Year</u></b>	<b><u>Cost</u></b>	<b><u>Priority</u></b>
Failure Replacement	2008	\$68,640	Low

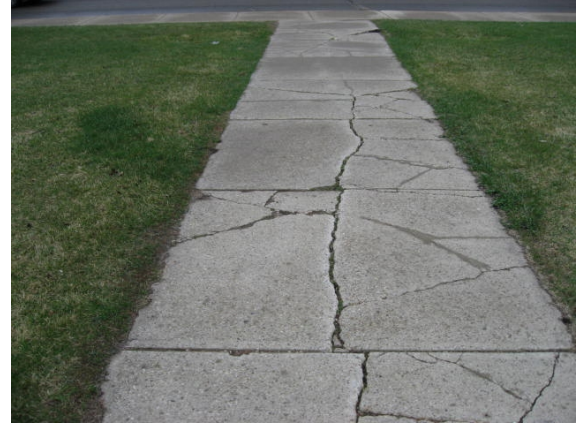
Several poured concrete walkways are cracked and pose a potential tripping hazard.

Cracked concrete walkways at the north-west end of the site.

**Event: Repair and/or replace all damaged walkways****Concern:**

Repair and/or replace all damaged walkways.

<u>Type</u>	<u>Year</u>	<u>Cost</u>	<u>Priority</u>
Repair	2008	\$8,580	Medium
