# **RECAPP Facility Evaluation Report**

## **Regional School Board**

### **Mayfield School**

B3207A  
Edmonton

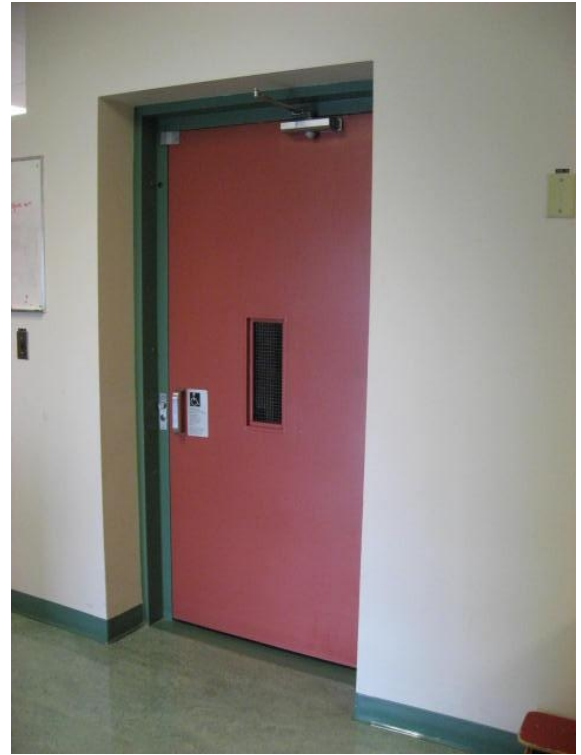
Passenger elevator - Entrance F2

**Event: Repair Lift****Concern:**

Repair lift for service.

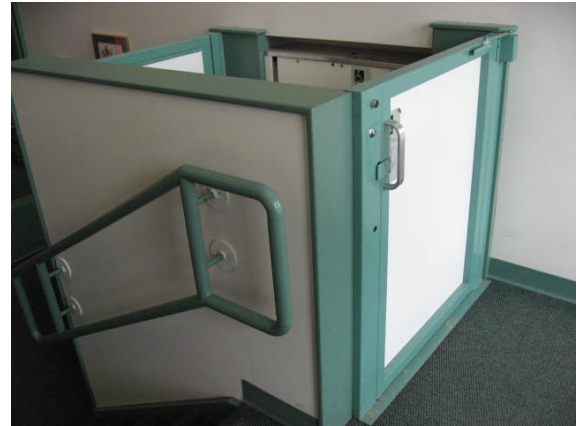
Lift at main entrance (F1) East elevation

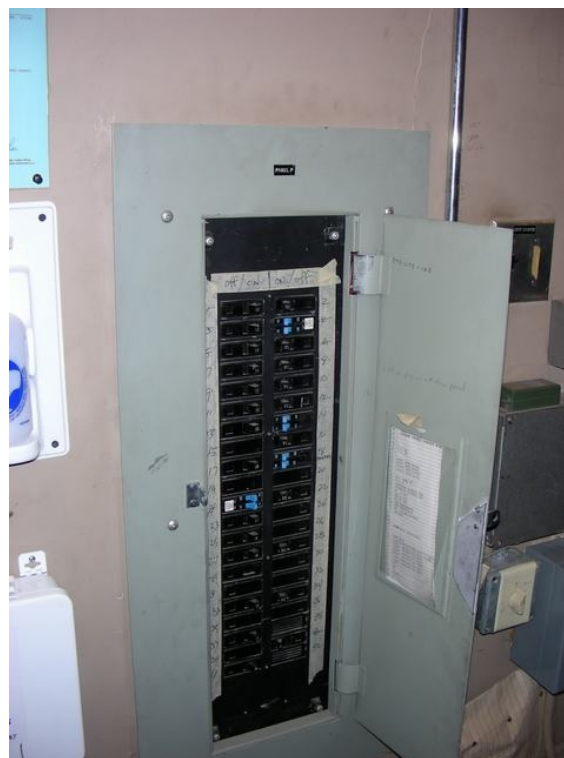
Panel P (1962) is at the end of its life expectancy. Over the life of the panel, breaker contacts become worn and the breakers will no longer operate correctly and may trip unnecessarily. Older panels do not readily accept newer style breakers.

Deferring replacement could lead to partial power outages and intermittent tripping of breakers as well as increased maintenance costs.

Aged Westinghouse panel P.

Replace aged panelboards and reconnect branch circuit wiring.

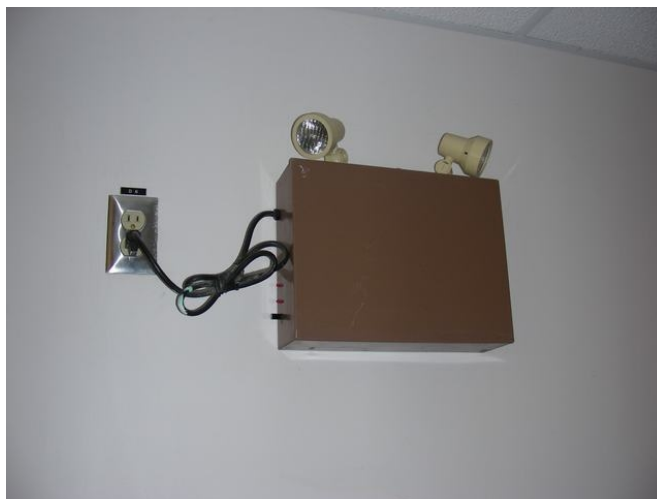
There are some older emergency lighting battery packs within the school that were not upgraded during the 1997 modernization.

Aged emergency lighting battery pack.

**Event: Replace Aged Emergency Lighting Battery Packs**

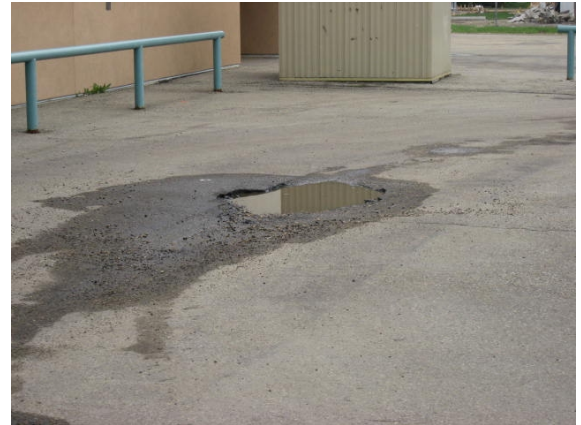
Sinkholes & cracks were observed in isolated areas throughout the asphalt paved parking area.

Sinkhole in parking area.

Repair all damaged asphalt surfaces
