RECAPP Facility Evaluation Report

Edmonton School District No. 7

McKee Elementary School

B3211A
Edmonton

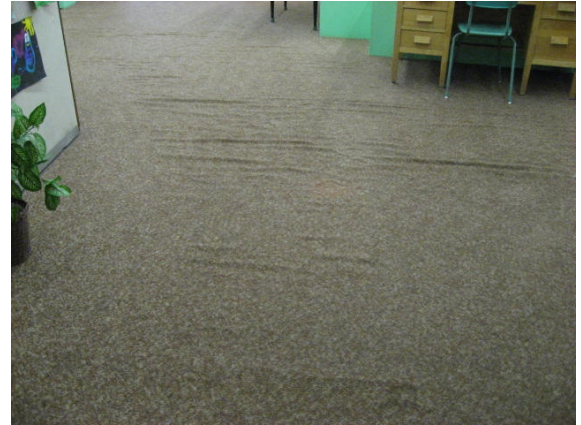
The carpet in the daycare and in room 33 is worn and stained throughout.

Rippled carpet in room 33.

Replace carpet throughout the daycare area.

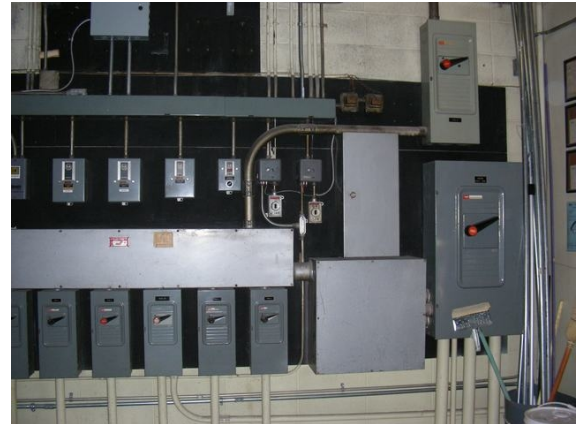
The existing main electrical distribution equipment has exceeded its life expectancy. Switch blade contacts begin to loosen with age which can lead to arcing.

Aged main electrical distribution.

Replace existing main distribution with a new service entrance switchboard with breaker distribution. Conduit and wiring for branch panels will have to be extended to new switchboard location.

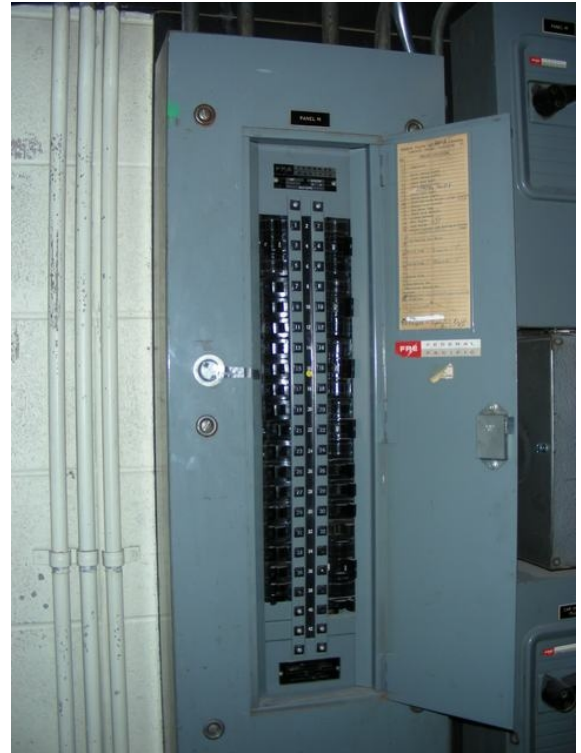
The branch circuit panels (1966) are at the end of their life expectancy. Over the life of the panel, breaker contacts become worn and the breakers will no longer operate correctly and may trip unnecessarily. Older panels do not readily accept newer style breakers.

Deferring replacement could lead to partial power outages and intermittent tripping of breakers as well as increased maintenance costs.

Aged branch circuit panelboard.

Replace aged panelboards and reconnect branch circuit wiring.

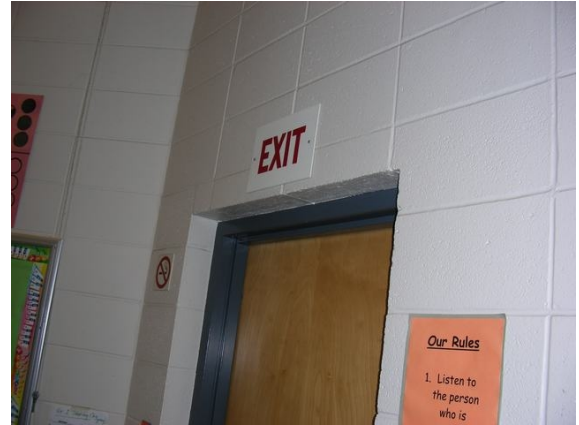
Non-illuminated exit sign in room 60.

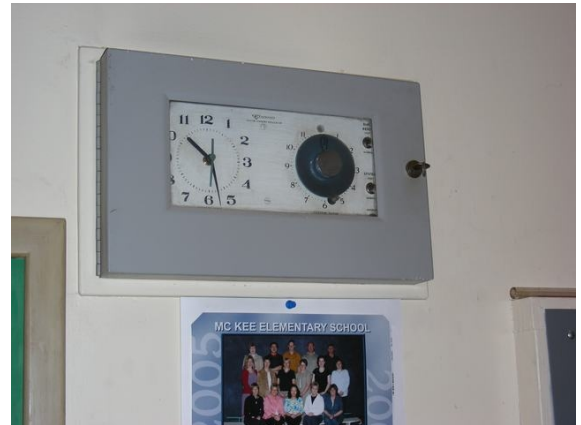
The existing clock system is well past its life expectancy. Replacement parts are not available and maintenance on the system is costly.

Aged master clock system.

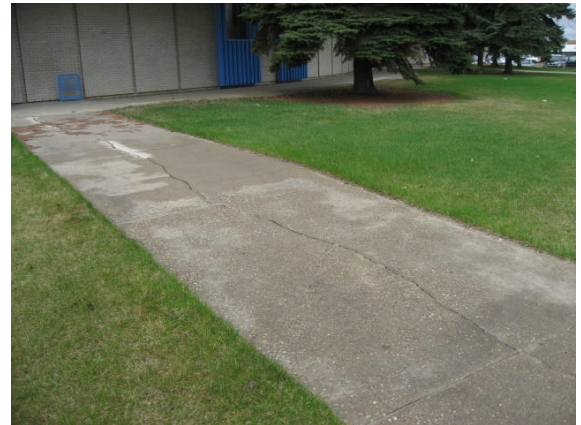
Cracked poured concrete walkway.

Event: Replace poured in place concrete walkways

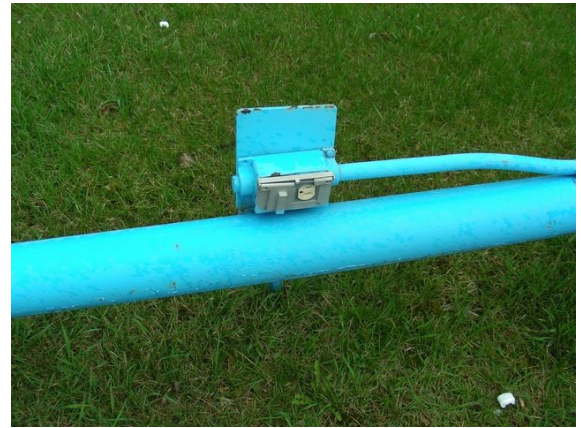
Damaged coverplate on car plug-in.
