# **RECAPP Facility Evaluation Report**

**McKernan Elementary / Junior High School**

B3213A  
Edmonton

<b>Evaluation Details</b>	
<b>Evaluation Company:</b>	A&E Architectural & Engineering Group Inc.
<b>Evaluation Date:</b>	October 26 2007
<b>Evaluator Name:</b>	Vic Maybroda

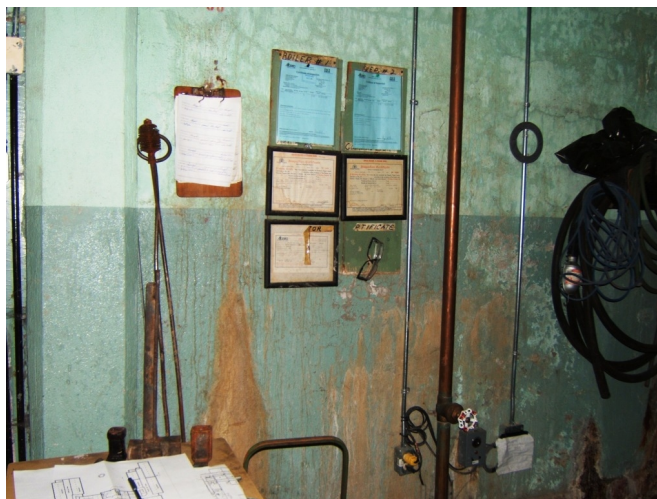
Exterior mechanical room wall.

Water infiltration into basement spaces causing severe damage in structural and built-in elements with possible mold build-up. Weeping tile installed in 2003 does not appear to have solved the situation.

- Review effectiveness of installed weeping tile.
- Review if moisture resistant membrane on exterior basement wall was installed.
- Review installation and operation of sump pumps.
- Replace damaged doors, frames and related elements.

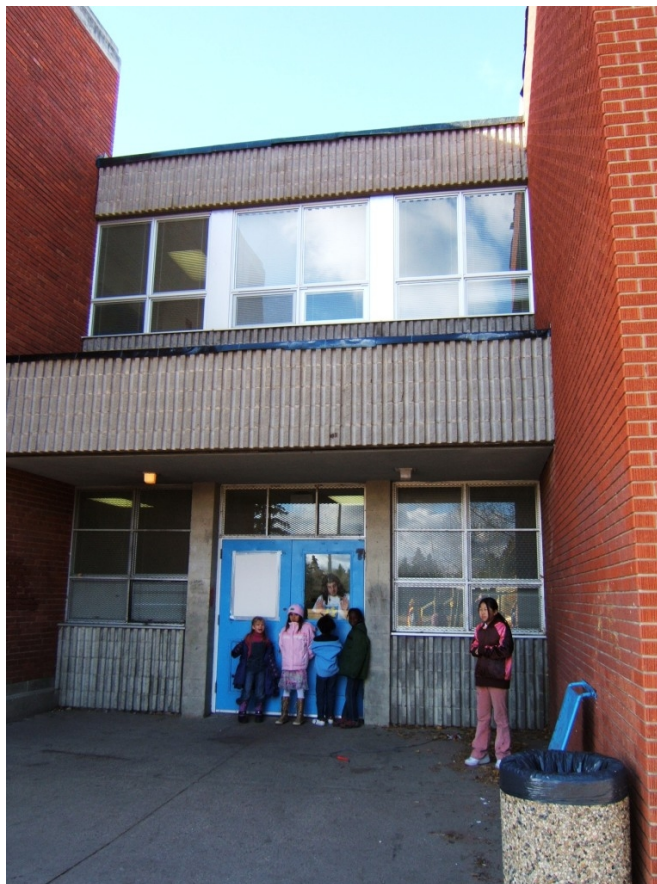
Precast concrete fascia elements and wall panels at entry vestibule.

Precast elements at east entrance to 1973 addition.

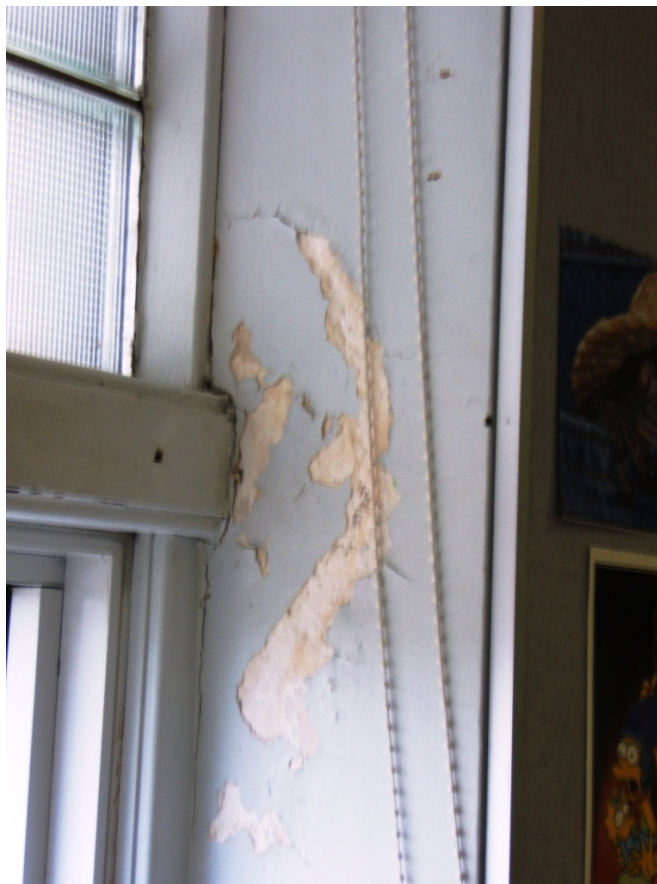
Various areas of second floor classrooms exhibiting condensation on perimeter finishes due to building movement and sealant failure.

Material finishes adjacent to windows and glass block contained in wood frames.

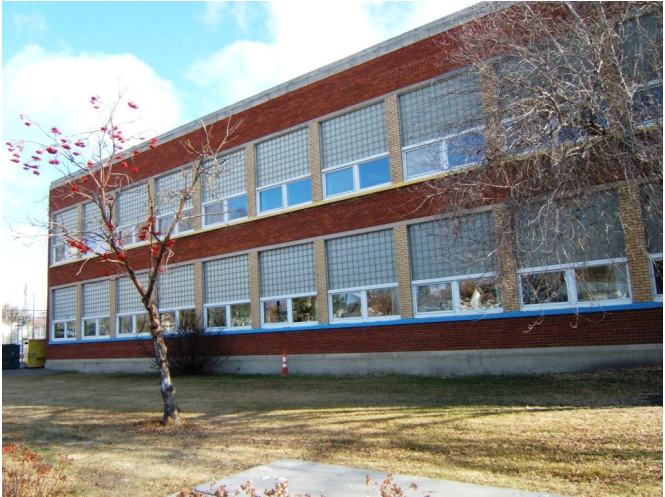
View of glass block over window units 1952 Section.

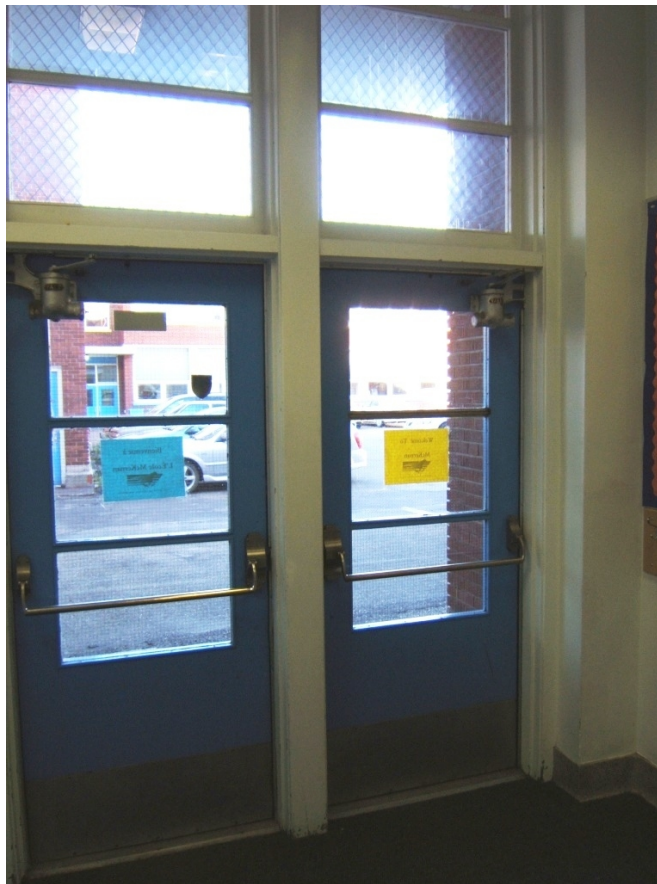
Typical exterior entrance doors all sections.

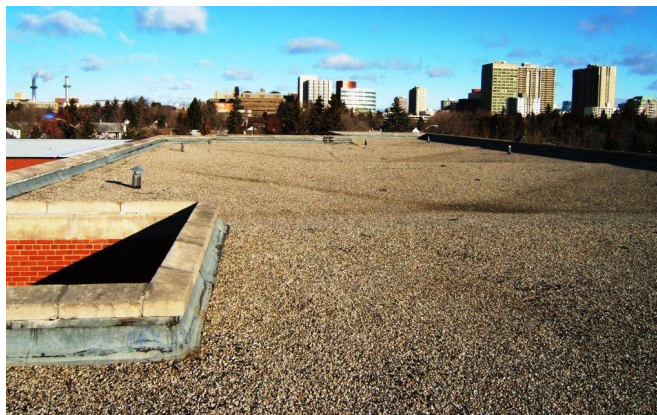
View of asphalt built-up roofing - 1952 and 1953 Sections.

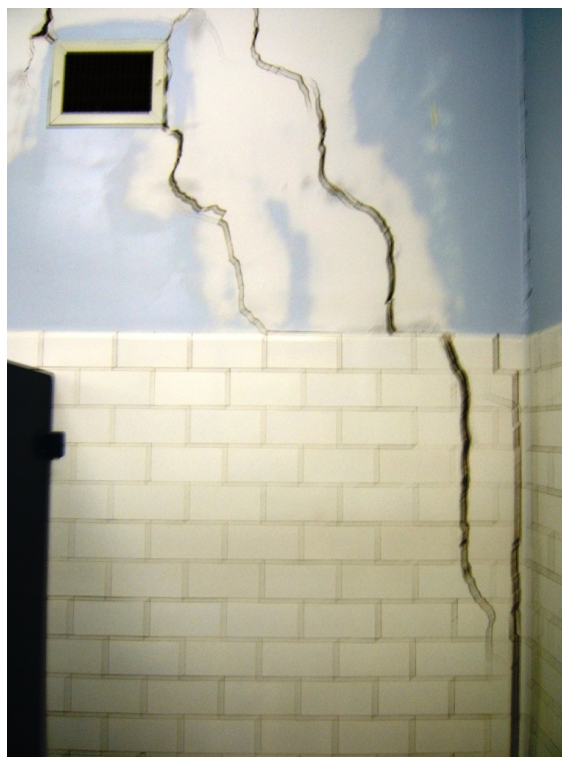
Settlement cracks in concrete block walls in wash rooms spaces causing potential health concern as well safety issue. Wall cracks in 2nd floor classroom and computer room over administration spaces.

Wall crack in staff wash room of 1952 section.

Review condition of walls in all sections, repair and make good finishes

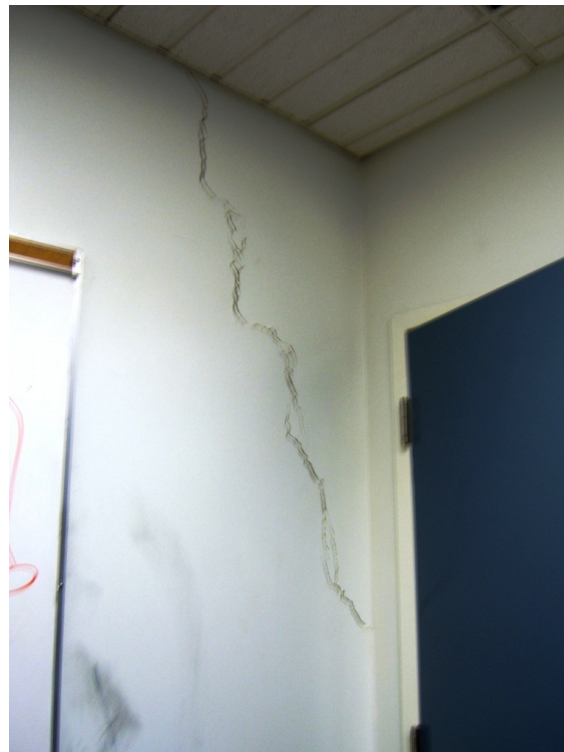
schools 003.jpg

Wall cracks disconcerting to school occupants.

Repair cracks and make good finishes.

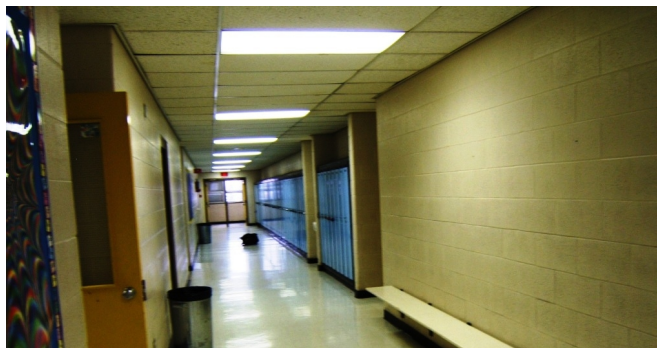
Corridor view with lockers.

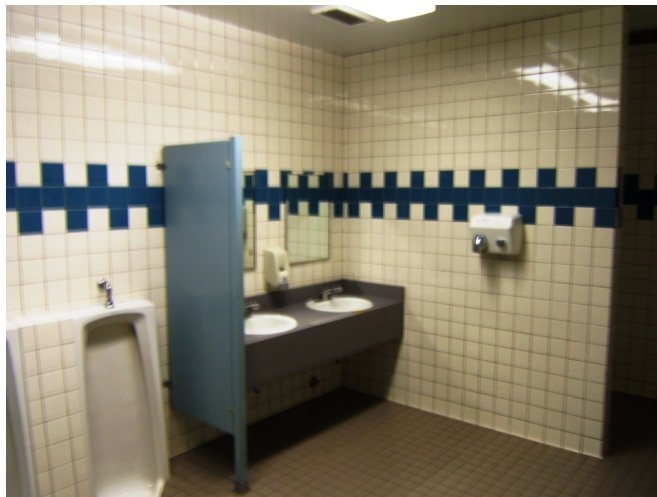
Typical upgraded washroom.

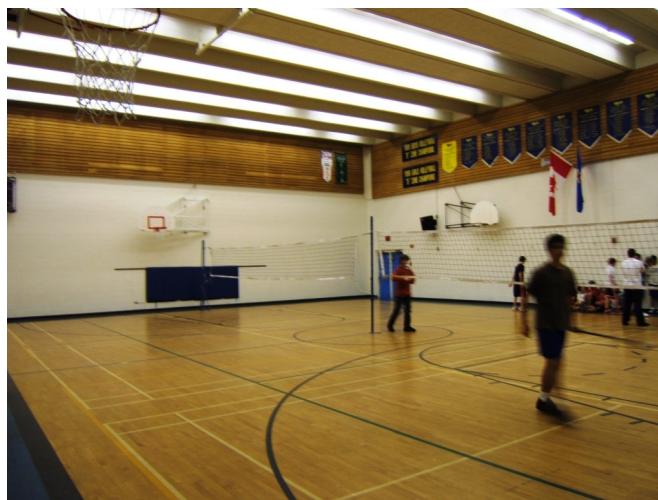
Stained wood wall panels in north gymnasium of 1973 Section.

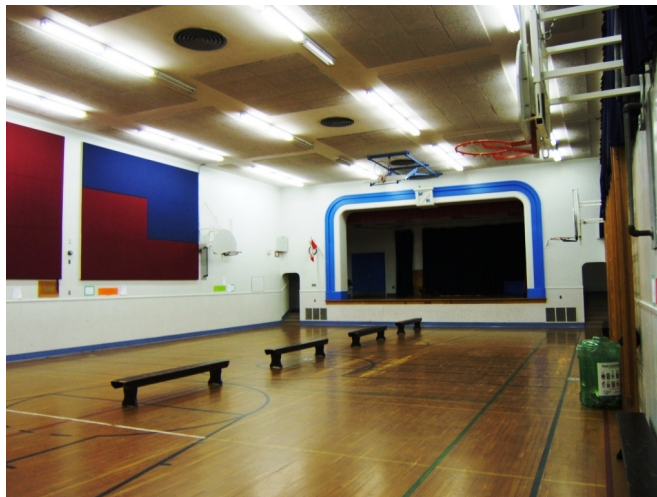
View of South Gymnasium.

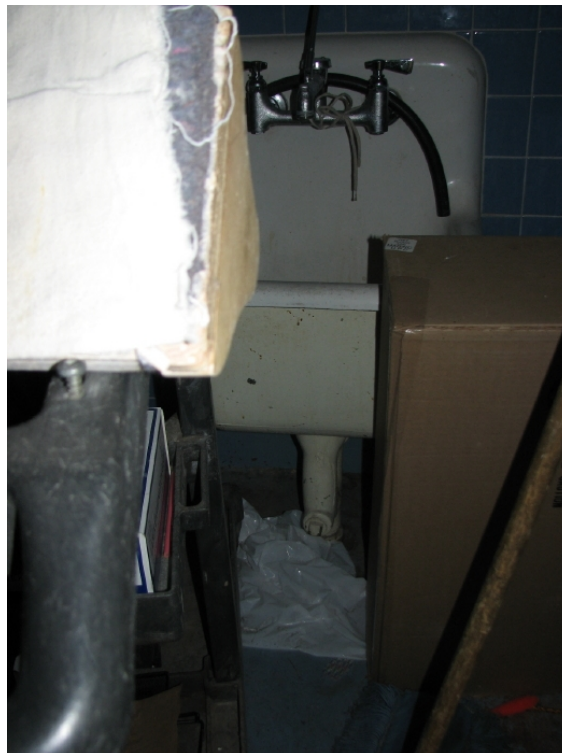
IMG\_3637\_47\_1\_1.JPG

Mop sinks located in the Janitor Room and the Home Economics Classroom are wall hung, steel, sinks, are leaking and need to be replaced as they are rusting and are no longer acceptable by code.

Replace existing sinks with Molded Stone 24"x24" floor mounted Mop Sinks.

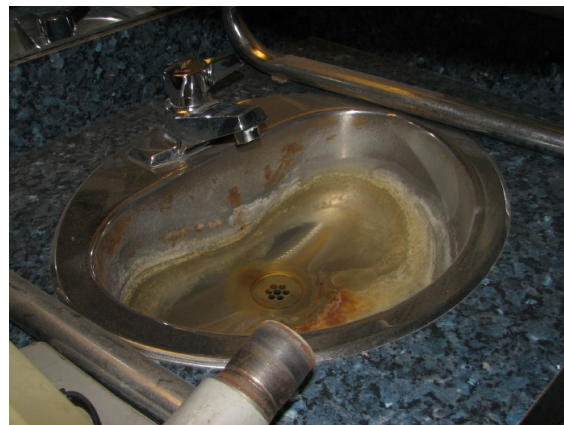
The Domestic Water lines are of steel construction, they are rusted and corroded.

Rust present in lavatories, suggest that the water lines are rusted.

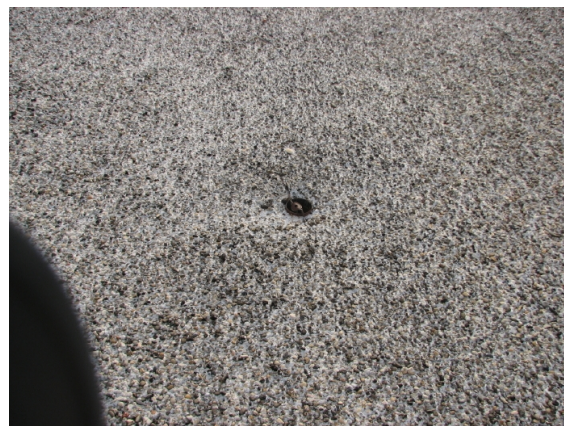
4" roof drains on gravel roof connected to the storm system. The roof drains are in poor condition as gravel traps are damaged and on some roof drains not existent. Need replacement

Typical condition of Roof Drains serving the school.

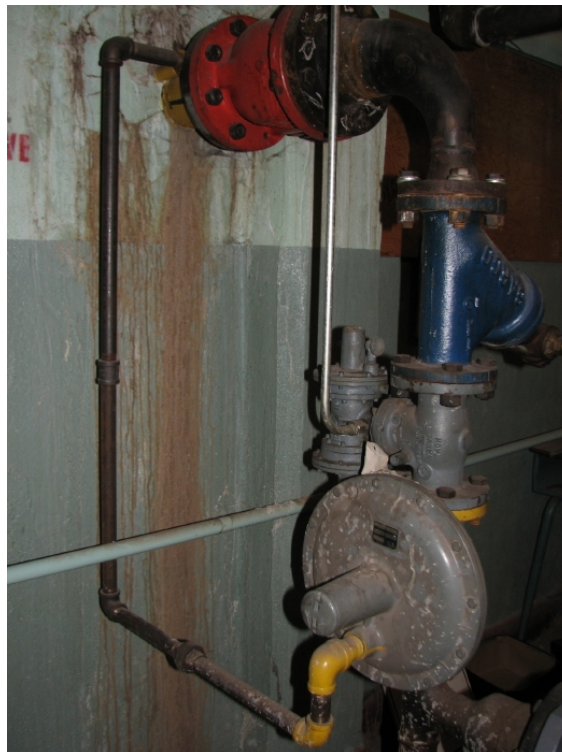
Main gas line entering the school shows signs of corrosion.

Rust and corrosion on main gas line.

Replace gas line entering school.

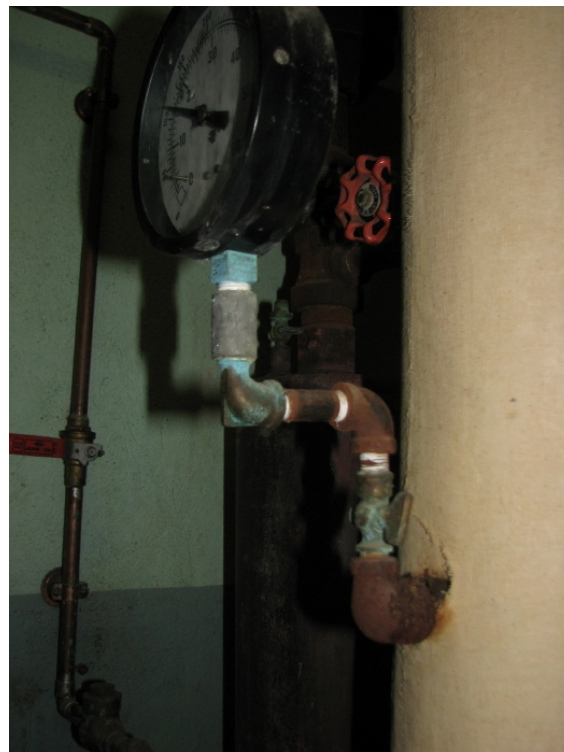
The schools heating system is in poor condition. The present steam boilers have been in operation since 1951, they show signs of corrosion on valves, hot water lines, chemical feeders, all the equipment that is associated with the Heating Boilers. The boilers are often failing, need constant repair and maintenance, costs for maintenance and service are extensive and are incurred often, and operating costs are very high as this steam system is a very inefficient system. The controls on the system are pneumatic and outdated. The condition of this system is poor and failure is imminent.

The following pictures show the condition of the Heating system in the school. All the components are corroded, rusted, show signs of age, and are a sign of imminent system failure.

Replace the whole school's heating system with a new hydronic boiler system, perimeter heating, and force flow heating system to serve the whole school (North and South) as the North side of the school is only heated through the AHU. The cost estimate in this section includes all perimeter heating, force flow heating for the whole school.

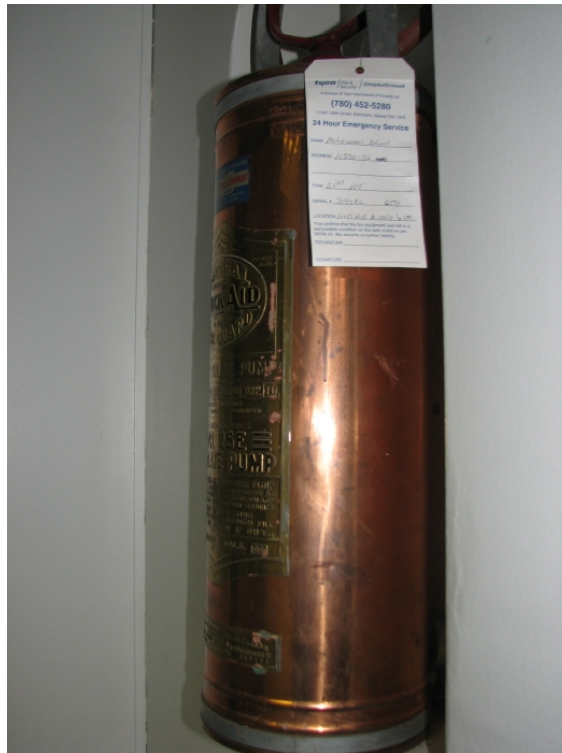
1951 original Pump Tank Fire extinguishers.
