RECAPP Facility Evaluation Report

Edmonton School District No. 7

McLeod Elementary School

B3214A
Edmonton

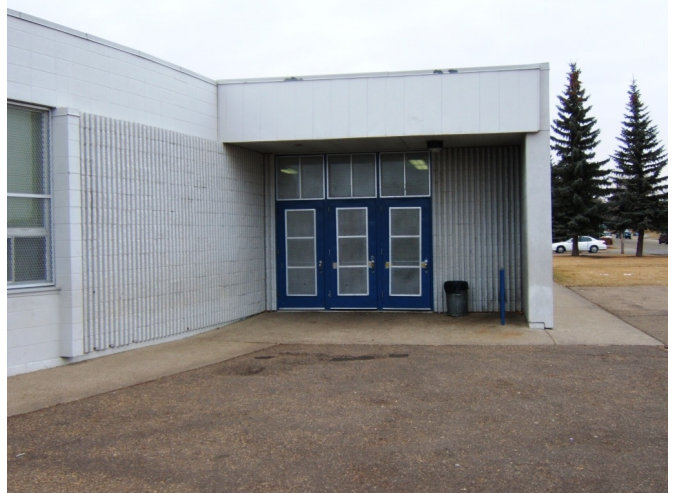
Painted metal doors and frames housing screened sealed glazing units.

<u>Rating</u>	<u>Installed</u>	<u>Design Life</u>	<u>Updated</u>
4 - Acceptable	1972	30	MAR-08

West side entry doors.

Event: Replace 10 Exterior Entrance Doors

<u>Type</u>	<u>Year</u>	<u>Cost</u>	<u>Priority</u>
Lifecycle Replacement	2012	\$28,600	Unassigned

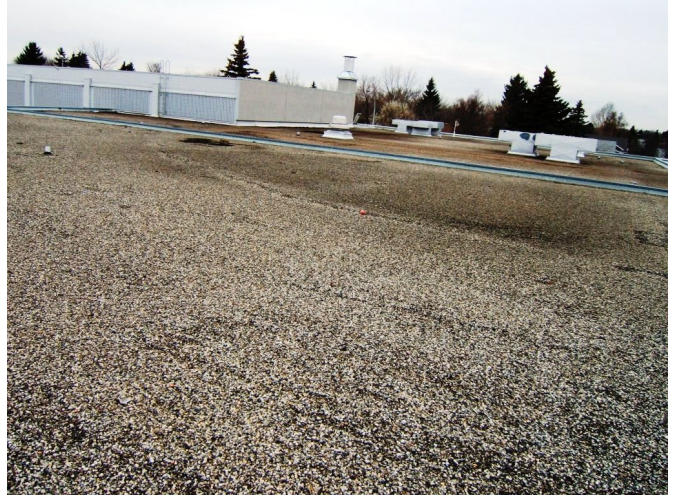
Built-up roof over all areas.

<u>Rating</u>	<u>Installed</u>	<u>Design Life</u>	<u>Updated</u>
4 - Acceptable	1972	25	MAR-08

Partial view of roof.

Event: Replace 3150 Sq. M Built-up Asphalt Roofing

<u>Type</u>	<u>Year</u>	<u>Cost</u>	<u>Priority</u>
Lifecycle Replacement	2012	\$324,324	Unassigned

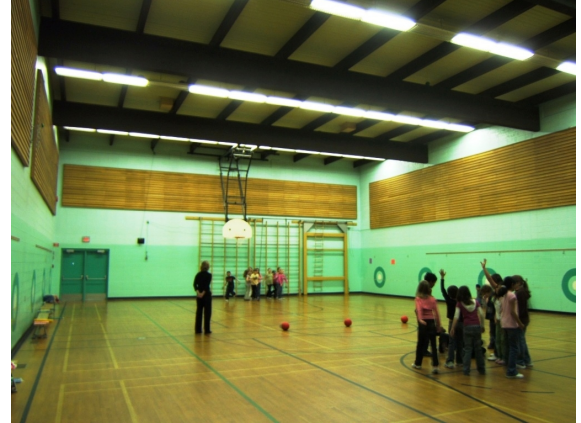
View of gymnasium finishes.

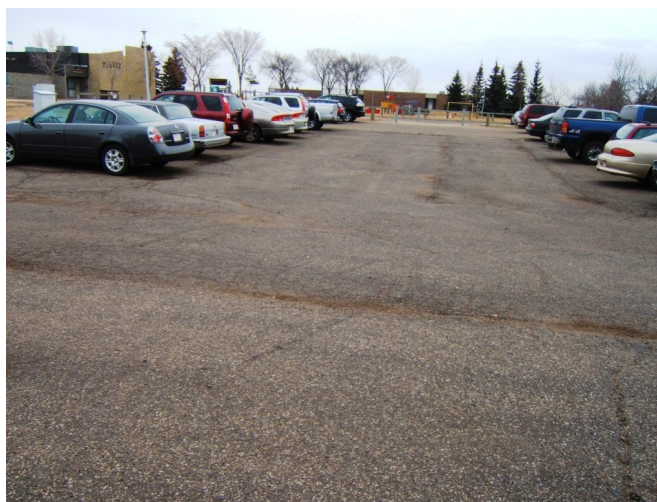
Located on south side of school contains minor cracks and indentations.

<u>Rating</u>	<u>Installed</u>	<u>Design Life</u>	<u>Updated</u>
4 - Acceptable	1972	25	MAR-08

Event: Replace 750 sq. M Flexible Paving Parking Lots(Asphalt)**

<u>Type</u>	<u>Year</u>	<u>Cost</u>	<u>Priority</u>
Lifecycle Replacement	2012	\$56,628	Unassigned
