RECAPP Facility Evaluation Report

Edmonton School District No. 7

Menisa School

B3219A
Edmonton

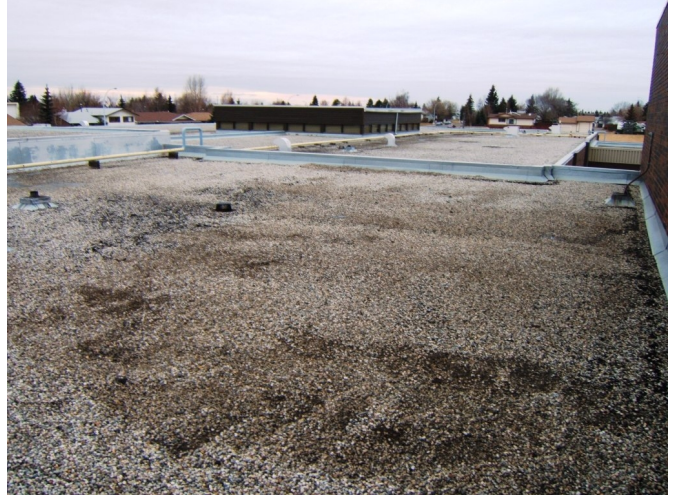
B3010.04.01 Built-up Bituminous Roofing (Asphalt & Gravel)**

Built-up asphalt roofing over all areas.

<u>Rating</u>	<u>Installed</u>	<u>Design Life</u>	<u>Updated</u>
4 - Acceptable	1981	25	MAR-08

Partial view of built-up roofing.

Event: Replace 2,188 sq. M Built-up Roofing

<u>Type</u>	<u>Year</u>	<u>Cost</u>	<u>Priority</u>
Lifecycle Replacement	2012	\$232,690	Unassigned

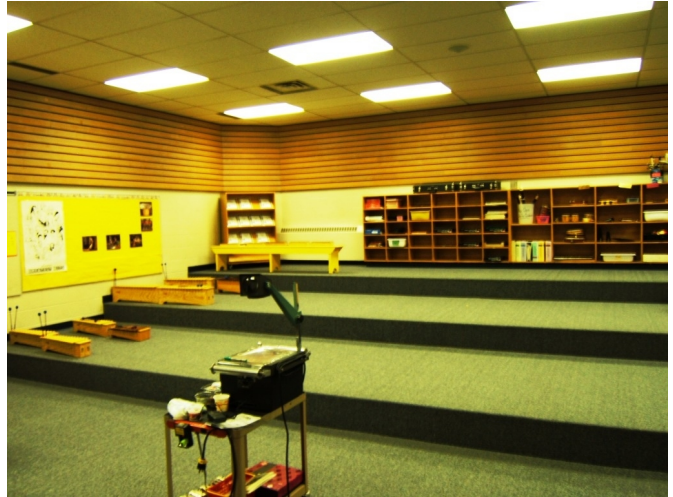
C3010.02 Wall Paneling - **

Stained wood strip paneling located in Music Room and upper wall level of Library.

<u>Rating</u>	<u>Installed</u>	<u>Design Life</u>	<u>Updated</u>
5 - Good	1981	30	MAR-08

Wall paneling in Music Room.

Event: Replace 150 sq. M Wall Paneling**

<u>Type</u>	<u>Year</u>	<u>Cost</u>	<u>Priority</u>
Lifecycle Replacement	2012	\$8,580	Unassigned

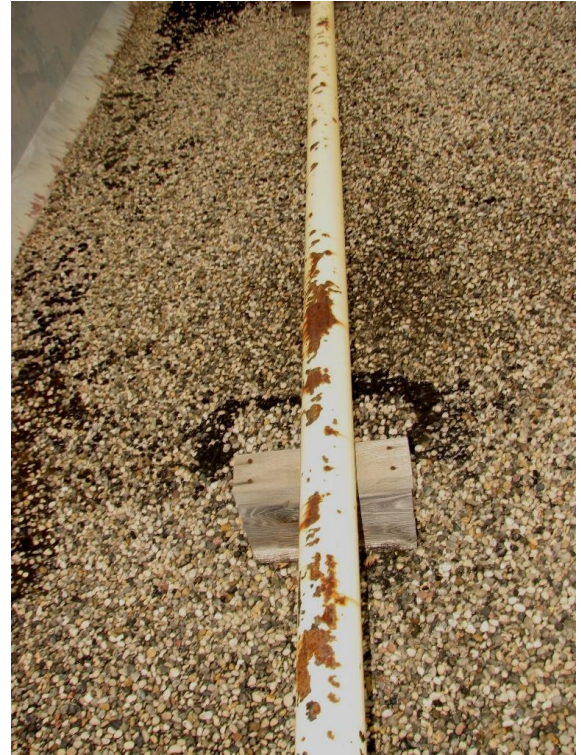
4" Gas lines enters the School via the Gas Metering Room on the South East corner of the School. A 3" gas line runs along the roof to the Portable Pods to provide gas to the furnaces, gas line is corroded and needs replacement.

Gas line is rusted.

Rusted gas line

Need replacement and ensure gas line is painted to protect from environment.

<u>Type</u>	<u>Year</u>	<u>Cost</u>	<u>Priority</u>
Preventative Maintenance	2008	\$9,650	Low

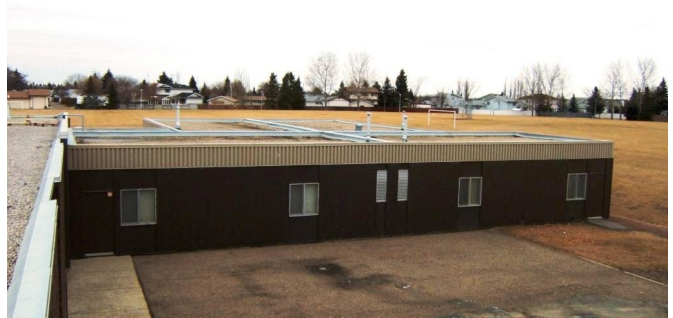
Green and tack boards are located in all units.
 Stained wood shelving with plastic laminated counter tops make up fixed casework.

Overall units in acceptable condition

<u>Rating</u>	<u>Installed</u>	<u>Design Life</u>	<u>Updated</u>
4 - Acceptable	1982	0	MAR-08

Exterior view of portable classrooms.

Mechanical and Electrical: Replace 4 furnaces and controls for a total of \$22,000

Event: Replace furnaces in all four portables

<u>Type</u>	<u>Year</u>	<u>Cost</u>	<u>Priority</u>
Lifecycle Replacement	2012	\$25,168	Unassigned

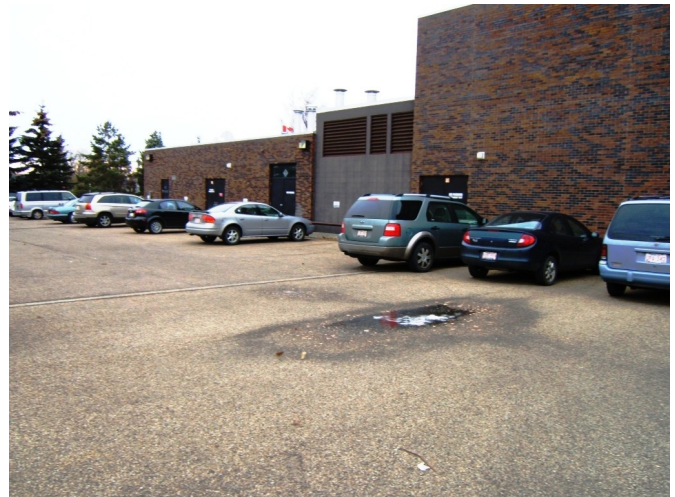
Catch basin repair cost included in replacement cost.

<u>Rating</u>	<u>Installed</u>	<u>Design Life</u>	<u>Updated</u>
4 - Acceptable	1981	25	MAR-08

Event: Replace 950 sq M (Flexible Paving Parking Lots(Asphalt)**

<u>Type</u>	<u>Year</u>	<u>Cost</u>	<u>Priority</u>
Lifecycle Replacement	2012	\$108,680	Unassigned
