RECAPP Facility Evaluation Report

Edmonton School District No. 7

Meyokumin School

B3220A
Edmonton

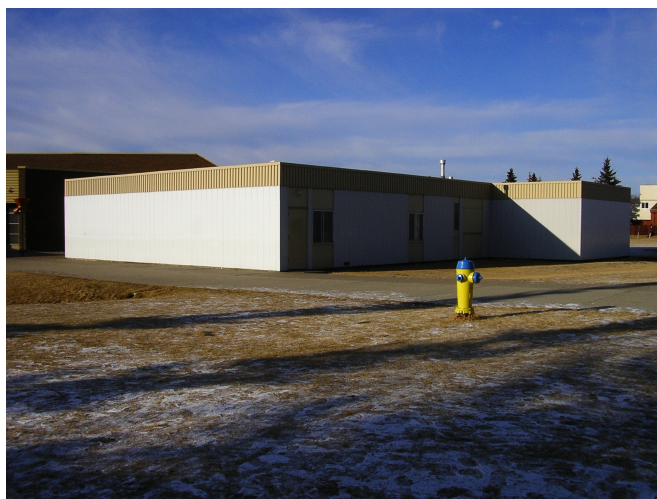
1982 portable class rooms

The built up roof is original and is deteriorating with pooling and bleeding of asphalt.

A Type B roof vent to the furnace in portable classroom 148 is crushed and possibly restricted although no down drafting was noted at the time of inspection.

Replace roof with SBS. Cost \$52,000

Replace Type B vent. Cost \$1000

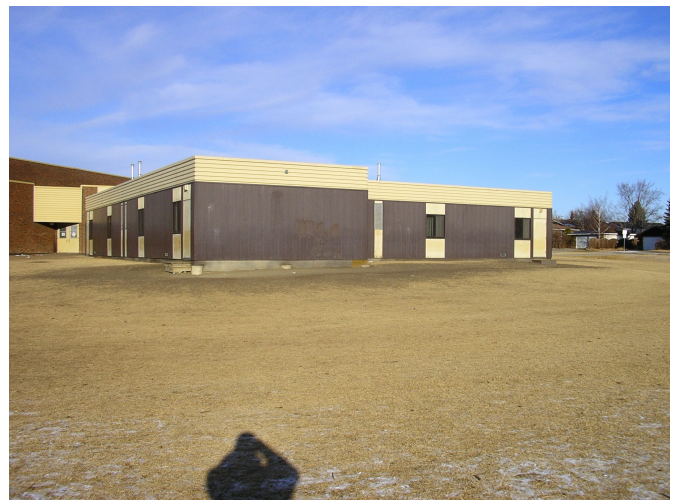
1983 portable class rooms

The built up roof is original and is deteriorating with pooling and bleeding of asphalt.

Replace roof with SBS.

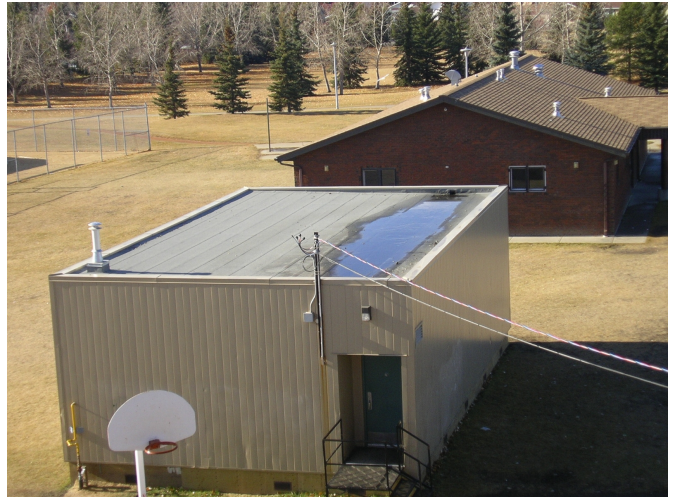
2000 portable class room

The deficiencies of this class room are:

Painted gypsum board walls are damaged and require repair and repainting:

T-bar ceilings are damaged and require repair:

Repair 100m2 wall: Cost \$1,000

Replace 80m2 acoustic tiles: Cost \$3,000
