RECAPP Facility Evaluation Report

Edmonton School District No. 7

Meyonohk Elementary School

B3221A
Edmonton

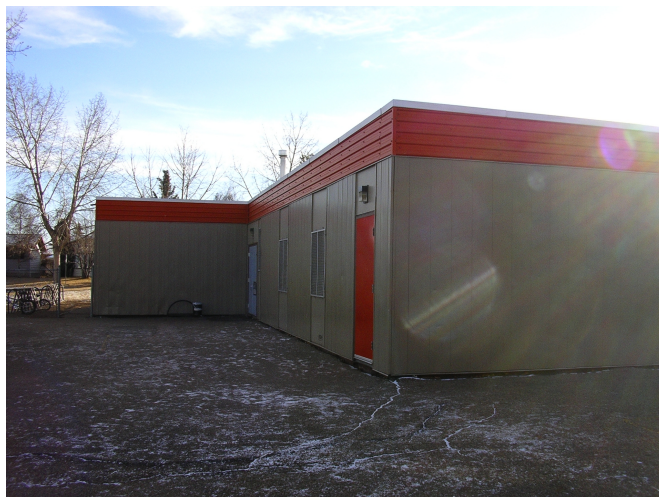
Meyonohk School 108.jpg

The metal siding is damaged, appears unsightly and requires repair.

The roof is original and has deteriorated with bleeding of asphalt through the gravel finish.

The exterior ply panels have deteriorated and require replacement.

Refinish and repair 400m2 damaged metal siding: Cost:
\$15,000

Replace 300m2 roofing with SBS: Cost:
\$35,000

Replace 4m2 wood deck: Cost:
\$1,000

Replace 20 painted exterior ply panels (1200mm x 1200mm):
Cost: \$15,000

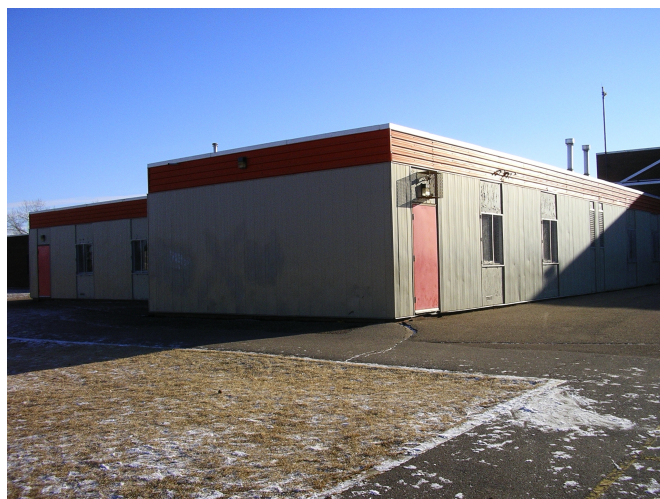
Meyonohk School 090.jpg

The metal siding is damaged, appears unsightly and requires repair.

The roof is original and has deteriorated with bleeding of asphalt through the gravel finish.

The exterior ply panels have deteriorated and require replacement.

Refinish and repair 400m2 damaged metal siding: Cost:
\$15,000

Replace 300m2 roofing with SBS: Cost:
\$35,000

Replace 20 painted exterior ply panels (1200mm x 1200mm):
Cost: \$15,000
