RECAPP Facility Evaluation Report

Edmonton School District No. 7

Minchau School

B3225A
Edmonton

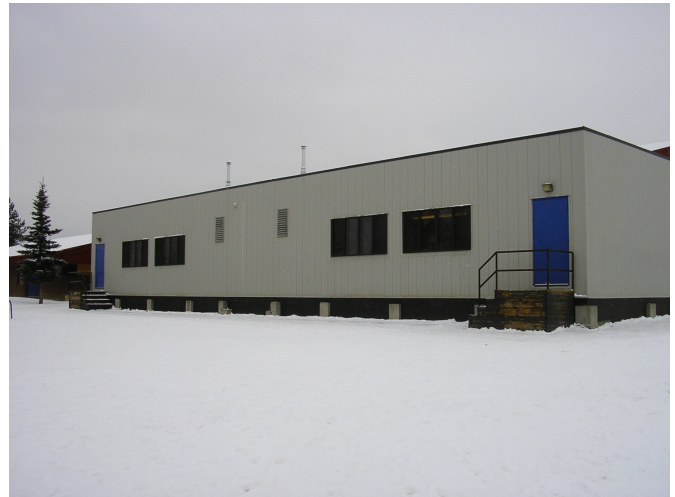
1998 Portable Classroom Pod

The roof has deteriorated, is pooling and bleeding asphalt.

The roof will deteriorate further with potential damage to interior of school.

Replace roof.

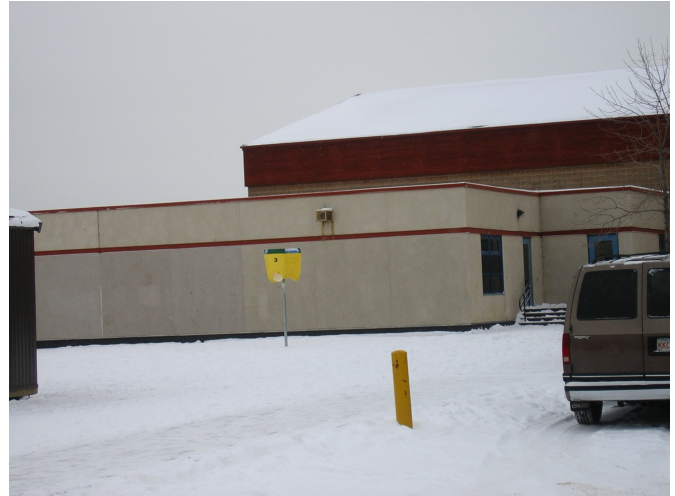
1992 portable classroom pod

There is damage and cracking in the exterior stucco.

Stucco will deteriorate further.

Repair and make good damaged and cracked stucco.
