# **RECAPP Facility Evaluation Report**

**Montrose Elementary School**

B3226A  
Edmonton

**Evaluation Company:** Robert Irlam Consulting Inc.  
**Evaluation Date:** December 13 2007  
**Evaluator Name:** J. R. Irlam

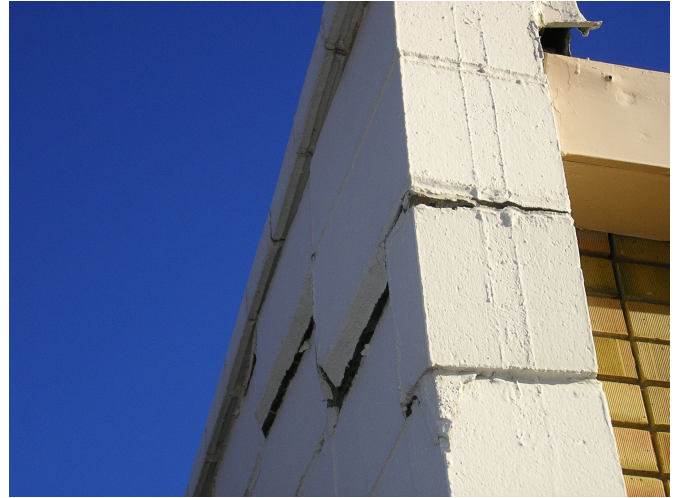
Montrose School 017.jpg

**Event: Replace two 200mm masonry walls (200m2 block work)****Concern:**

There is movement at the top of the exterior concrete block wall on the north west corner of the 1956 section of the school. An October, 2007, consultant's review of the structure observed that "at both the high roof and the low roof approximately where the roof joists bear in the wall, the masonry appears to be cracking at the horizontal mortar joints." The review recommended the removal and replacement of the masonry walls in question.

Walls will deteriorate further and risk of failure will persist.

Replace cracked masonry walls.
