RECAPP Facility Evaluation Report

Edmonton School District No. 7

Northmount Elementary School

Evaluation Company: Kenneth M. Lee Architect
Evaluation Date: November 30 2007
Evaluator Name: Ken Lee

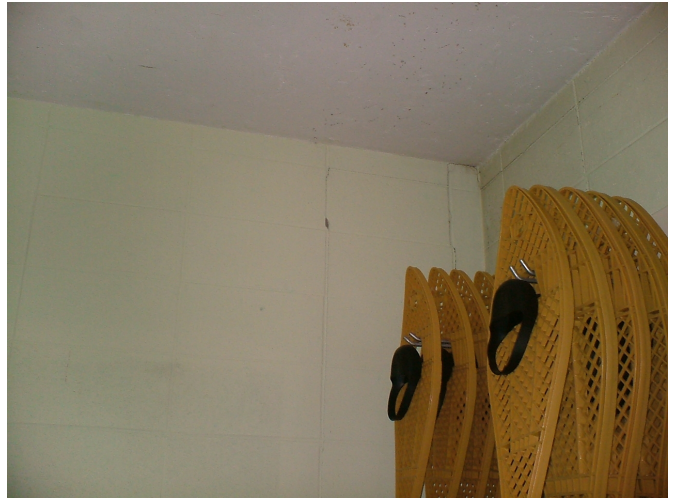
There are a lot of cracks in the concrete blocks walls in the gymnasium, gym storage room and shelter room. The floors along the west exterior walls in the gymnasium and shelter room slopes down towards the exterior walls.

Cracks on the concrete block wall in the gym storage room.

Cracks in concrete block walls in the gymnasium, gym storage room and shelter room. The floors in the gymnasium and shelter room along the west exterior walls slopes down towards the exterior wall. It might be due to soil settlement.

Conduct repairs as recommended by study results. Cost estimate is based on repairing 3 failed piles.

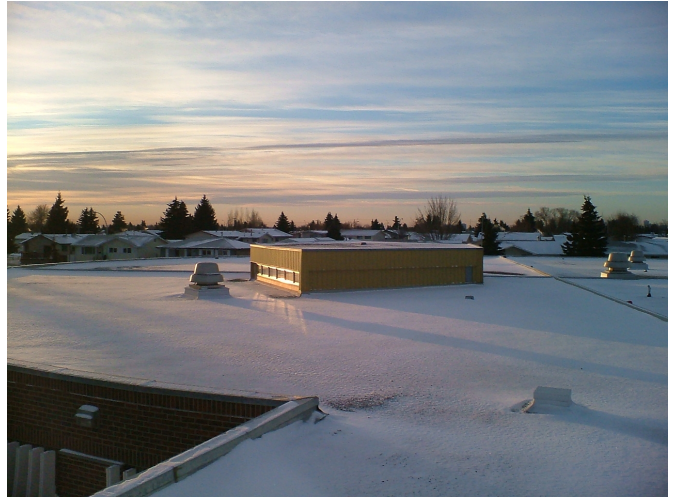
Prefinished aluminum sidings on exterior walls above the library.

Event: Replace aluminum sidings. (300.00 sq.m.)

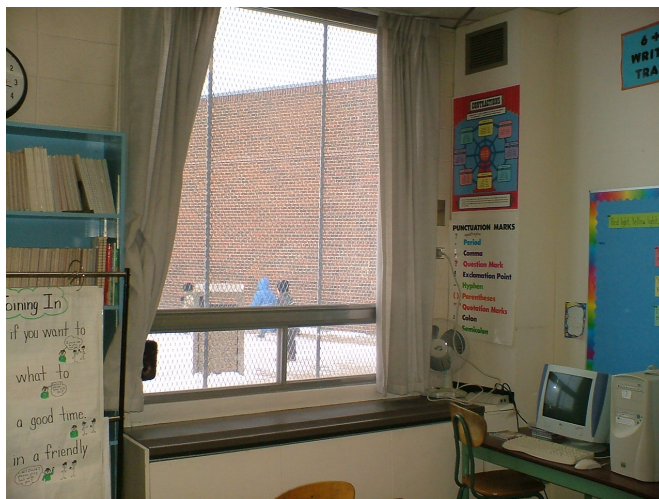
Aluminum window for classroom.

Event: Replace aluminum windows. (38)

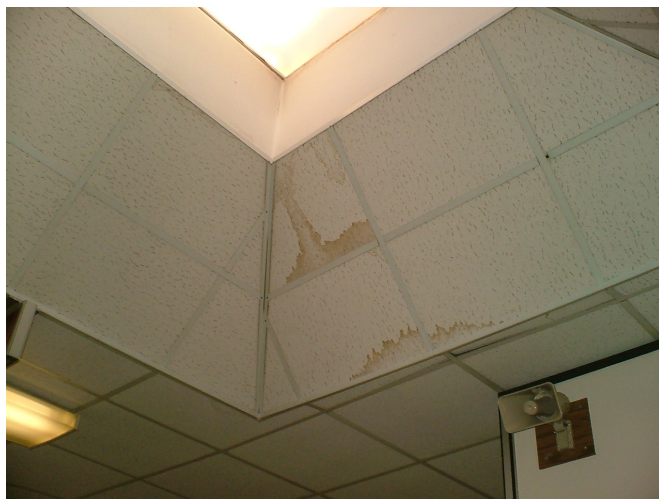
Three plastic doom skylights. The size for each skylight is 1200 mm x 1200 mm. There are water stains on some ceiling tiles below the skylights.

Water stains on ceiling tiles below the skylight.

There are water stains on the ceiling tiles below the skylights.
The sealers for the skylights are worn out.

Event: Re-seal the skylights. (3)**Concern:**

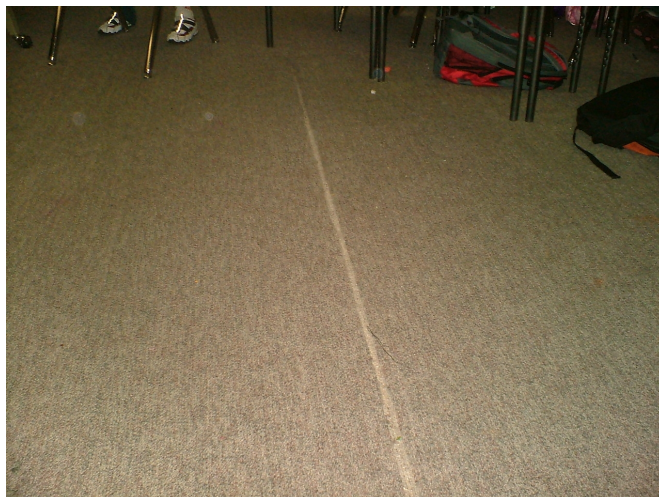
Carpets in most areas are worn out. A lot of carpets in classrooms have open seams.

Carpet in a classroom.

Carpets in most of the areas are worn out. A lot of carpets in the classrooms have open seams. Trip hazard.

Replace the carpet.

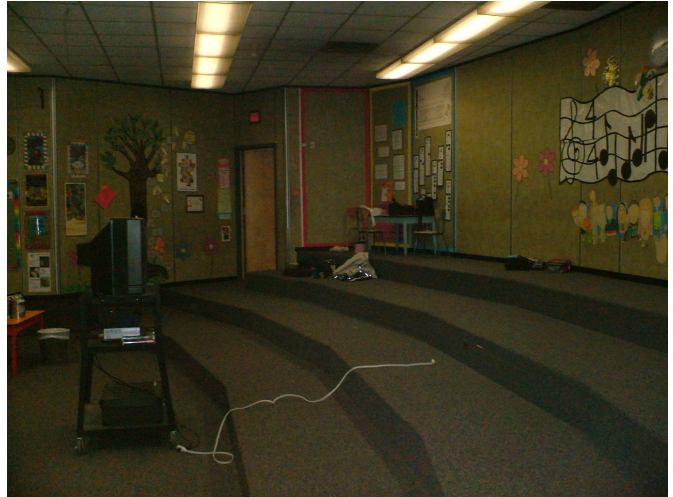
Barrier free access to all areas except to the stage in gymnasium, stage in music room, floor level in music room, mezzanine above gym storage room and mezzanine above phy. ed. office.

The handicapped cannot go to the floor level in the music room.

Event: Install a wheelchair lift and 2 ramps.

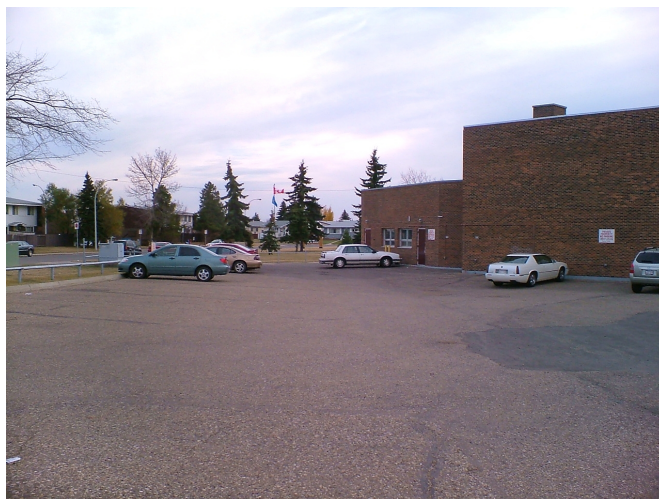
Asphalt paved parking lot accessed from 88A Street with 28 stalls for staff, visitors and the handicapped. There are pot holes and cracks in the parking lot.

Asphalt paved parking lot.

Event: Repair asphalt pavement. (285.00 sq.m.)**Concern:**

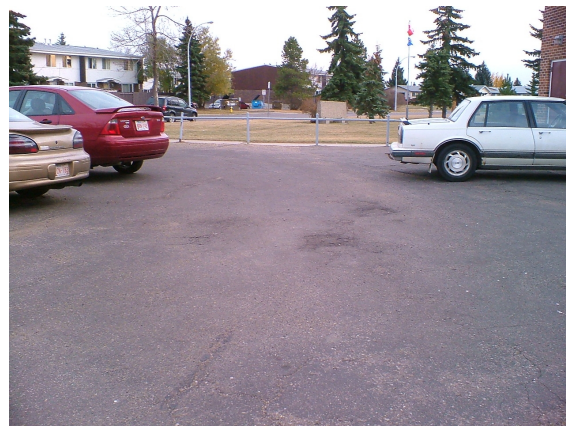
Pot holes and cracks in parking lot.

Event: Repave parking lot. (1,140.00 sq.m.)

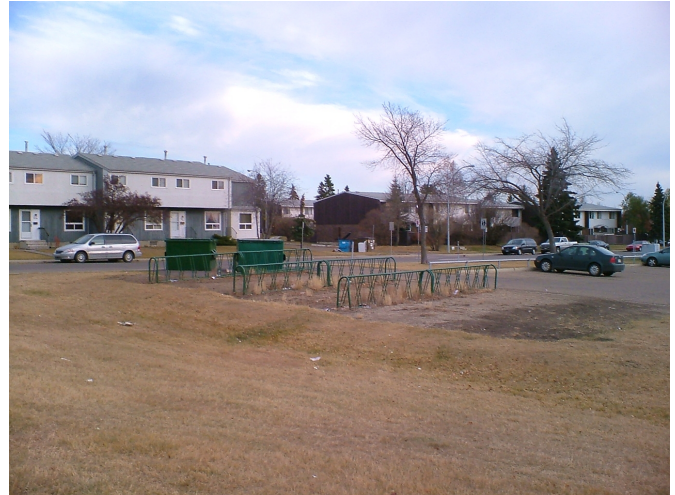
Most of the gravels of the gravel pavement at the bike rack area are gone.

Gravel pavement at bike rack area.

Event: **Repave gravel pavement with asphalt pavement.**
(74.50 sq.m.)

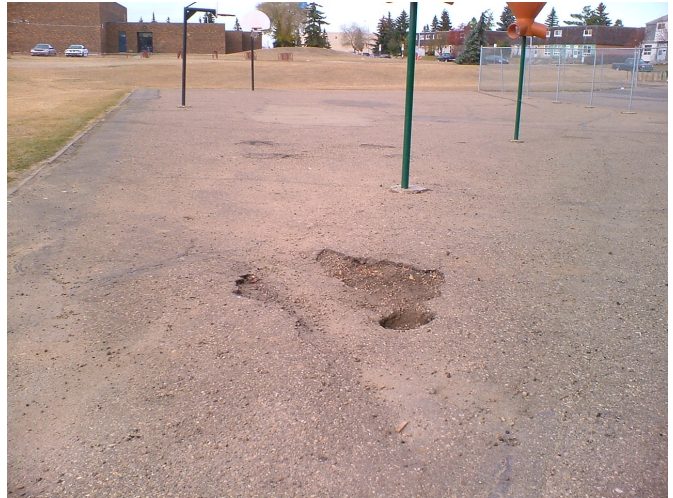
The asphalt pavement is cracking and breaking up in a number of areas. It also has a lot of pot holes.

Asphalt pavement with cracks and pot holes.

Event: **Repave the asphalt pavement. (910.00 sq.m.)**
