RECAPP Facility Evaluation Report

Edmonton School District No. 7

Norwood Elementary School

B3234A
Edmonton

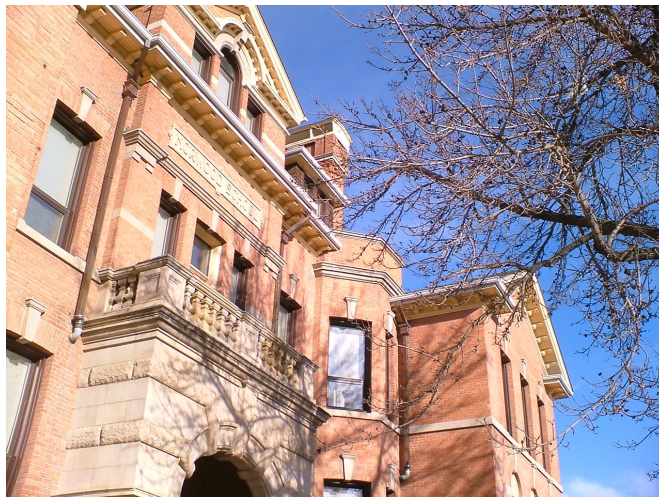
An exterior balcony above the main entrance.

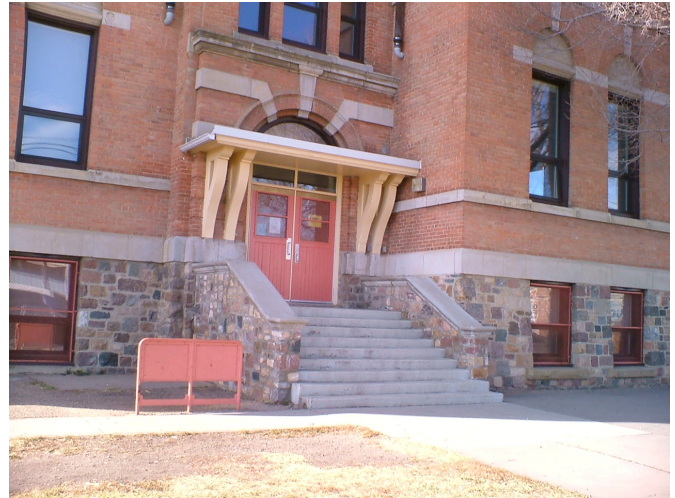
Main entrance has an exterior balcony with concrete floor supported by masonry walls for canopy.
East entrance has a wood canopy supported by wood frame structure mounted on exterior wall.

Wood canopy of east canopy.

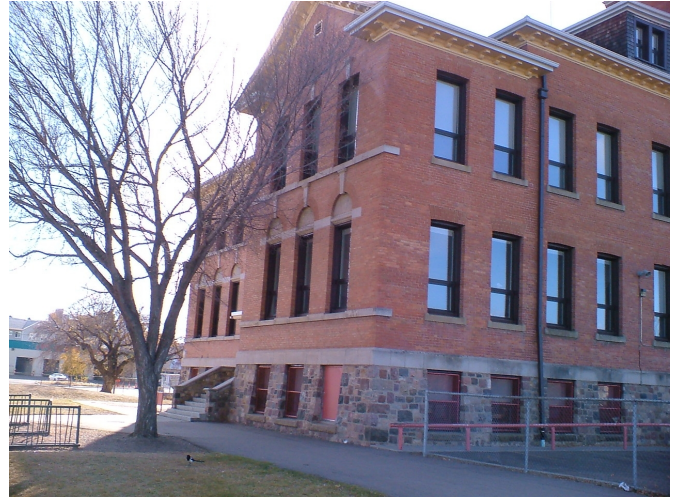
1908 - Brick masonry and stone masonry walls.

1908 building has brick masonry and stone masonry exterior walls.

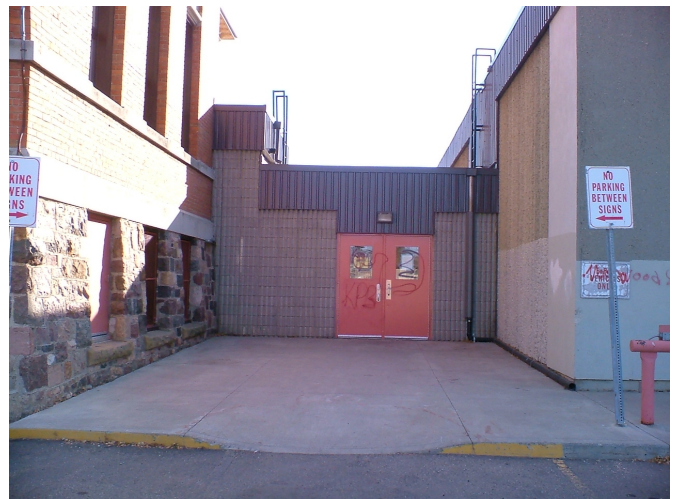
1971 - Concrete block walls and stone masonry wall for the vestibule between the gymnasium and 1908 building.

North exterior wall of the connection between the gymnasium and 1908 building.

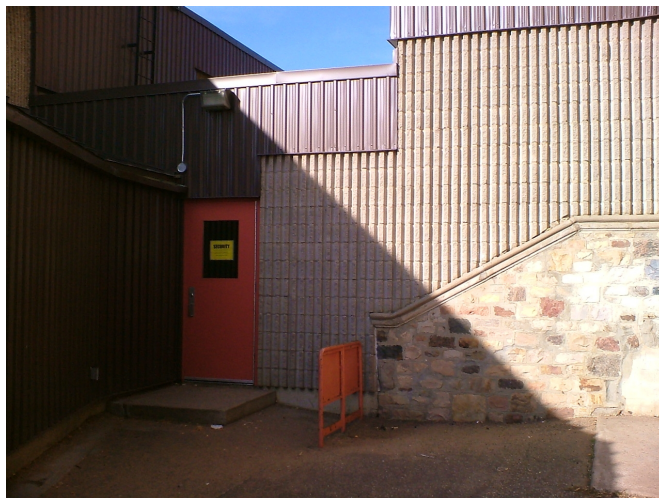
The south exterior wall of the connection corridor between the gymnasium and the 1908 building.

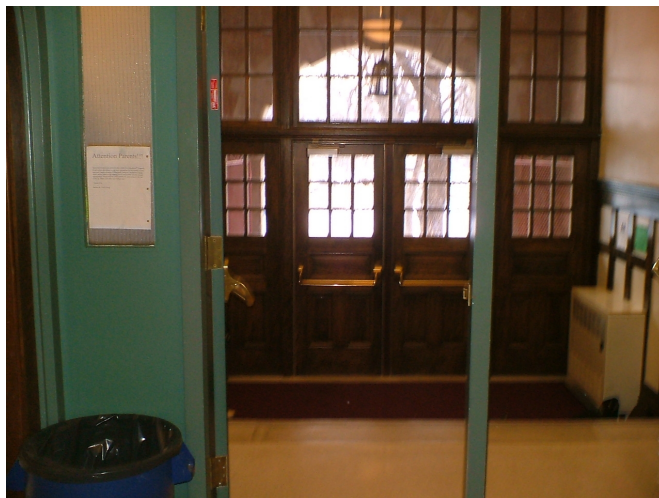
1908 - It has wood entrance doors in wood frames for main entrance, east entrance and balcony entrance on 2nd floor. Installed in 1908 and refinished in 1999. These are the original 1908 classical wood doors and were refinished in 1999. Retain for the style and historical value.

Wood entrance door for main entrance.

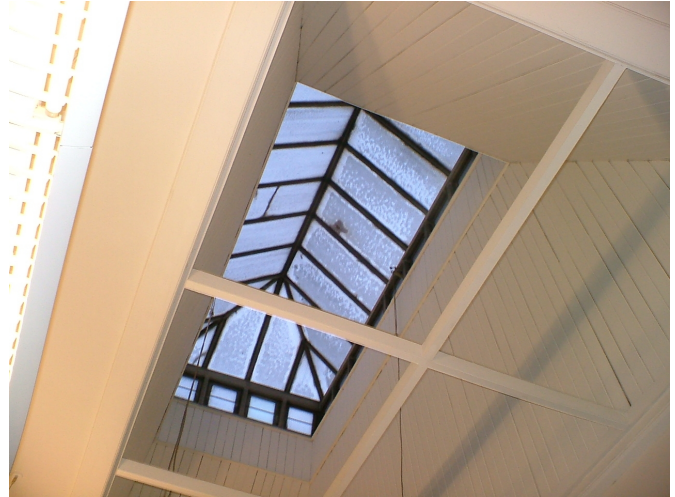
1908 - One metal frame skylight.

Skylight.

Event: Replace 1 skylight.

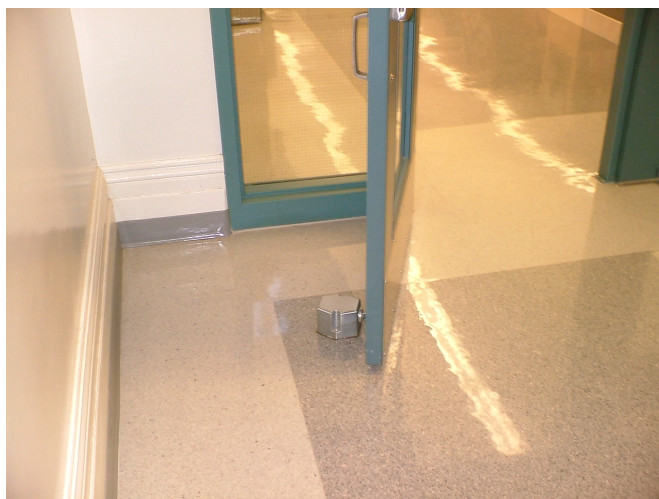
1908 - Solid core wood doors and hollow metal doors in pressed metal frames throughout. Installed in 1999. The classroom doors, library doors and corridor doors at stair # 1 and stair # 2 have magnetic door holders.

The library at stair # 1 has magnetic door holder.

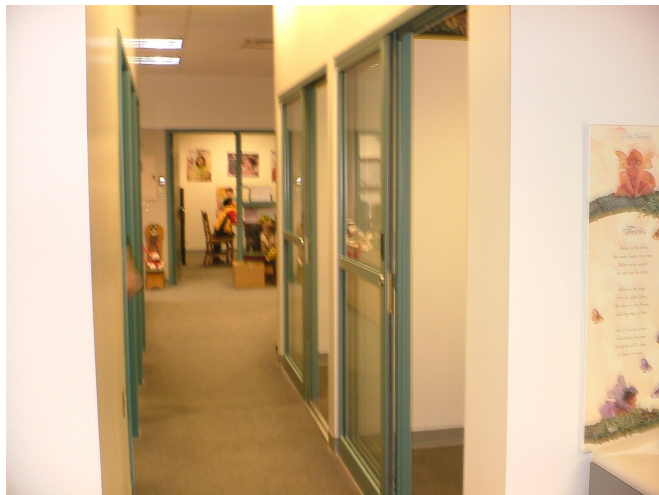
Two aluminum glass sliding doors for 2 quiet rooms in the administration office on main floor.

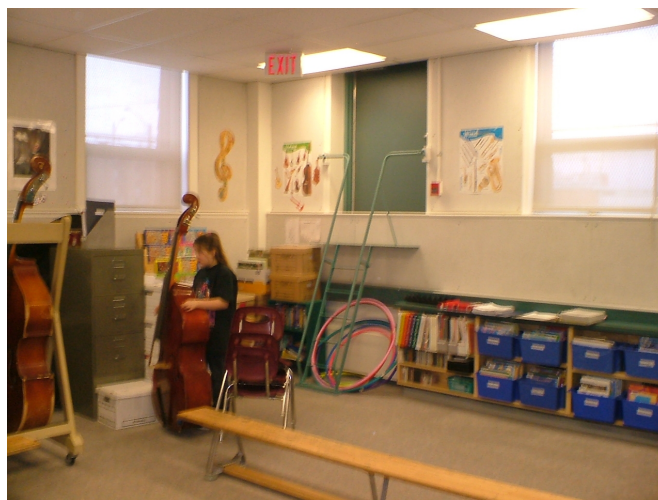
There are 4 basement classrooms have a steel framed ships ladder type stair to an exit door. Installed in 1999.

A steel framed ships ladder type stair to an exit door in a basement classroom.

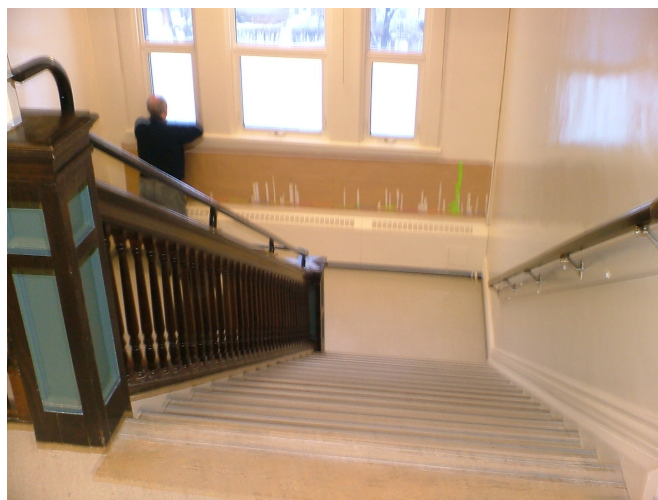
1908 - Wood balustrades with steel tube handrails mounted on top of the wood handrails in stair # 1 and stair # 2. Steel balustrades with steel top rail for the small stage in the library on 3rd floor.

Stair # 2 in the 1908 building.

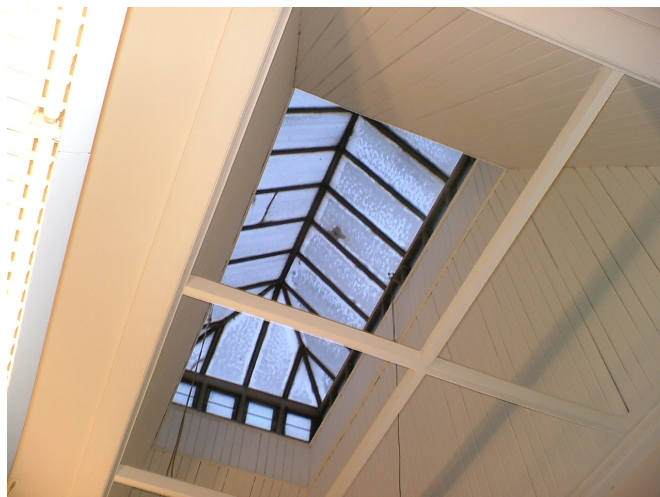
1908 - Painted wood panels on walls at skylight opening.

Wood panels on walls at skylight opening.

Event: Replace wood panels. (60.00 sq.m.)

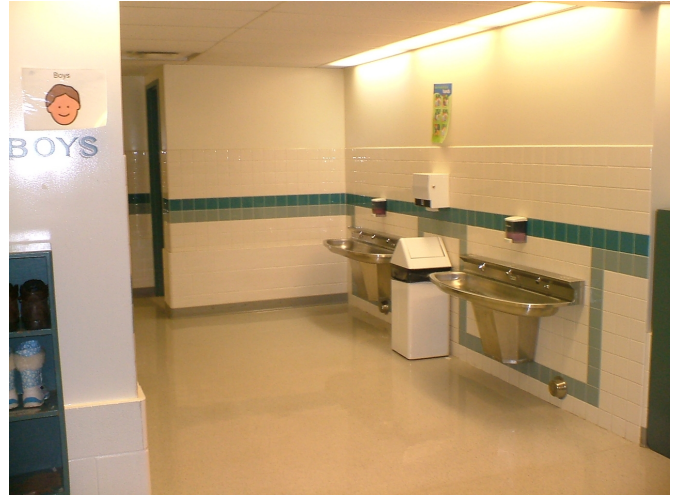
1908 -Ceramic wall tiles in boy's washrooms, girl's washrooms, staff washrooms and janitor rooms. Installed in 1999.

Boy's washroom in the basement.

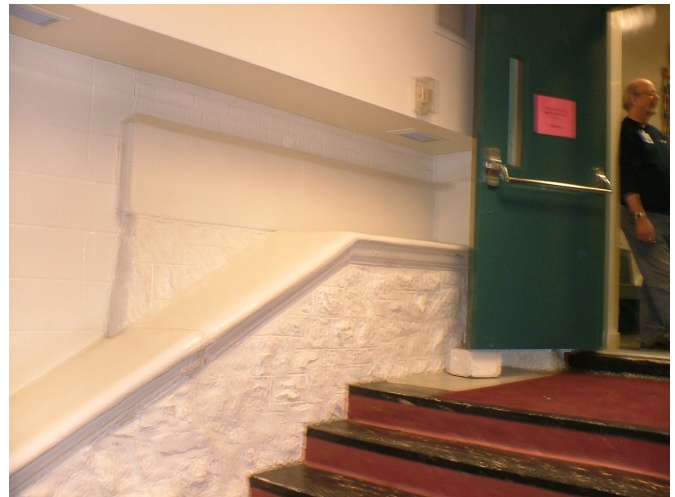
The stair with stone facing wall finish in the vestibule of the 1971 addition. This stair was constructed in 1908 for an exterior stair of the 1908 building.

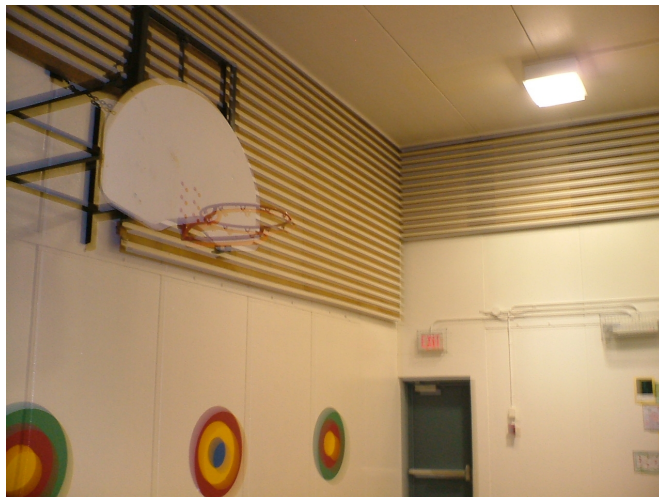
1971 - Acoustic wall panels in gymnasium. Installed in 1999.

Acoustic wall panels in gymnasium.

Event: Replace acoustic wall panels.

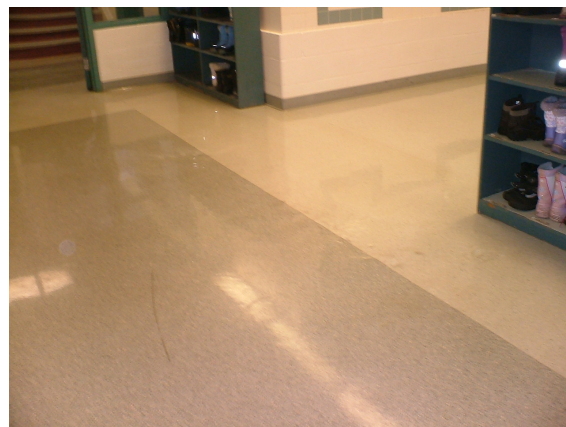
Some vinyl sheet flooring in the basement corridor has uplifted with a lot of bubbles. Trip hazard.

The vinyl sheet flooring in the basement corridor has uplifted with a lot of bubbles.

Replace the uplifted vinyl sheet flooring in the basement corridor.

Event: Replace vinyl sheet flooring. (35.00 sq.m.)**Concern:**

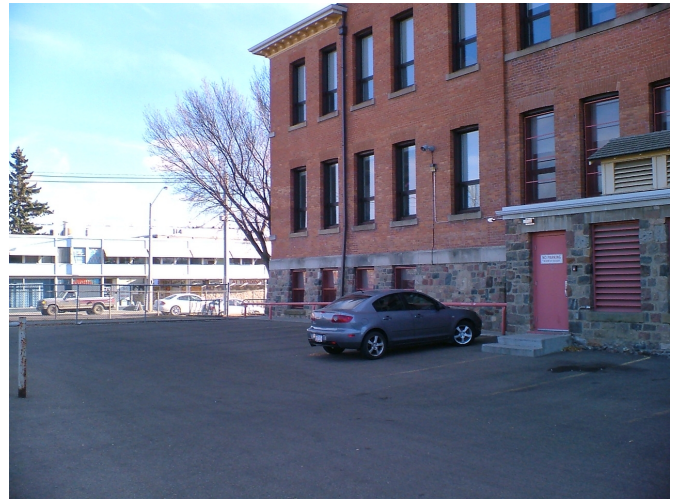
Asphalt paved parking lot on the north side of the school with 19 stalls for staff and 1 for handicapped. Asphalt paved parking lot on the west side of the school for visitors.

North parking lot.

Event: Repave parking lot. (1,380.00 sq.m.)

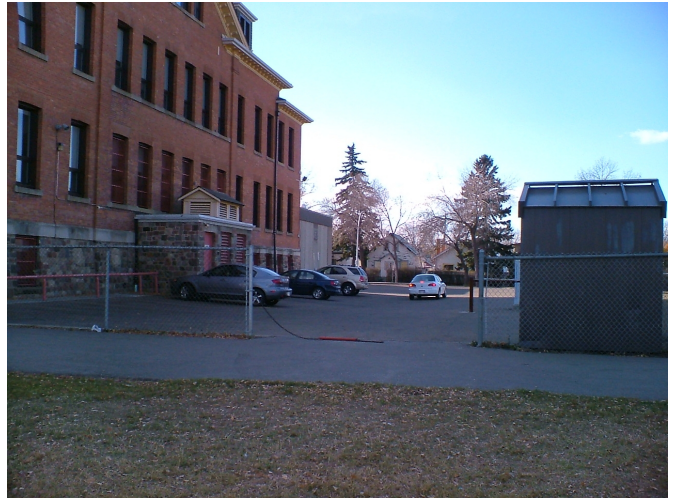
Steel guard rails on steel guard posts for the parking stalls in the north parking lot. A steel chain for the opening in the chain link fences at the east end of the north parking lot. Steel guard rails and a steel post gate on steel guard posts for the transformer in the north parking lot.

A steel chain for the opening in the chain link fences at the east end of the north parking lot.

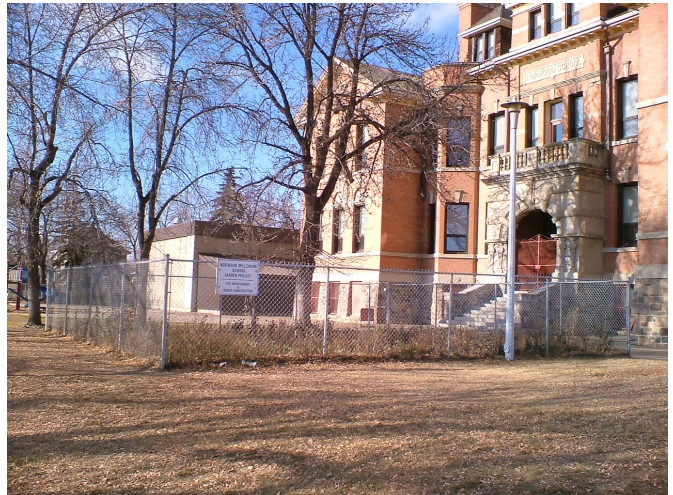
A garden with chain link fences and a chain link fence gate on south lawn.
