# **RECAPP Facility Evaluation Report**

### **Ormsby Elementary School**

B3238A  
Edmonton

**Evaluation Company:** Lotus Architecture  
**Evaluation Date:** November 16 2007  
**Evaluator Name:** Tonu Mitra

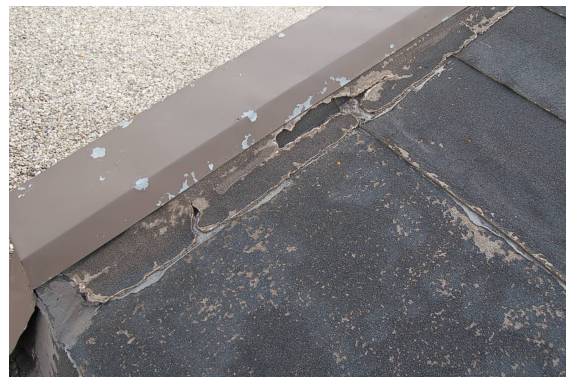
The original membrane roofing on the sloped section has deteriorated. It is torn along roof edges and has delaminated, bubbled and curled.

Torn and deteriorated membrane on the roof of clearstory well structure.

Replace membrane roof on the sloped portion of clearstory window with 2 ply SBS membrane roofing.
