RECAPP Facility Evaluation Report

Overlanders Elementary School

B3243A
Edmonton

Evaluation Company: Francis Ng Architect Ltd.
Evaluation Date: October 18 2007
Evaluator Name: Francis Ng

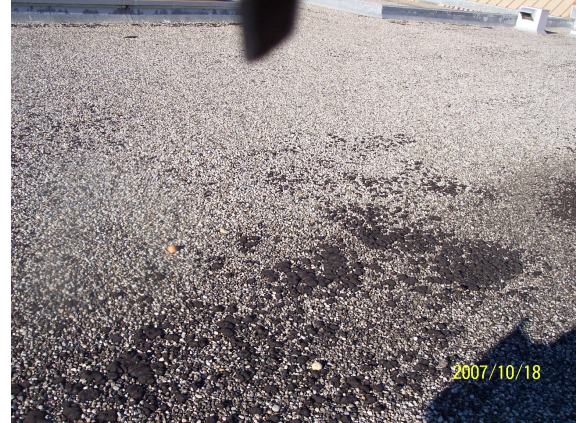
The original built-up roofing has blisters and is worn out.

Lower roof has blisters along South corner.

Replace built-up roofing. (approx. 3,000 square metres)

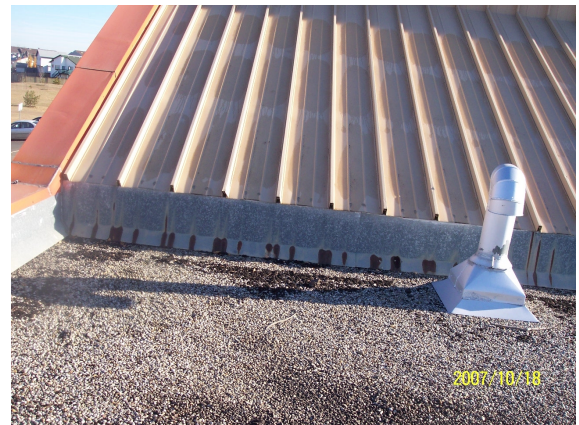
Sheet metal roof - does not have closures and has rusty flashing base.

Replace metal sheet base and provide closures. (approx. 60 linear metres)

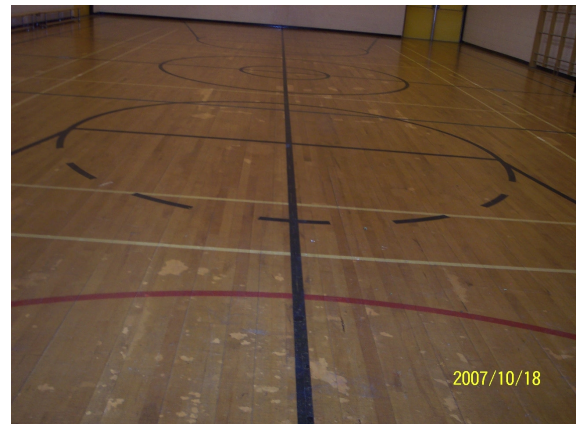
Gymnasium 135, 136 - wood flooring is worn out.

Gymnasium 13, 22 - original wood flooring has worn out.

Replace wood flooring. (approx. 485 square metres)

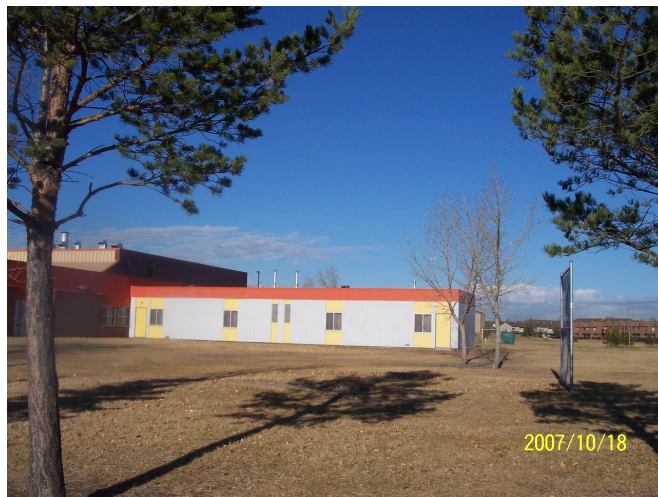
100_2061.JPG

Exterior metal siding and fascia worn out and rippled.
 Exterior wood panels below windows rotten.
 Classrooms and Corridor have stained acoustic ceiling tiles.
 Interior wood doors chipped.
 Classrooms 149, 150 - have damaged millwork.
 Classrooms have worn out carpet.
 Classrooms and Corridor - have worn out vinyl asbestos tile finishes.
 Boot racks are rusty.
 Skirting damaged.

Repair exterior metal siding and fascia. (approx. 100 square metres) \$10,000
 Exterior wood panels below windows. (approx. 6 square metres) \$6,000
 Replace Classrooms and Corridor acoustic ceiling tiles. (approx 10 square metres) \$1,000
 Repair interior wood doors. (approx. 11 doors) \$3,300
 Repair Classrooms 149, 150 millwork. (approx. 6 linear metre) \$9,000
 Replace Classrooms carpet. (approx. 430 square metres) \$64,500
 Replace Classrooms and Corridor vinyl asbestos tile finishes. (approx. 80 square metres) \$16,000
 Replace metal boot racks. (approx 3 linear metres) \$3,000
 Replace skirting. (approx. 35 square metres) \$3,500

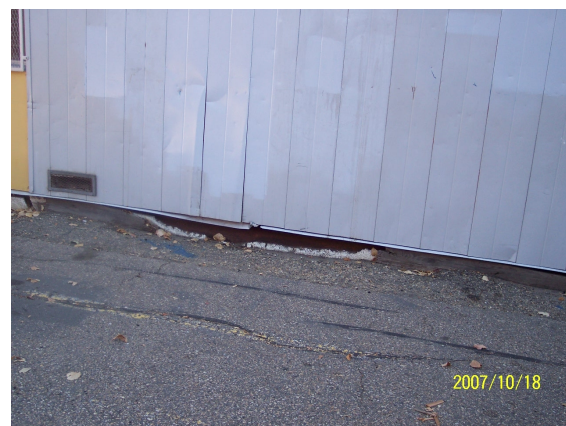
Skirting, metal siding areas damaged.

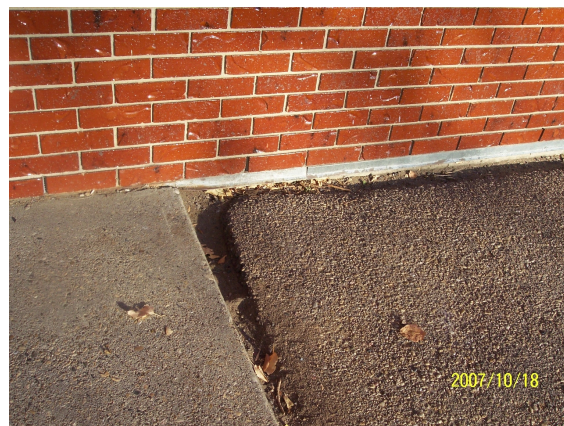
East Entrance area, Northeast of Gymnasium - outdoor basketball courts paved asphalt is cracked in several areas.

East side of building - has open gap between concrete sidewalk and paved asphalt.

Repair asphalt pavement. (approx. 250 square metres)
