# **RECAPP Facility Evaluation Report**

**Edmonton School District No. 7**

**Parkview Elementary / Junior High School**

**Evaluation Company:** Francis Ng Architect Ltd.  
**Evaluation Date:** October 19 2007  
**Evaluator Name:** Francis Ng

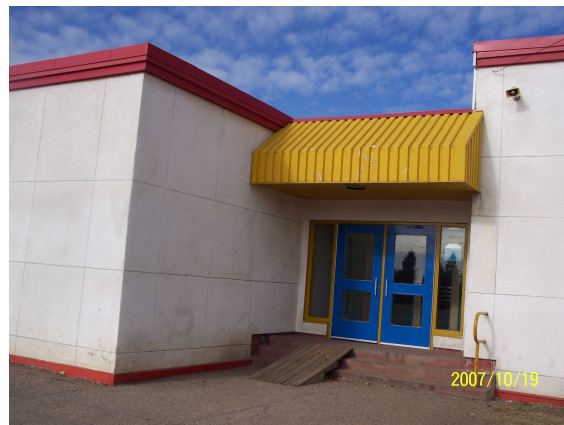
(1955) South Entrance - a wood ramp is steep and does not have proper handrails.

Replace the wood ramp. ( 1 ramp)

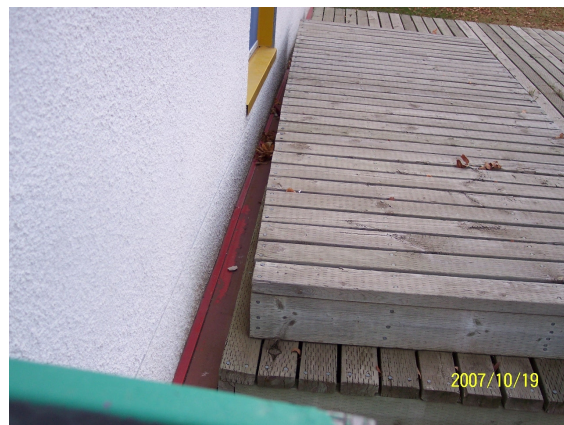
(1955) Classrooms 10, 11, 12, 13, 25, 38, 39, 49, 50, Arts 24, ECS 26 - wood decks and steps are loose and damaged.

(1955) Classroom 50 has damaged wood deck.

Repair wood deck and steps. (11 decks)

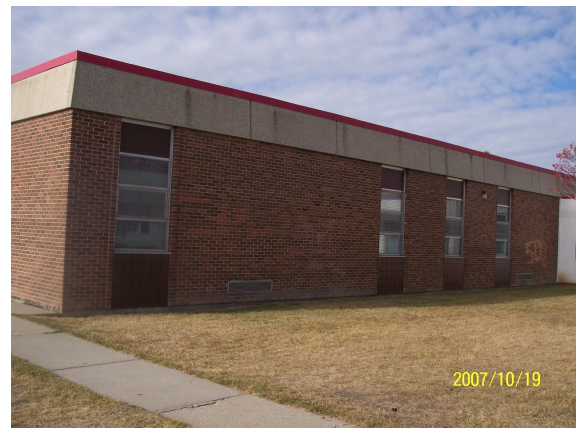
Graffiti from facing brick.  
Corners have damaged facing brick.

(1967) graffiti on facing brick.

Remove graffiti from facing brick and repair supports.. (approx. 50 linear metres)

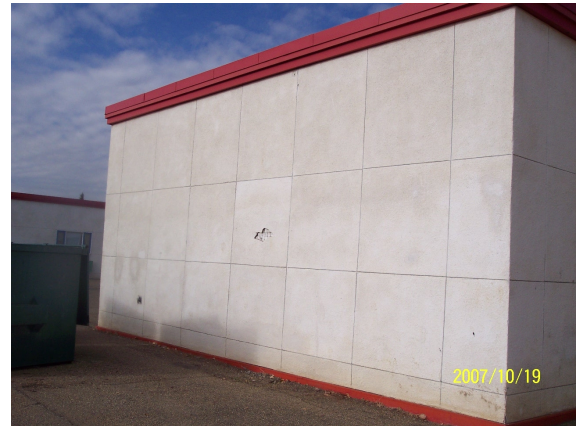
(1955) South wall of Home Economics 18 - has damaged stucco.

Repair stucco. (approx. 20 square metres)

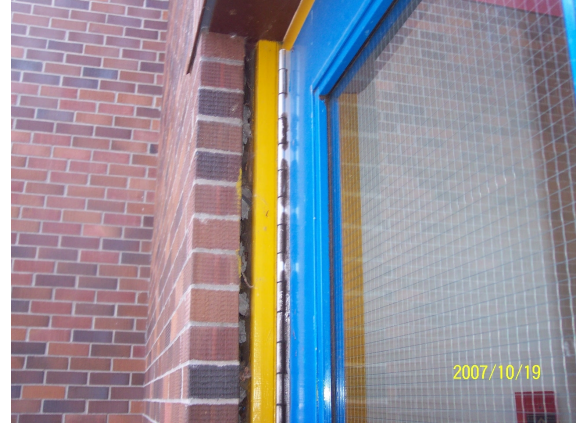
(1955) North Entrance door jamb separated from brick wall.

Repair caulking. (approx. 10 linear metres)

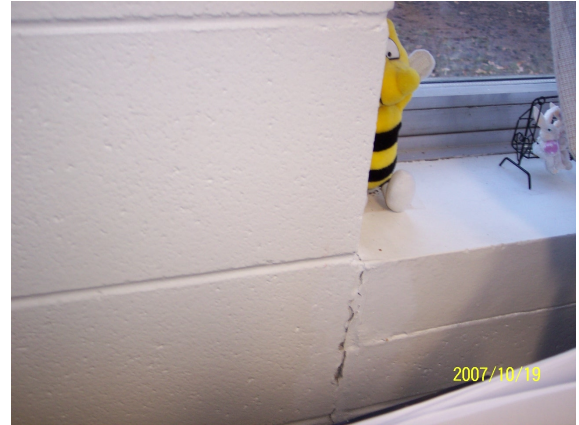
Mortar joints at window sills crack.

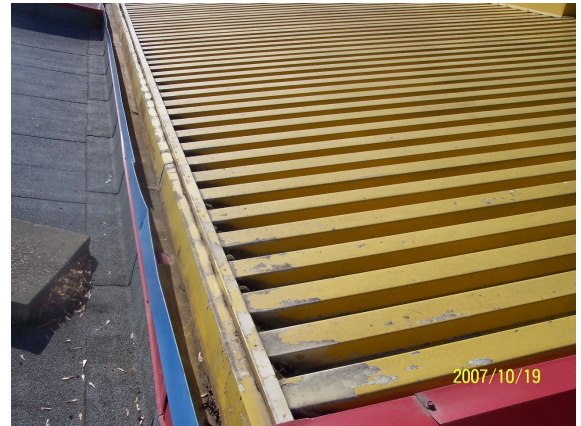
(1955) Multipurpose 6 Addition - metal standard seam roofing is damaged.

Repair metal roof. (approx. 200 square metres)

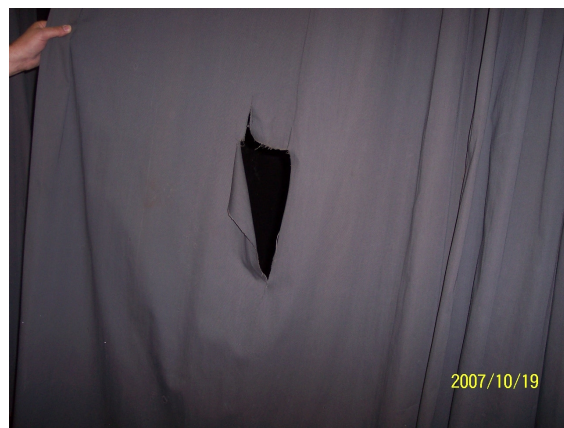
(1955) Stage 9 - stage curtains are damaged.

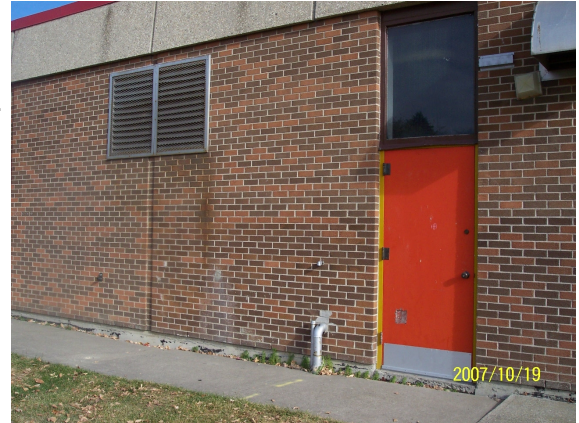
(1967) West side of building - has settlement.

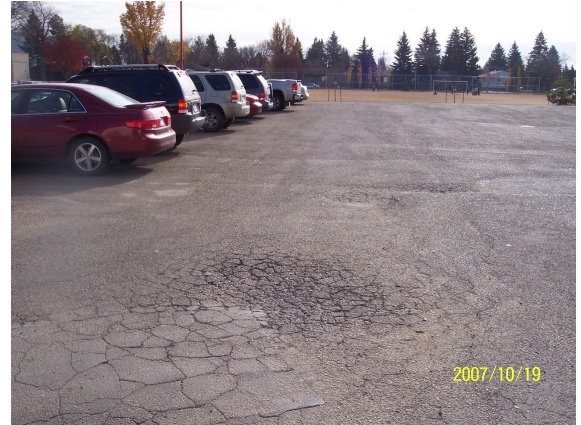
Parking lot has damaged asphalt paved spots.

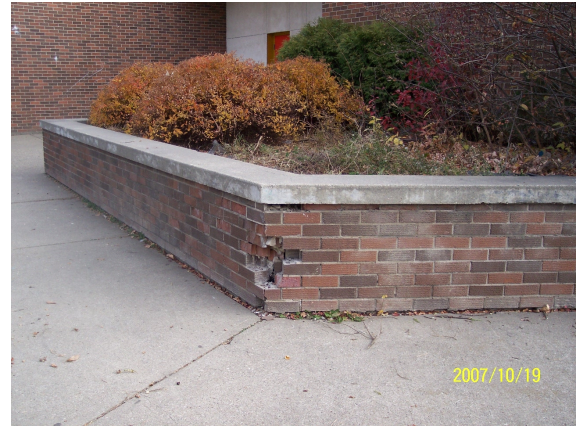
Brick planters are damaged.
