RECAPP Facility Evaluation Report

Edmonton School District No. 7

Patricia Heights Elementary School

Evaluation Company: Francis Ng Architect Ltd.
Evaluation Date: October 22 2007
Evaluator Name: Francis Ng

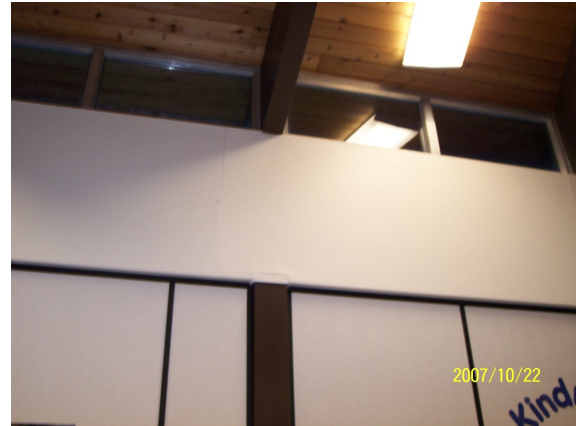
Library 29 - sloped roof - wall under sloped glulam beam sagged.

Library - sloped roof - has 64 mm T & G wood deck on glulam beams and glulam columns.

Repair column supports. (8 columns)

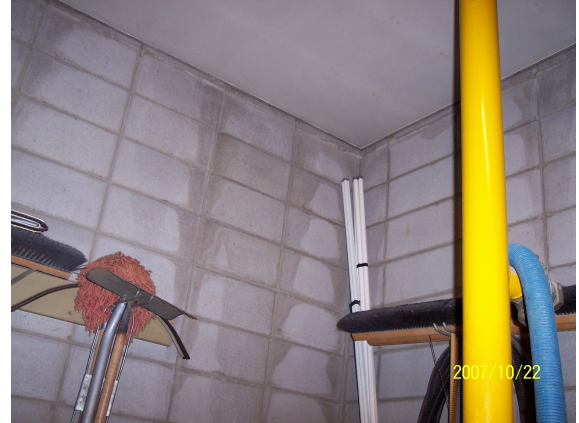
Mechanical Room 21 - has water marks on exterior concrete block walls.

Mechanical Room 39 - has water marks on exterior concrete block walls.

Repair concrete blocks. (approx. 50 square metres)

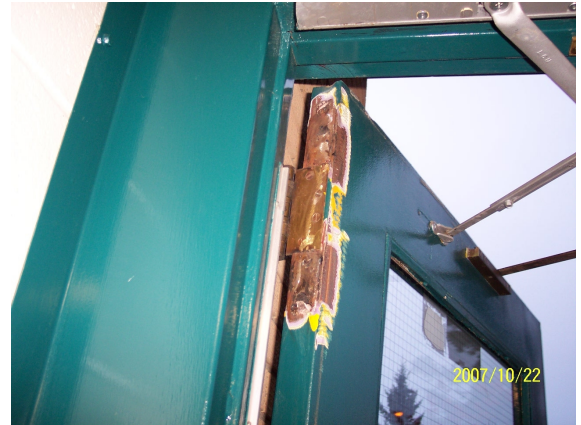
South Entrance - has damaged doors.

Replace entrance doors. (2 doors)

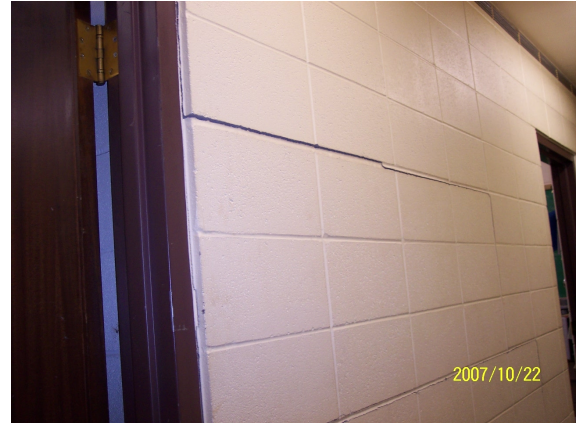
MECH 21 - has water marks on exterior concrete blocks.
Corridor outside General Storage 18, Custodian Storage 20, Office 19, General Storage 18, Staff 4, VP 3, Utility 12, Boys Washroom 15, Girls Washroom 14 - concrete blocks crack along mortar joints.

Corridor outside General Storage 36 - concrete blocks crack along mortar joints.

Repair concrete blocks. (approx. 50 square metres)

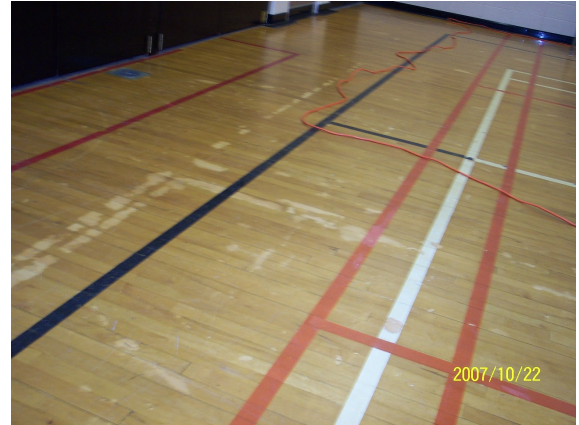
Gymnasium 39 - original wood flooring is worn out.

Replace wood flooring. (approx. 220 square metres)
