RECAPP Facility Evaluation Report

Pollard Meadows School

B3249A
Edmonton

Evaluation Company: Francis Ng Architect Ltd.
Evaluation Date: October 23 2007
Evaluator Name: Francis Ng

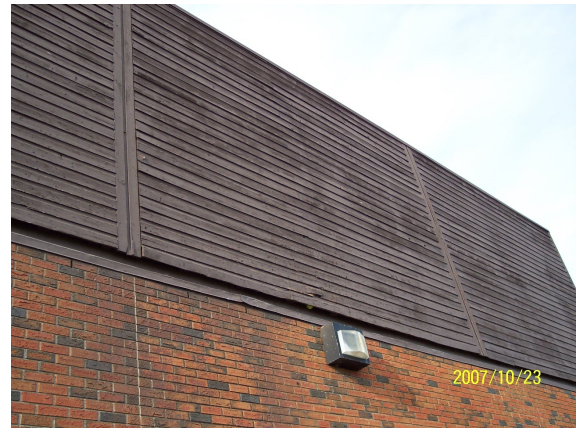
Mezzanine Mechanical Room, Library Clerestorey - cedar siding panels are worn out.

Mezzanine Mechanical Room has worn out wood siding.

Replace wood siding. (approx. 200 square metres)

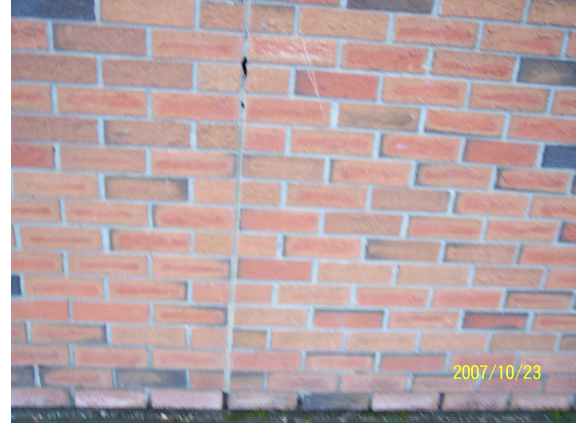
Caulking is missing.

Facing brick - expansion joint caulking is missing

Repair caulking. (approx. 60 linear metres)

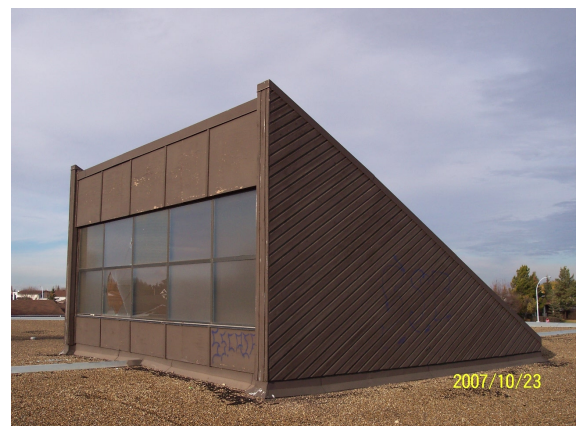
Library Clerestorey - has broken windows.

Library Clerestorey windows - have broken glasses.

Replace glasses. (approx. 4 glasses)

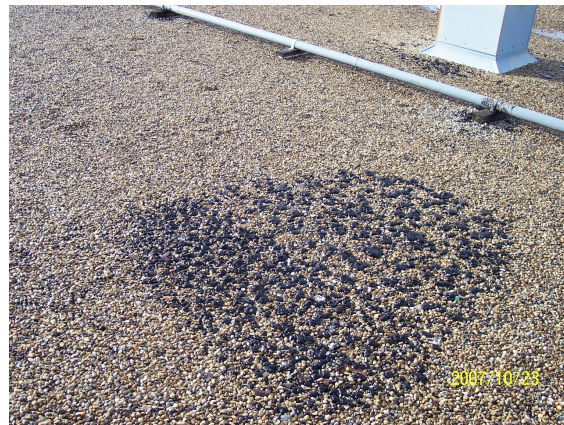
Built-up roofing has blisters.

Replace built-up roofing. (approx. 3120 square metres)

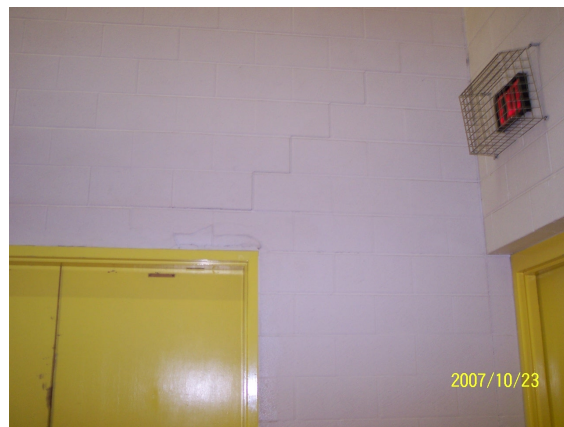
GYM 112, KIT 150, LS 146 - mortar joints crack.

GYM 128 - mortar joints crack.

Repair mortar joints. (approx 50 square metres)

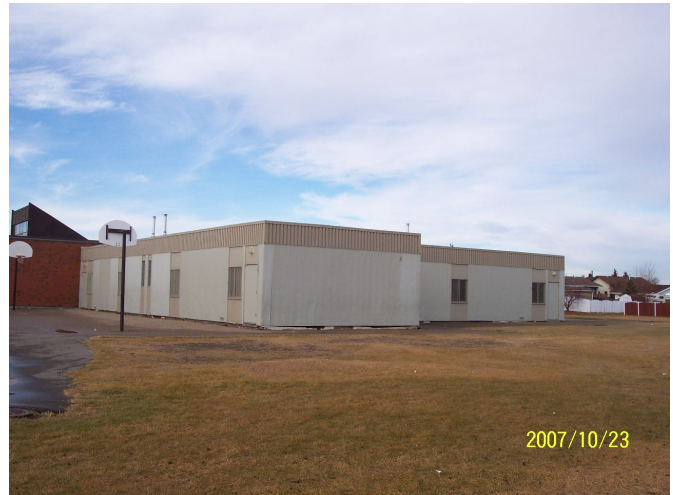
Northeast Elevation of 1982 Portables.

1. Classrooms, Storage and Corridor - have vinyl asbestos floor tiles.
2. Classroom 151 - has damaged countertop.
3. Corridor - has stained acoustic ceiling tiles.
4. Corridor - has damaged vinyl covered drywall.
5. Classrooms - original carpet is worn out.
6. Built-up roofing - has blisters.
7. Portables - have damaged metal siding.
8. Portables - have damaged wood panels under aluminum windows.
9. Portables - have damaged skirting.

1. Replace vinyl asbestos floor tiles. (approx. 200 square metres) \$40,000
2. Repair countertop. (approx. 12 linear metres) \$6,000
3. Replace acoustic ceiling tiles. (approx. 100 tiles) \$2,000
4. Repair vinyl covered drywall. (approx. 24 linear metres) \$6,000
5. Replace carpet. (approx. 200 square metres) \$30,000
6. Repair built-up roofing. (approx. 400 square metres) \$30,000
7. Replace metal siding. (approx. 280 square metres) \$42,000
8. Replace wood panels under aluminum windows. (approx. 4 windows) \$4,000
9. Replace skirting. (approx. 35 square metres) \$3500

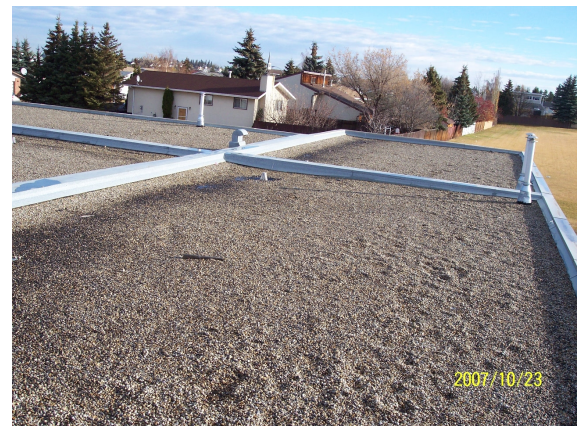
Built-up roofing has blisters.

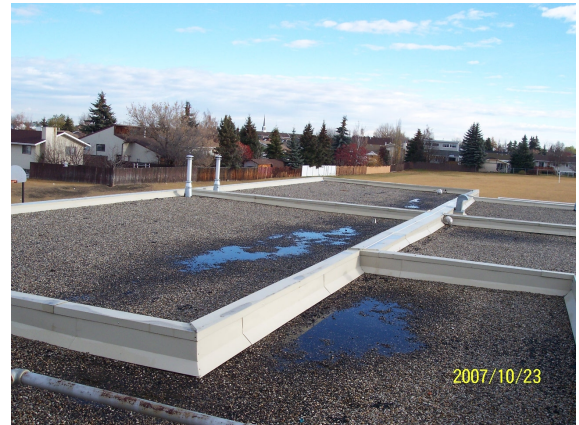
Built-up roofing has blisters.

1. Replace vinyl asbestos floor tiles. (approx. 100 square metres) \$20,000
2. Repair countertop. (approx. 12 linear metres) \$6,000
3. Replace acoustic ceiling tiles. (approx. 100 tiles) \$2,000
4. Replace carpet. (approx. 300 square metres) \$45,000
5. Repair built-up roofing. (approx. 400 square metres) \$30,000
6. Replace metal siding. (approx. 280 square metres) \$42,000
7. Replace wood panels under aluminum windows. (approx. 4 windows) \$4,000
8. Replace skirting. (approx. 35 square metres) \$3500

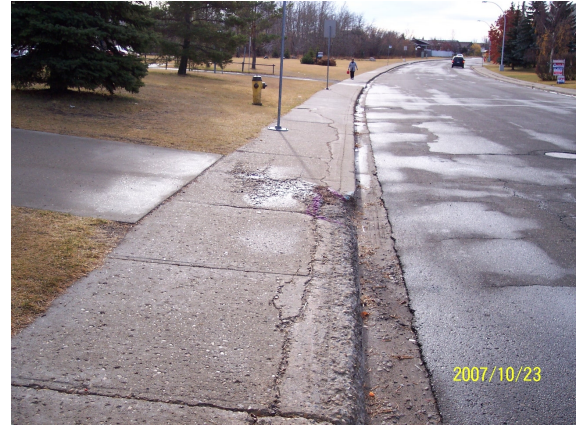
Concrete curb cut was not suitable for barrier free access.

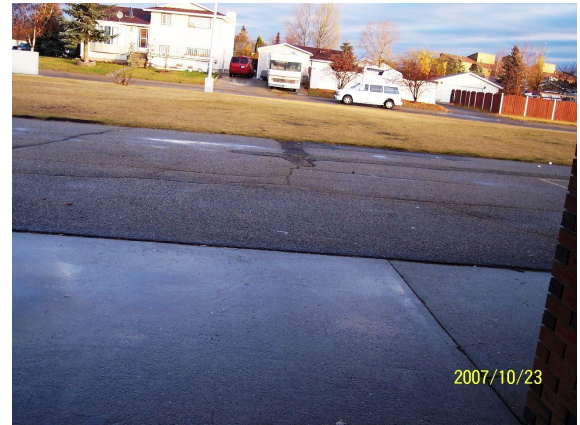
North play area - has damaged asphalt pavement.
