# RECAPP Facility Evaluation Report

Edmonton School District No. 7

**Ross Sheppard Composite High School**

B3264A  
Edmonton

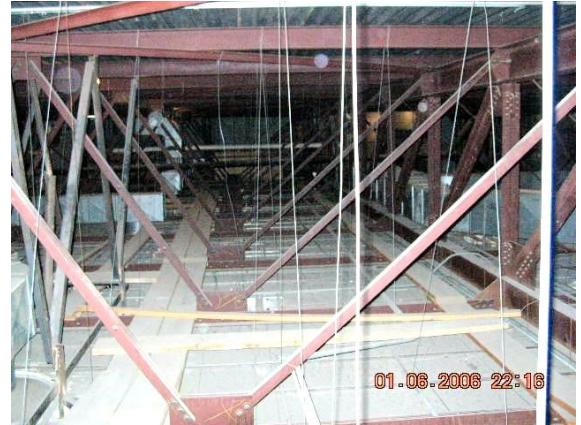
The existing catwalk does not have railings and wood planks loosely secured, pose safety hazard.

Catwalks in large Gymnasium truss spaces - loosely laid planks are unsafe.

Build new catwalks, as required to access Stage lighting and sound equipment and according to building codes. Secure catwalks to 3000mm deep steel trusses of large Gymnasium (estimate ranges from \$60,000 to \$150,000, depending on the number of catwalks required).

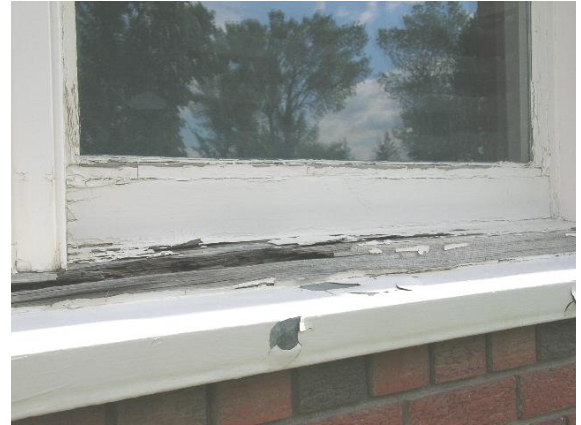
Wood windows are rotted and beyond repair. They are well past their service life. Several hopper sections have fallen and opening sealed with plywood. Several broken panes have been sealed with taped plastic sheets. These are safety concerns on second floors. Blowing snow, rain and cold air infiltration through many windows. Adjacent wall surfaces have deteriorated in some areas due to moisture. No insect screens.

Typical deterioration of wood window frames.

Replace all windows with aluminum windows, complete with sealed double glazing and awning sections with screens. Rebuild window sills. (Approximately 334 window units of various sizes).

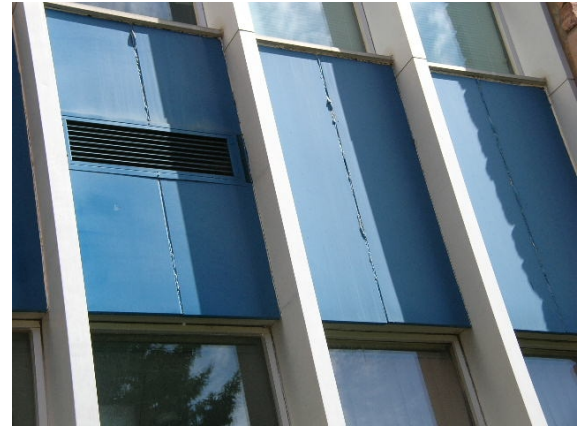
Original curtain walls in Library / Book Loft are site built from wood frame structure and is well past it's service life. Metal spandrels have started to buckle; joints opening up and colour has faded. Caulking has deteriorated. Narrow frame aluminum windows are inefficient. Cold air and water infiltration have caused some moisture / condensation damages to adjacent walls in the past. Very little insulation. No operable sections. Broken seals / condensation. Curtain wall in boxed window of Archives Room has exceeded life expectancy. Framing members are not thermally broken (condensation) and sealed units are broken.

Deteriorated panels of curtain walls and aluminum covered site built mullions.

Replace east and west curtain walls in Library \ Book Loft with new aluminum frame curtain walls, complete with sealed double glazing, with operable sections and insulated metal spandrel panels. (\$98,000).

Replace curtain wall in Archives Room box window with new thermally broken aluminum frame sections and insulating glass. (22,000).

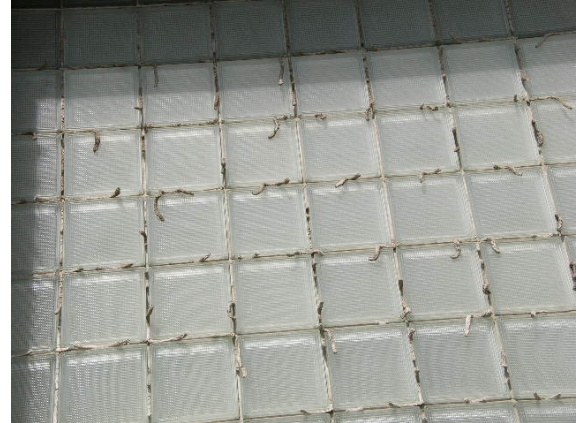
All glass blocks are original and served past their theoretical service life. Translucence of glass blocks have diminished considerably. Sealant on glass blocks on all south and west walls has deteriorated completely. Glass blocks along all of south wall have been sealed from inside with painted plywood (and heat build up may have contributed to deterioration of caulking). Several glass blocks are cracked and several others were replaced recently.

Deteriorated caulking.

Replace all glass blocks above windows with prefinished insulated metal panels (approximately 800m<sup>2</sup>). Work should be undertaken with window replacement. Repoint all other glass block joints. Replace broken units.

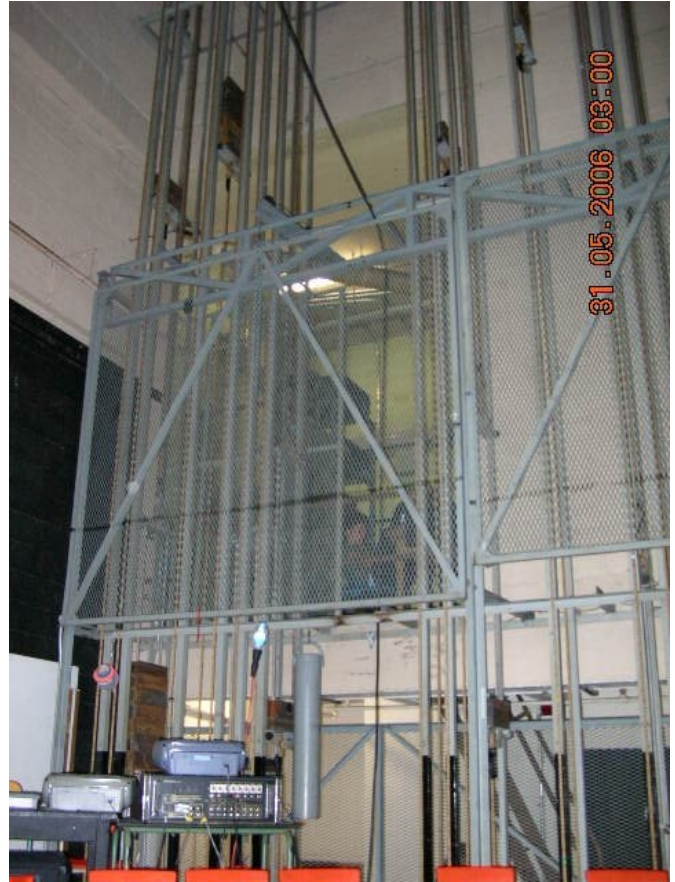
Stage in large Gymnasium has large curtains and movable folding screen. Curtain is operated by elaborate original counter weight rigging system with steel caged walls 12m high, complete with permanent steel ladders and steel grate platforms - minor modifications to the rigging system were completed in 2003.

<u>Rating</u>	<u>Installed</u>	<u>Design Life</u>	<u>Updated</u>
3 - Marginal	1956	25	MAR-09

Stage counter weight and rigging system.

**Event: Upgrade / replace stage curtain rigging system.**

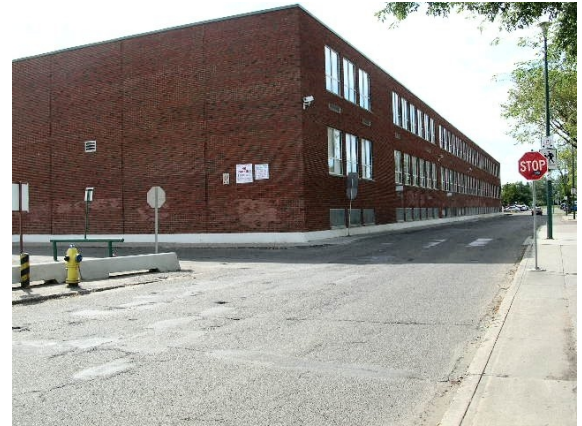
City's public access road to community swimming pool and curling rink.

- 1) Parking lots: Both concerns could result in creation of a new combined parking lot along the east and south-east. Access roads from 135 Street and 111 Avenue to be located as far away as possible from the busy intersection at SE corner (approximately \$747,000.00).
- 2) Access road: Negotiations are underway with the City to abandon this road and to build a new road for public on the west side of the school from 111 Avenue; no action is required.
- 3) Provide adequate space for delivery truck parking for Cafeteria goods and re-build the loading area, may be with a scissor lift (budget amount: \$80,000.00). No action required for the second loading area until Gymnasium expansion plans are finalized and the new City access road on the west side is confirmed.
