RECAPP Facility Evaluation Report

Edmonton RCSSD #7

St. Monica Catholic Elementary School

B3320A
Edmonton

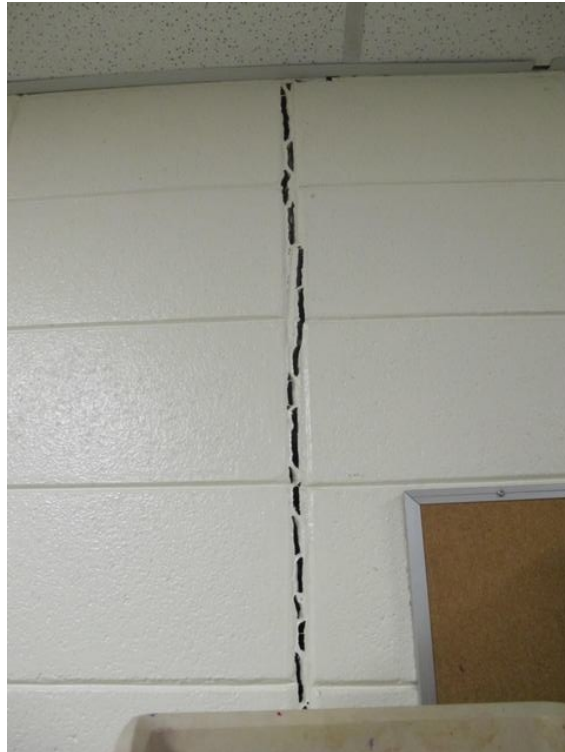
Excessive cracks were observed, primarily along the exterior south and west walls. The load-bearing concrete block walls are showing significant cracking, possible movement of the grade beams and concrete piles.

Excessive cracks along the inside face of the exterior south wall.

Conduct an intrusive soil & structural investigation of the foundation assembly.

Repair as outlined in the intrusive soil & structural investigation of the foundation assembly. (The cost provided is an estimate to repair and/or replace significant components of the foundation assembly.)

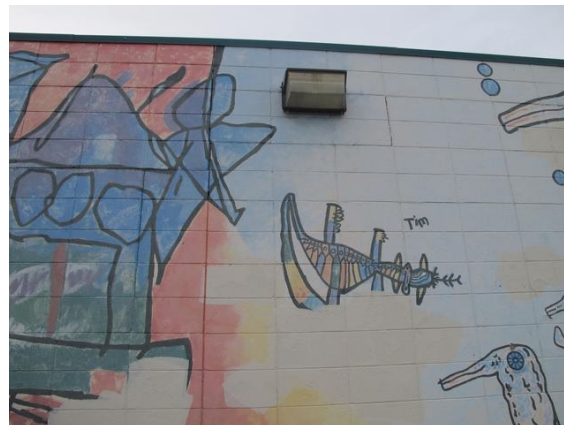
Several cracked between the mortar joints was observed on the exterior south, west and east walls. See A1010 Standard Foundations for details.

Structural movement between mortar joints on exterior east wall

Repair exterior masonry walls and mortar joints as required.

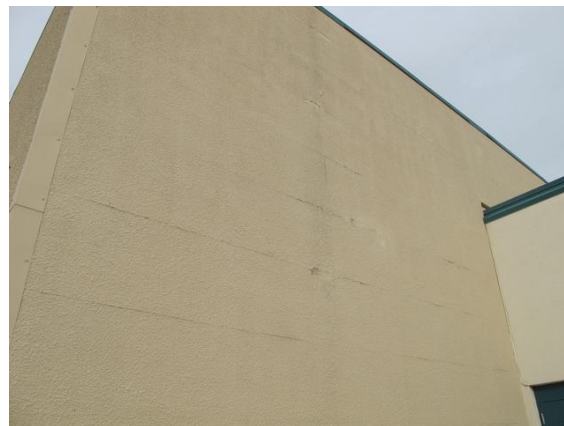
Several cracks were observed on the exterior gymnasium walls. The movement of the foundation assembly may be the main contributor of the cracks on the exterior stucco.

Cracks observed on the south elevation of the gymnasium wall.

Repair EIFS assembly once the structural review is complete.

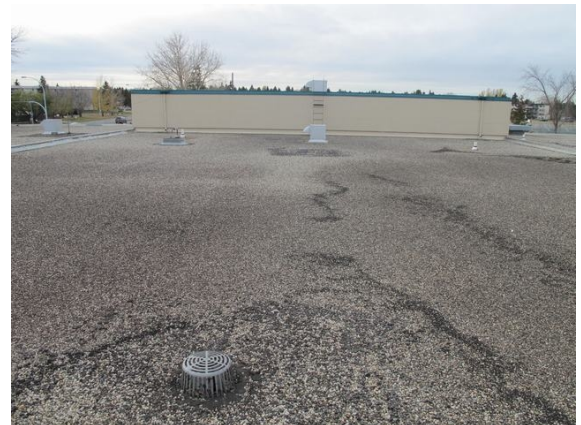
Major water leakage is imminent.

Several blisters and evidence of ponding throughout.

Replace Built-up Bituminous Roofing - Area - 1620m2

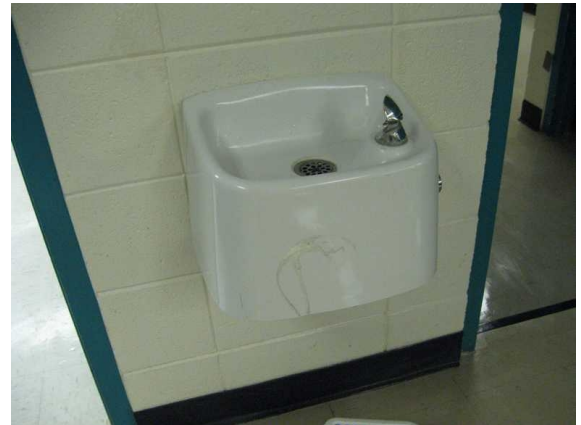
One of the fiberglass cover of the drinking fountain is cracked. Although the crack has been patched, further damage may occur. The durability of the unit is not suitable for this application.

Drinking fountain with crack

Replace the existing drinking fountains with stainless steel type drinking fountains.

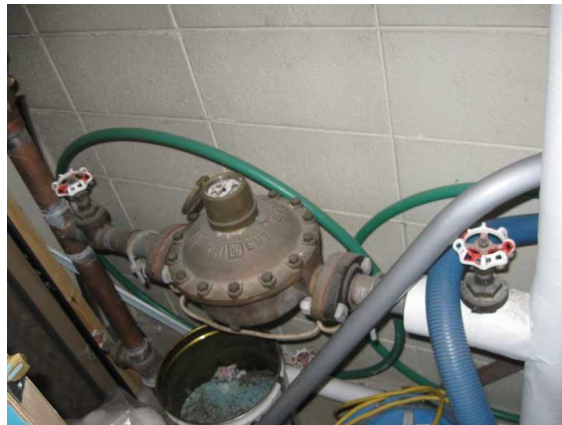
Potential contamination of the municipal water supply caused by backflow from the building.

Domestic water main without backflow preventor

Install a backflow prevention device on the building domestic water supply (50 mm).

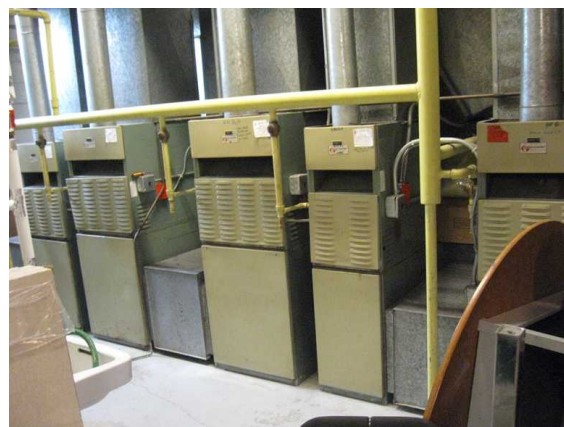
Typical Flame-Master furnaces in Mechanical Room

Replace ten natural gas furnaces with new air handling units.

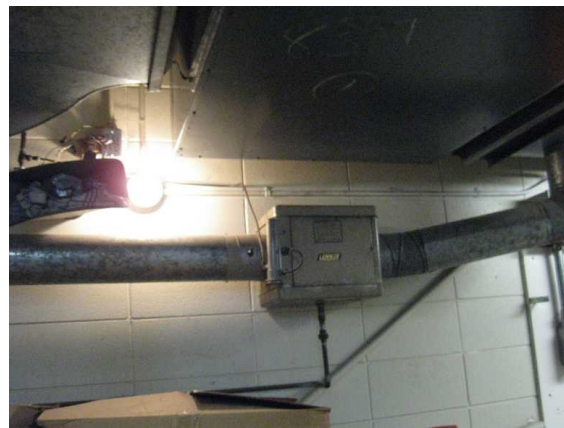
The humidifier is out of order and has been decommissioned. The capacity of the humidifier is not adequate to provide humidity in this building.

Lennox humidifier

Replace existing humidifier with steam type humidifier of adequate size. Water softener shall be installed to prolong useful life of the humidifier.

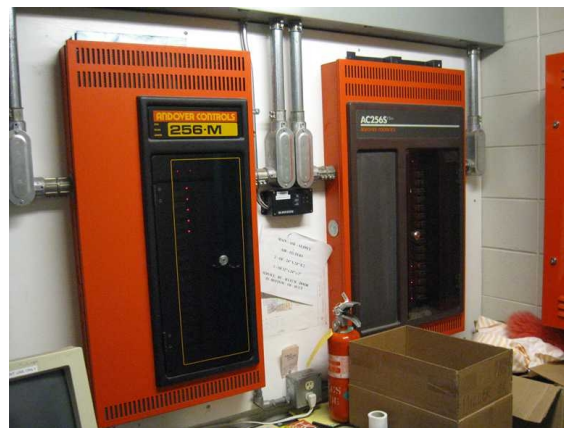
The Building Management and Control System (BMCS) is obsolete and replacement parts for the Andover system are becoming difficult to obtain.

Andover main control panel in Mechanical Room

Replace the Building Management and Control System (BMCS).

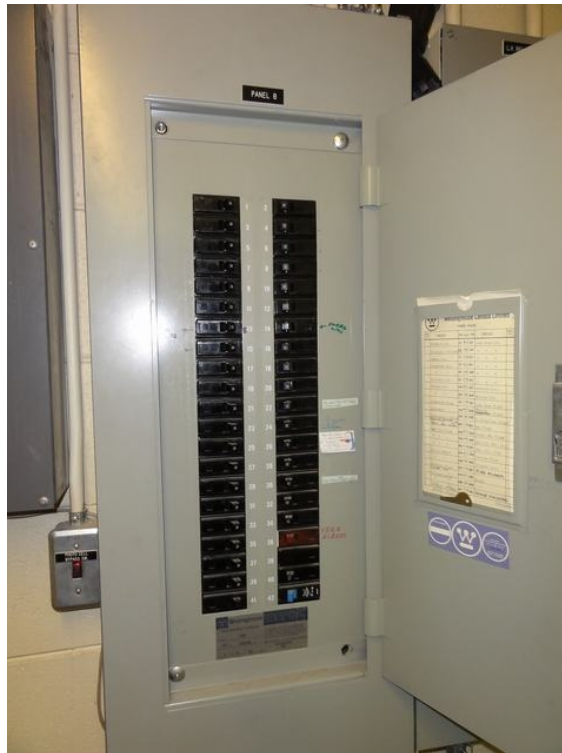
The 120/208V Westinghouse panels are well past their life expectancy and are at capacity. Over the life of the panel, breaker contacts become worn and the breakers will no longer operate correctly and may trip unnecessarily. Older panels do not readily accept newer style breakers.

Westinghouse 120/208V branch circuit panel (1973).

Replace existing panels with new branch circuit panels c/w sufficient circuits to accommodate all building loads.

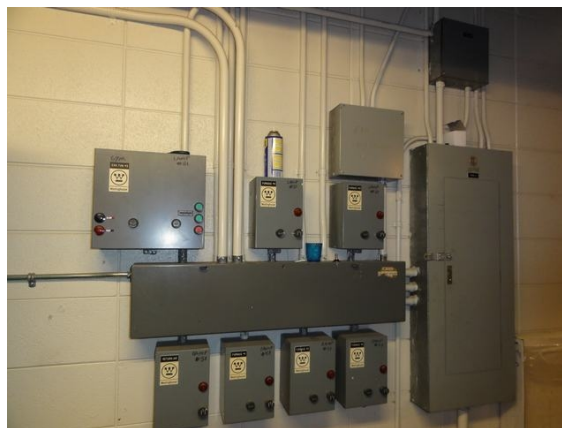
The original motor starters in the building are aged. Replacement parts are no longer readily available.

Westinghouse motor starters in mechanical room.

Replace motor starters and manual motor starter switches.

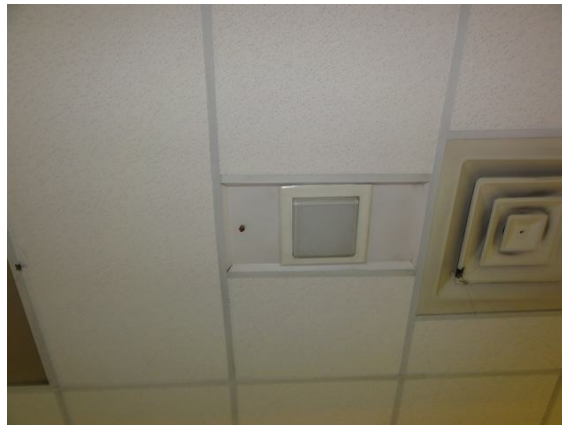
Ceiling mounted emergency lighting unit.

Replace ceiling mounted emergency lighting units with wall mounted emergency lighting battery packs.

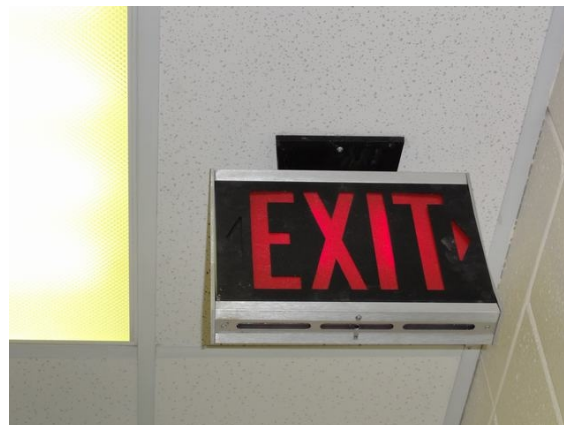
Existing exit signs are in poor condition. Exit signs are not connected to battery backup units.

Exit sign in corridor.

Replace existing exit signs with new LED exit signs (to current code requirements) complete with battery backup.

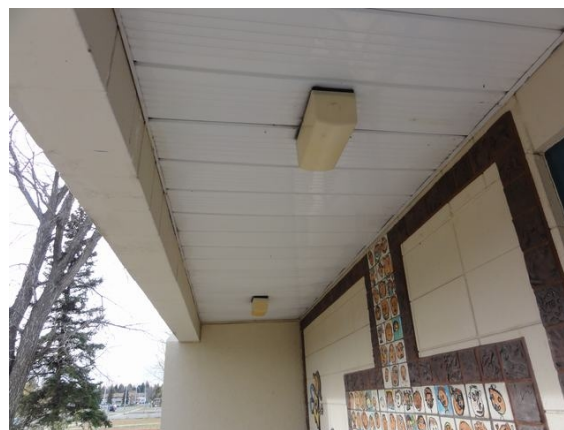
Incandescent lighting fixtures in soffit.

Replace exterior incandescent lighting fixtures with new HPS light fixtures. Repair soffit.

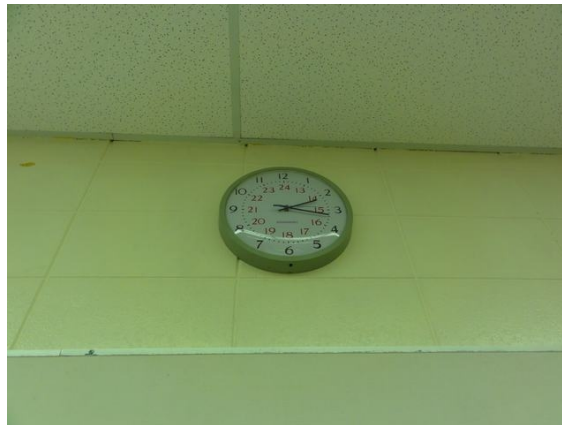
Classroom clock.

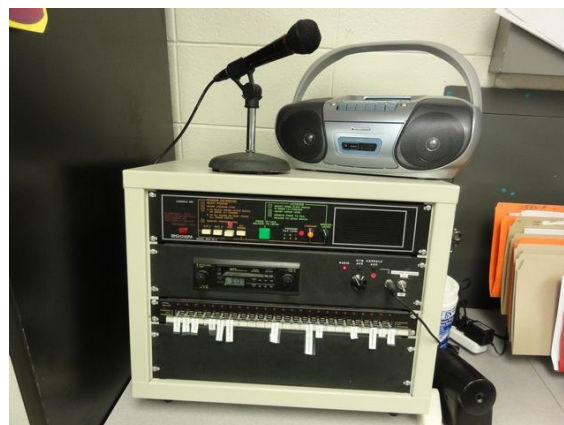
The Bogen MCP-35A P.A. System is obsolete. Replacement parts are not readily available.

Bogen MCP-35A P.A. System in general office.

Replace P.A. system with new system to school board standards.

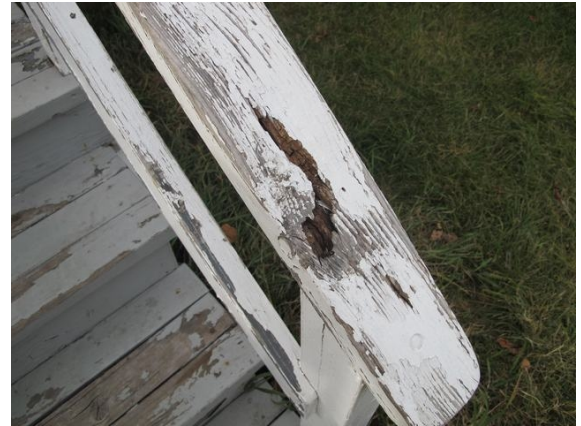
Exterior stair handrails - Portable 238

Event: Replace exterior stair handrails - Portable 238

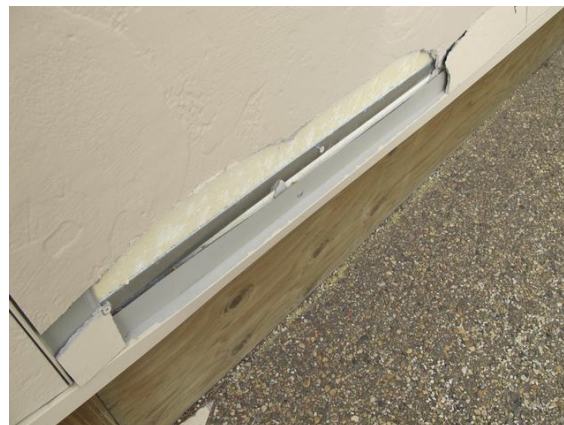
Damaged exterior stucco panel - South Elevation

Repair exterior stucco - South Elevation
