# **RECAPP Facility Evaluation Report**

**Peace River School Div #10**

**E. E. Oliver Elementary School**

**Evaluation Details**

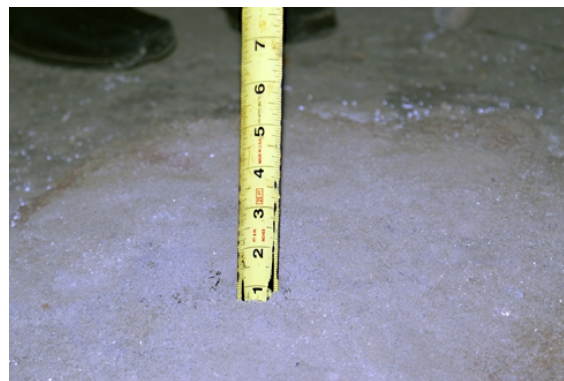
DSC01270-edited.jpg

Mould can be found in significant quantities in the crawl space- up to 1" deep growth. Mould was found along the base of the walls redone from the 1981 addition. Mould events are addressed in the S7 Site.

Mould growth is assumed to be hazardous.

Remove mould and dirt floor surrounding mould growth.  
Remove/dig out 3" depth of dirt from beneath mould growth.  
Remove/dig out minimum 1'-0" surrounding area of dirt from current mould growth. Replace with clean dirt/gravel.

Removed dirt and mould requires treatment.

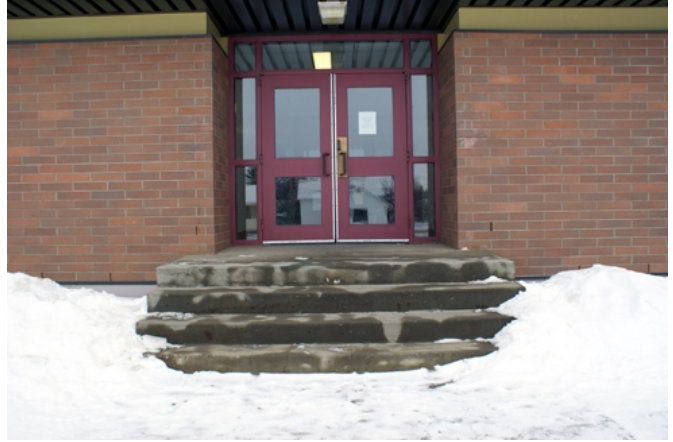
DSC01252-edited.jpg

Stairs are lacking handrails and are badly chipped.  
Mud room #160, 162

Repair concrete stairs and add rails.  
4 Steps. 10'-0" width.

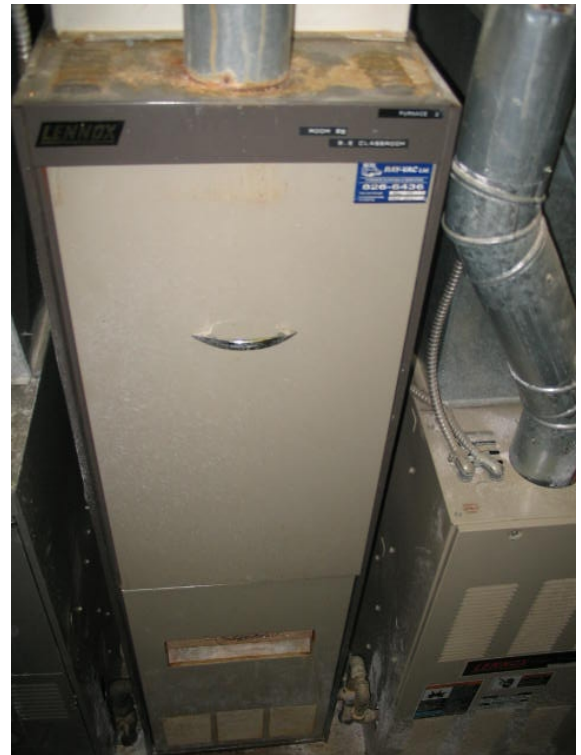
Original furnaces from 1981 deteriorates, parts are not available. One furnace appears to have back drafting problem.

1981 Furnace

Replace 1981 furnaces. Typical of 3.

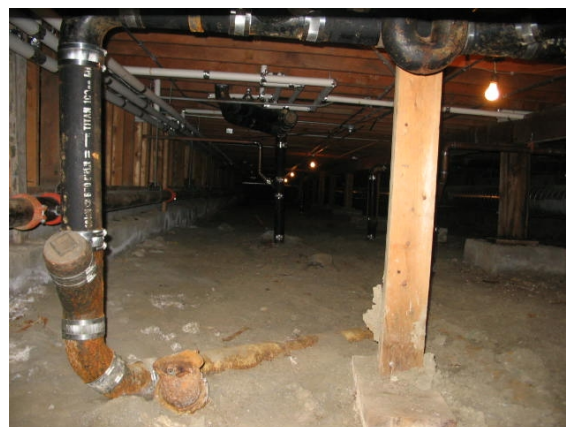
Poor ventilation in Crawl space resulting high moisture level.

Crawl space.
