RECAPP Facility Evaluation Report

Thickwood Heights School

B3437A

Evaluation Company: Burgess Brede Architect Ltd.
Evaluation Date: August 26 2010
Evaluator Name: Mr. Burgess Brede

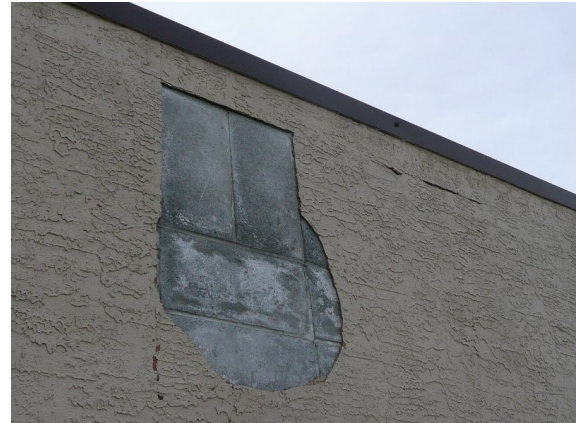
Stucco finish applied over bulk of exterior walls around gym. Cracking and loose sections in stucco; appearance of moisture in stucco. See B2010.02.03.

Moisture migration through concrete block is damaging stucco finish.

Stucco that has fallen off wall since repainting in 2009.

Replace stucco finish with EIFS system complete with insulation.

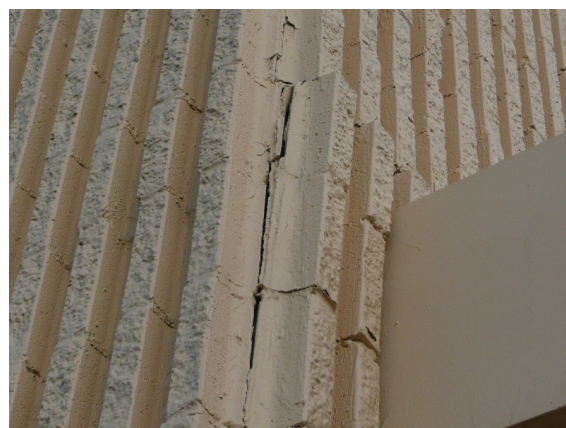
Moisture migration through concrete block is causing cracks and some spalling of face on block.

Spalling could undermine structural capability.

Spalling of concrete block where steel framing of canopy is bearing.

Add spray foam insulation over fluted concrete block. Add EIFS to walls around gym and gym stage. Spalling could undermine structural capability.

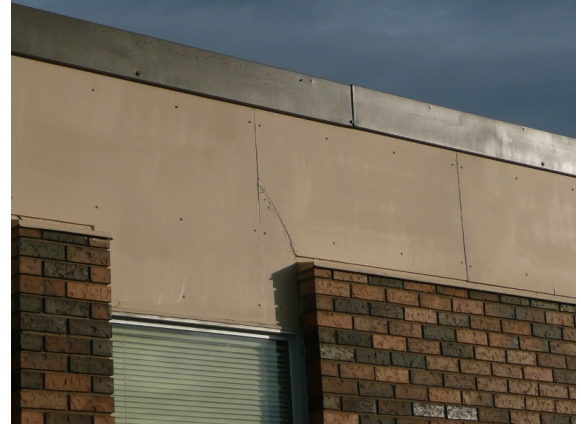
Asbestos panels are cracked and may be admitting water into wall assembly. Plywood panels are cracking due to water penetration.

Cracks in asbestos cement panels.

Replace asbestos panels and plywood with EIFS. Cost increased by 30% for HAZMAT procedures.

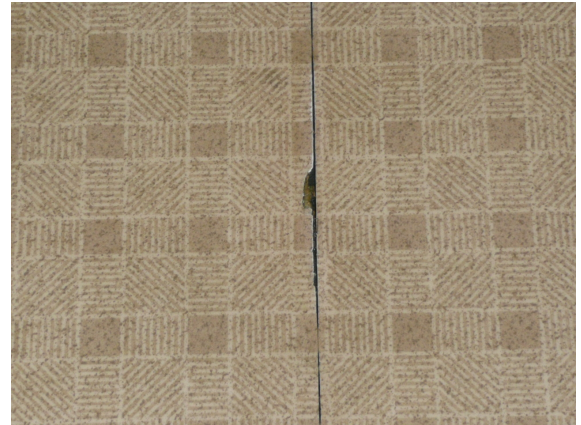
P1090981.JPG

Seams in flooring are opening up and flooring is being damaged.

Replace sheet vinyl flooring in CTS room.

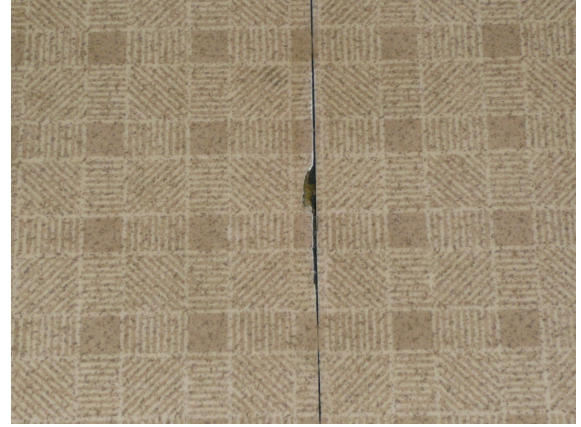
P1090981.JPG

Seams in flooring are opening up and being damaged.

Replace sheet vinyl flooring in CTS room.

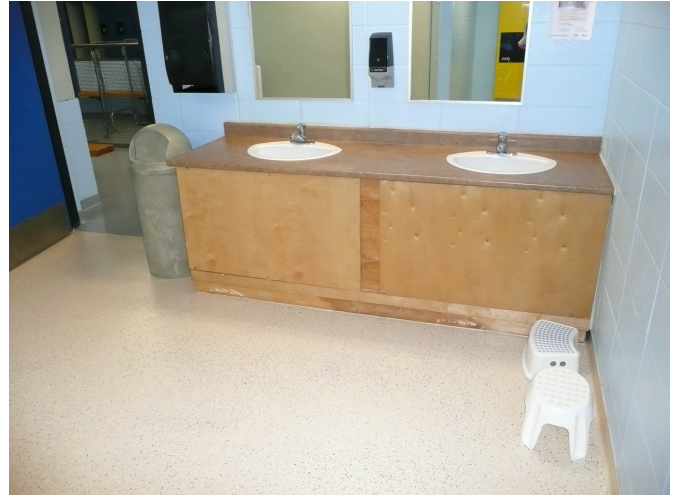
P1090943.JPG

Plastic laminate is cracked and delaminating from casework creating un-hygenic conditions.

Replace vanities in washrooms and locker rooms.
