RECAPP Facility Evaluation Report

Fort McMurray S Dist #2833

Westwood Community High School

B3440A
Fort McMurray

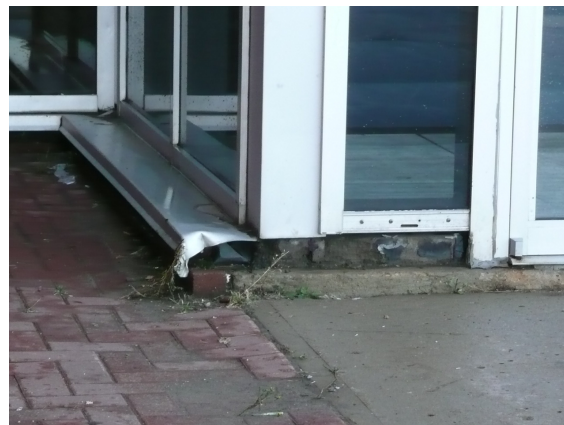
P1090827.JPG

Damages to curtain wall are unsightly.

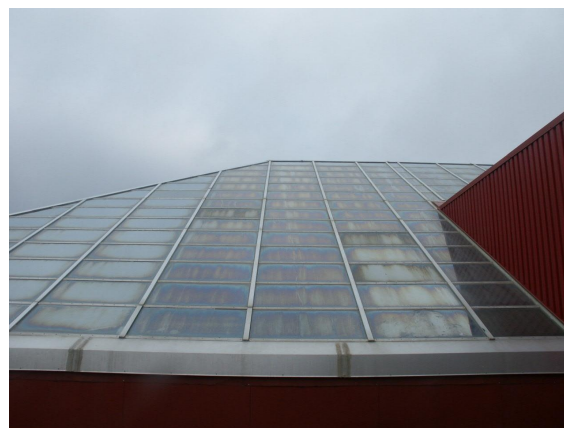
Very large skylight with significant and persistent leaks since building was occupied. Mould detected in ceiling space below.

Oily slick on glazing related to caulking failure.

Replace skylight over streets. Skylight is 1,400 sq m plus 400 sq m of end walls. cost based on Alberta Infrastructure report and should include remedial work to finishes below.

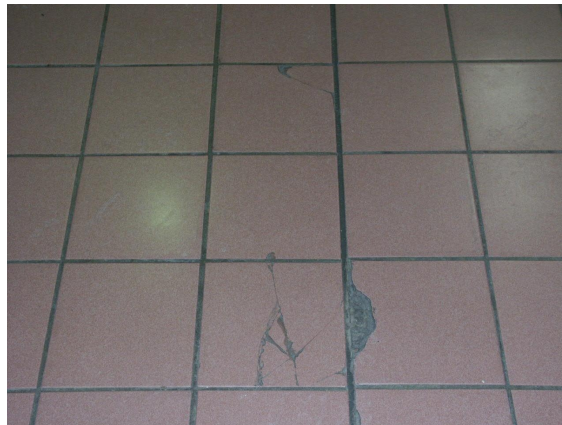
Floor tiles are cracked and damaged in a number of areas. Likely due to glue / mortar voids below tiles.

Cracked and damaged floor tiles in streets.

Repair and replace damaged floor tiles in streets.

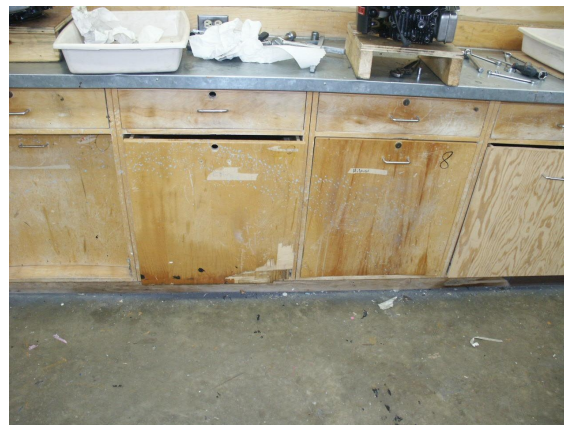
Stained and damaged casework.

Replace casework and countertops in CTS shops with more durable casework.

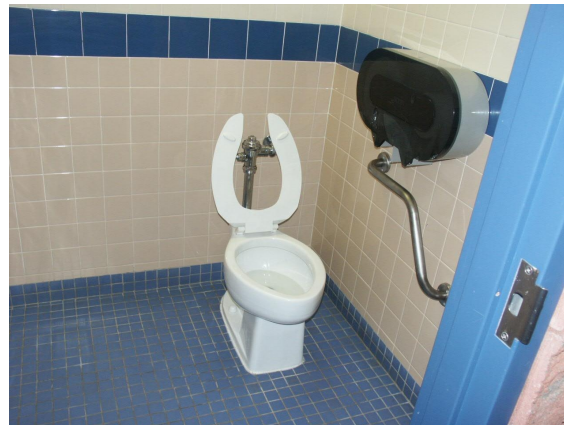
BFA cubicle missing grab bar over toilet.

Upgrade BFA washroom by adding grab bars, notching vanity, lowering a portion of the mirror and providing a wider door to cubicles.
