RECAPP Facility Evaluation Report

Sturgeon School Div #24

Gibbons School

B3471A

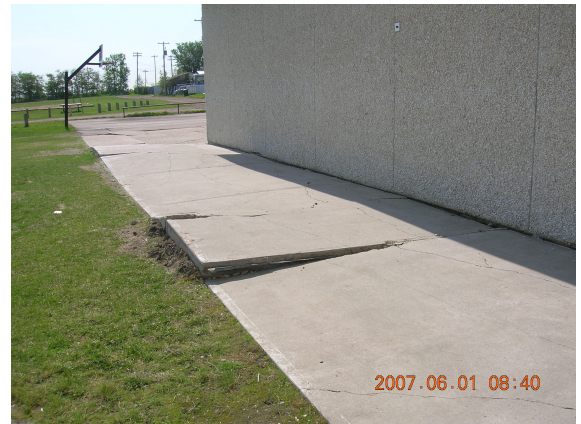
G2030.04 Rigid Pedestrian Pavement (Concrete) - South of Building**

Continuous concrete walk along front of building as well as steps and curbs. Drawings indicate these walks are supported on concrete piles.
